## Compliance Assessment Report CAR\_NRW0037494

**Permit being assessed:** EP3795FQ.

For: Penallta Civic Amenity Site, held by Caerphilly County Borough Council

**Type of assessment carried out:** Site Inspection, Reason: Routine.

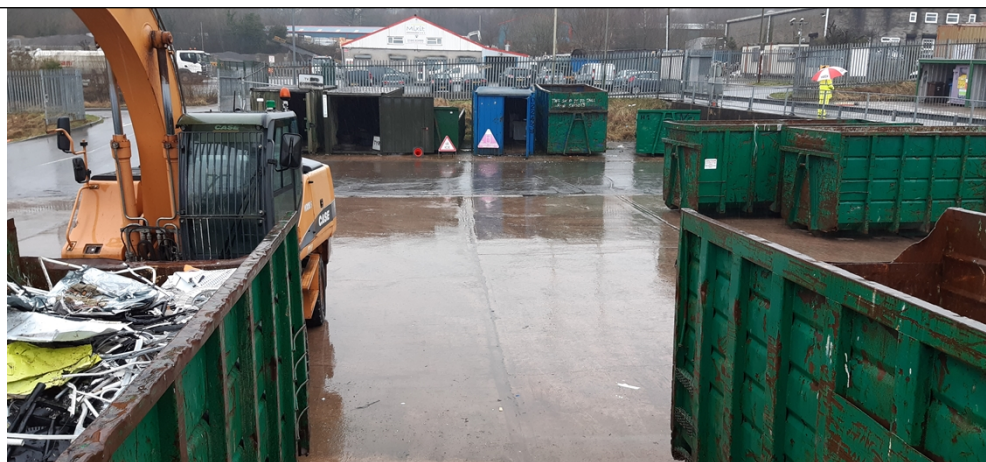
The site had numerous skip containers (as seen in photo 1) which were all clearly identified with the correct labelling waste type to determine which waste would be placed in the correct skip container without confusion. There were also 3 employees on site directing traffic and informing members of the public the correct skip containers to use to segregate the waste correctly. This was witnessed by NRW officers at the time of the inspection.

**Photo 1** - Various skip containers housing segregated waste

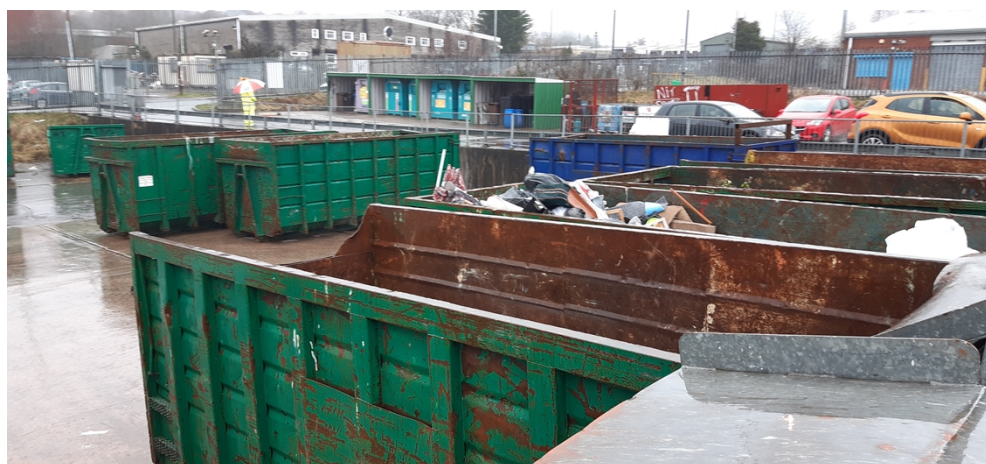
The site was in good condition with no issues with the interceptor drainage system, which was fully operational at the time of the inspection. The general housekeeping of the site was kept to a good standard with very little debris located on the floor and designated zones set up for the various waste streams. The site was abiding by current COVID-19 restrictions by only allowing a small number of vehicles access to the site to drop off waste at any one time. The flooring condition on site is in good order with no cause for concern (as seen in photo 2).

**Photo 2** - Flooring condition along with segregated skips along with good housekeeping standards

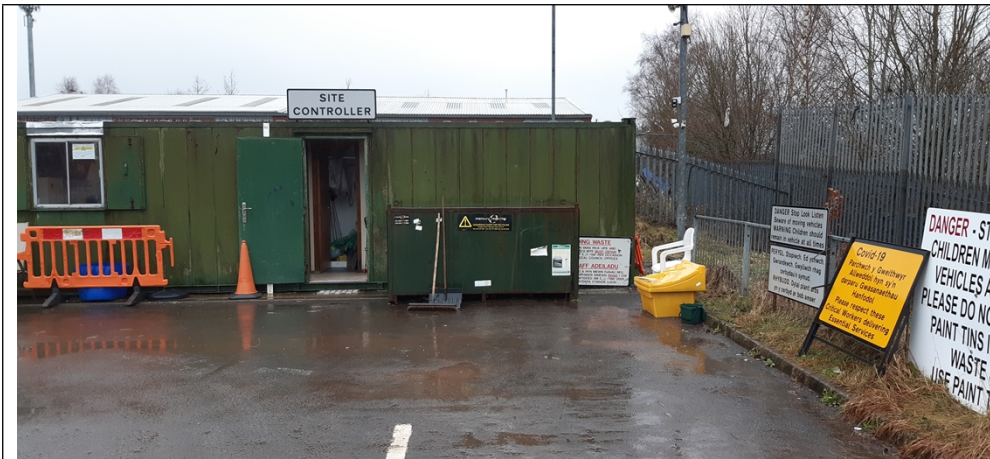
It was noticed by NRW officers that a small green container contained a hazardous waste symbol (as seen in photo 3) which the site manager identified to NRW officers that it contained fluorescent tube lighting. This small green container was correctly sealed and stored and caused no concern at the time of the site inspection. This type of hazardous waste is permitted for this site under EWC (European Waste Classification) **20 01 21\*** fluorescent tubes and other mercury-containing waste.

**Photo 3** - Small green container, sealed and stored correctly containing fluorescent tube lighting

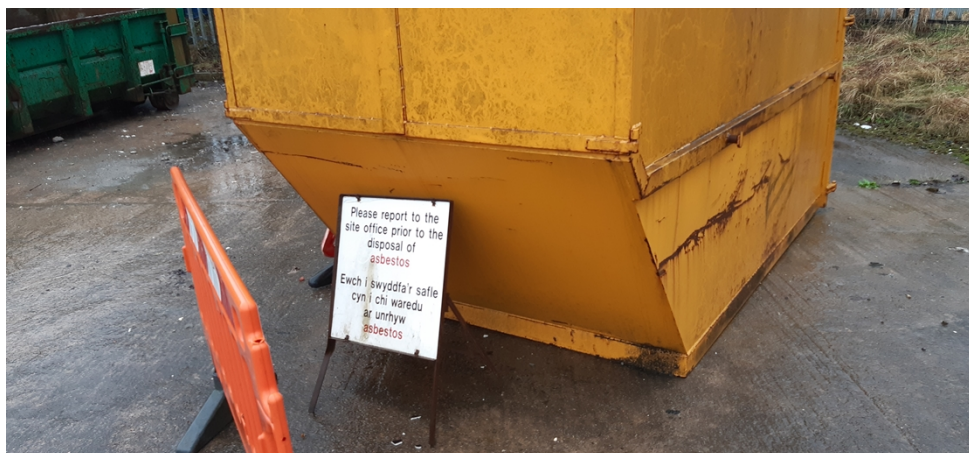
During the site inspection, a sealed skip containing asbestos materials was identified (as seen in photo 4). The integrity of the skip was in good condition with no apparent damaged areas where a possible loss of containment could occur and was situated on site in a designated / quarantined zone away from persons. The site manager informed NRW officers that the asbestos must be double wrapped (to prevent loose fibres) before it is accepted on to site. There was no issue with this container during the site inspection.

**Photo 4** - Sealed skip containing asbestos waste

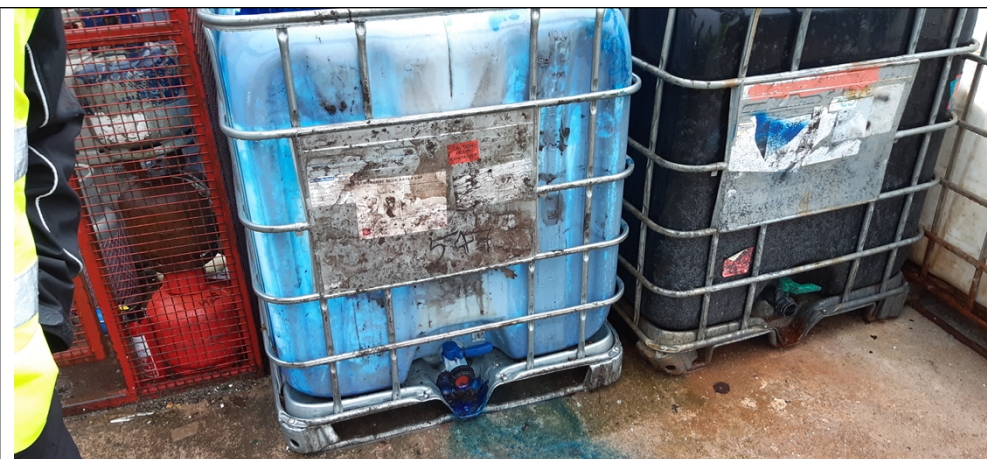
Prior to leaving the site it was noted by NRW officers of a potential leak / loss of containment from a IBC (Intermediate Bulk Container) due to a small amount of blue liquid emanating from the tap point on the IBC (as seen in photo 5). This IBC contained hazardous liquids such as paints and chemicals. The liquid was draining to the on site interceptor drainage system, which was fully operational and no cause for concern at the time of the site inspection. It was noted, as a quick countermeasure, that adding absorbent pads / sawdust to the affected area would help alleviate the issue with a new IBC / secured tap a longer term solution.

**Photo 5 - IBC with blue liquid leaking from tap point**

| Criteria | Action needed | Complete by |
|---|---|---|
| B4 | Ensure IBC's on site have no potential loss of containments of hazardous liquids | 01/03/2021 |

**ACTION:** Ensure loss of containment from IBC's is prevented with the appropriate countermeasures in place
