As mentioned in our application for an NRW transitional abstraction licence, the Whitworth 1 Mine Water Treatment Scheme (MWTS) has not been regularly monitored for flow rates.

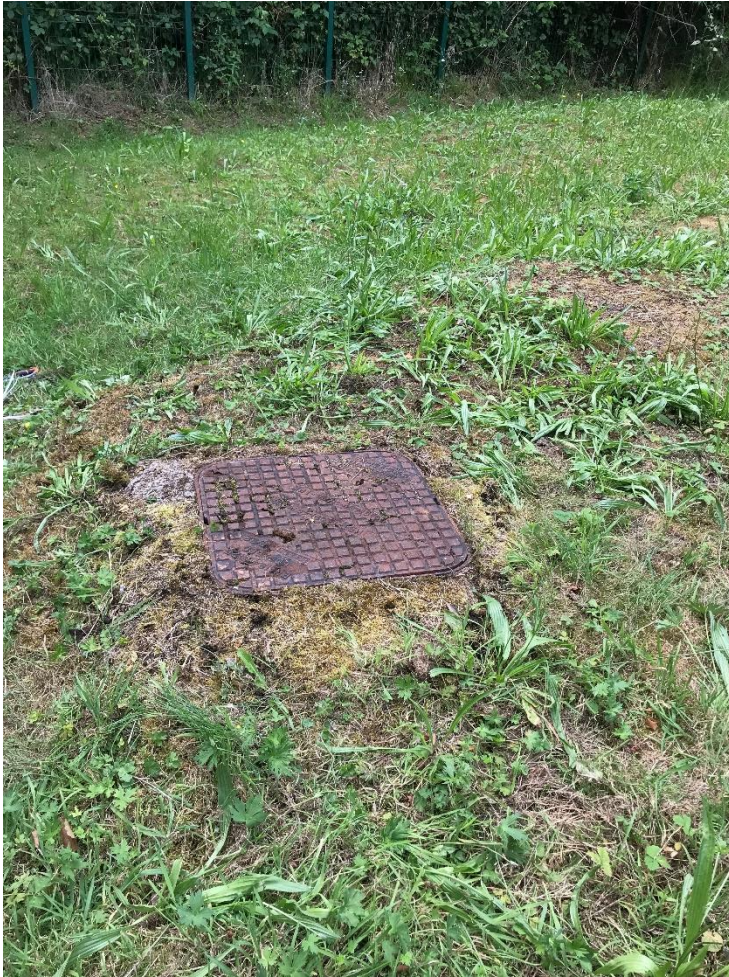
Photo A shows the access to the V-notch weir chamber.

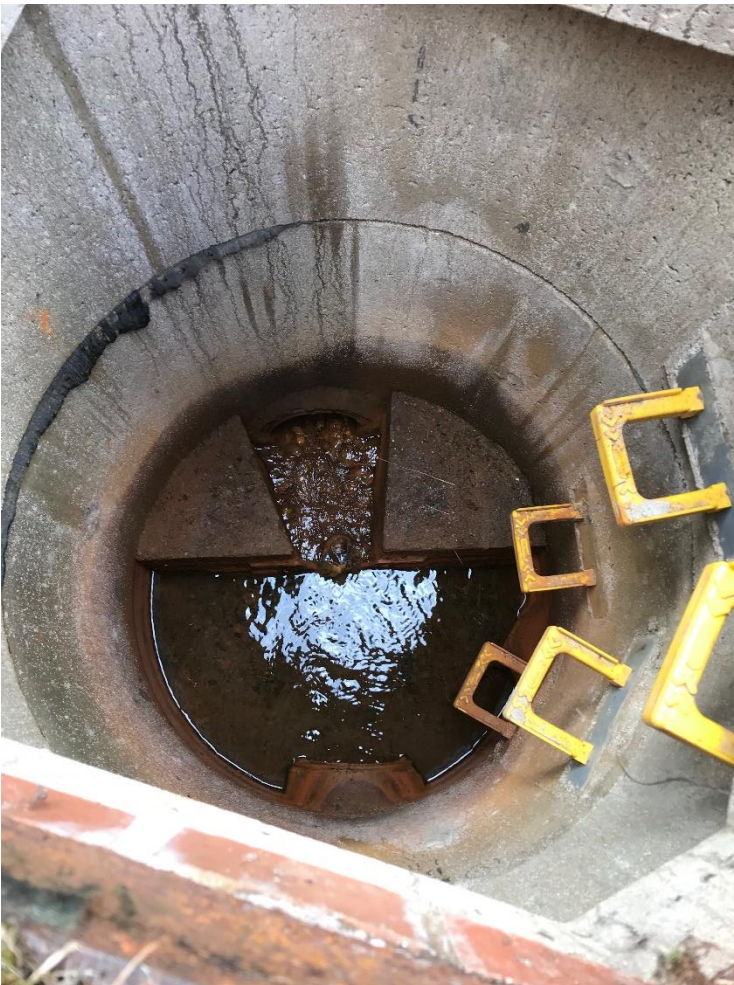
Photo B shows the confined chamber. The v-notch weir can be seen in the centre of the photo. It is thought that the weir plate is a 90 degree weir although this cannot be confirmed as access into the chamber is not permitted.
