STATUS: SUITABLE FOR REVIEW AND COMMENT **S3**

Project: Newport Transporter Bridge

Proposed Repair Details Marking Plan

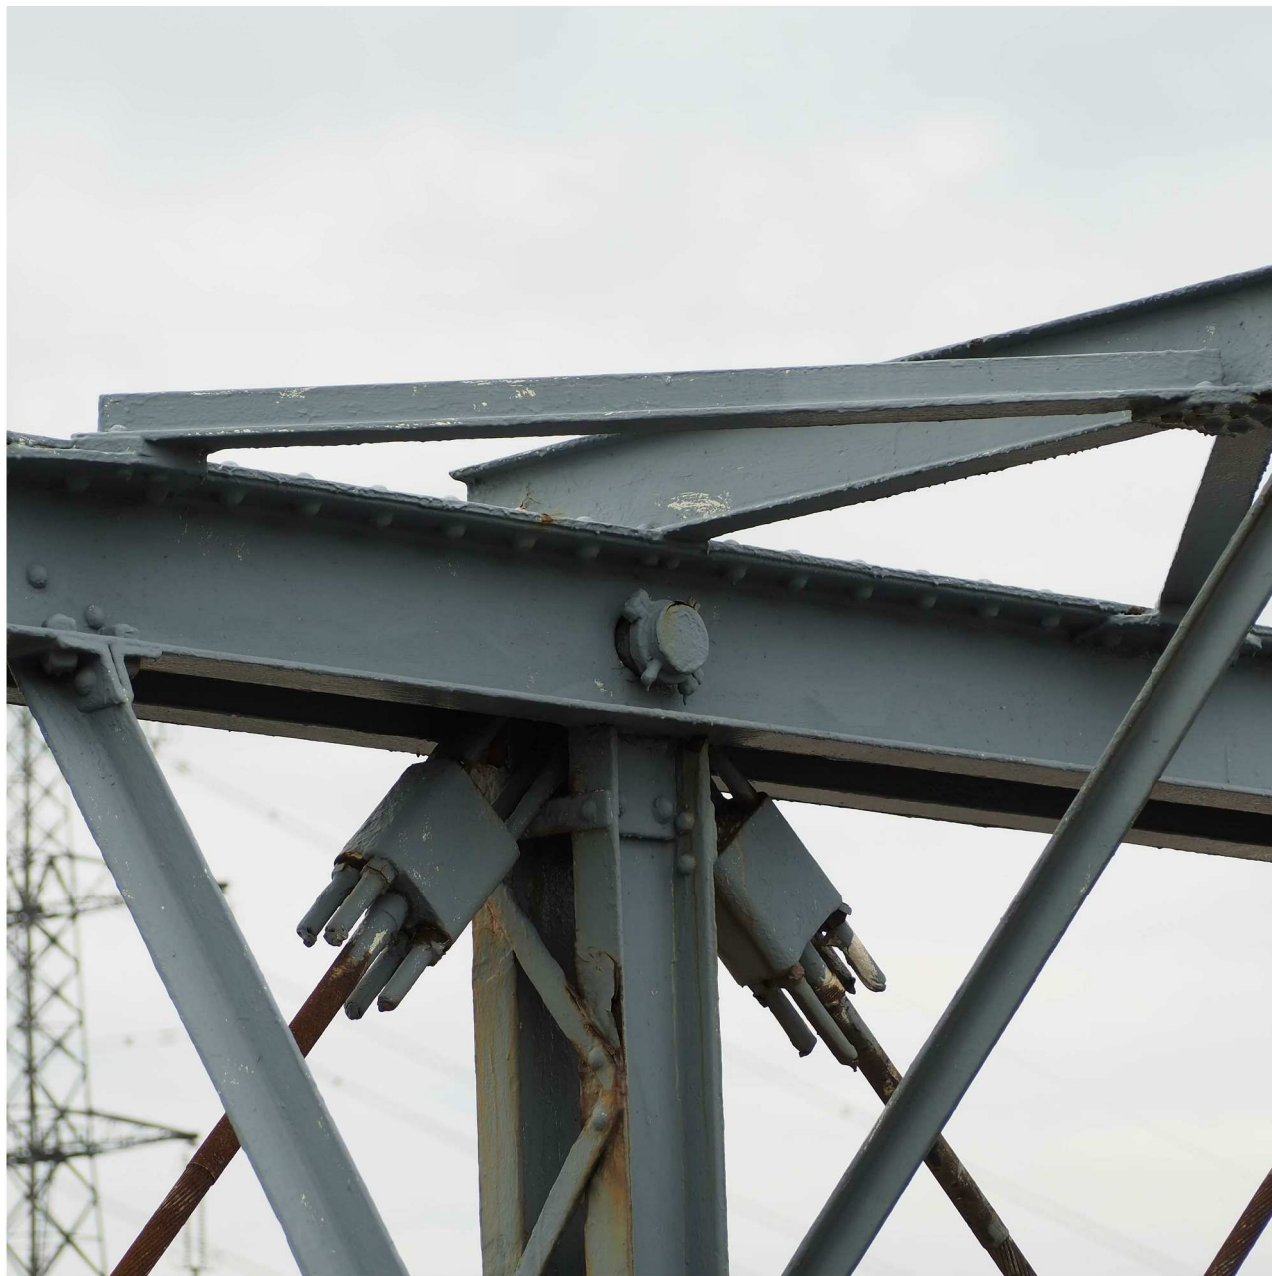
Typical In-situ condition

For typical repair detail of element  
shown refer to drawings  
B072084-CUR-ZZ-ZZ-SK-D-27112/113

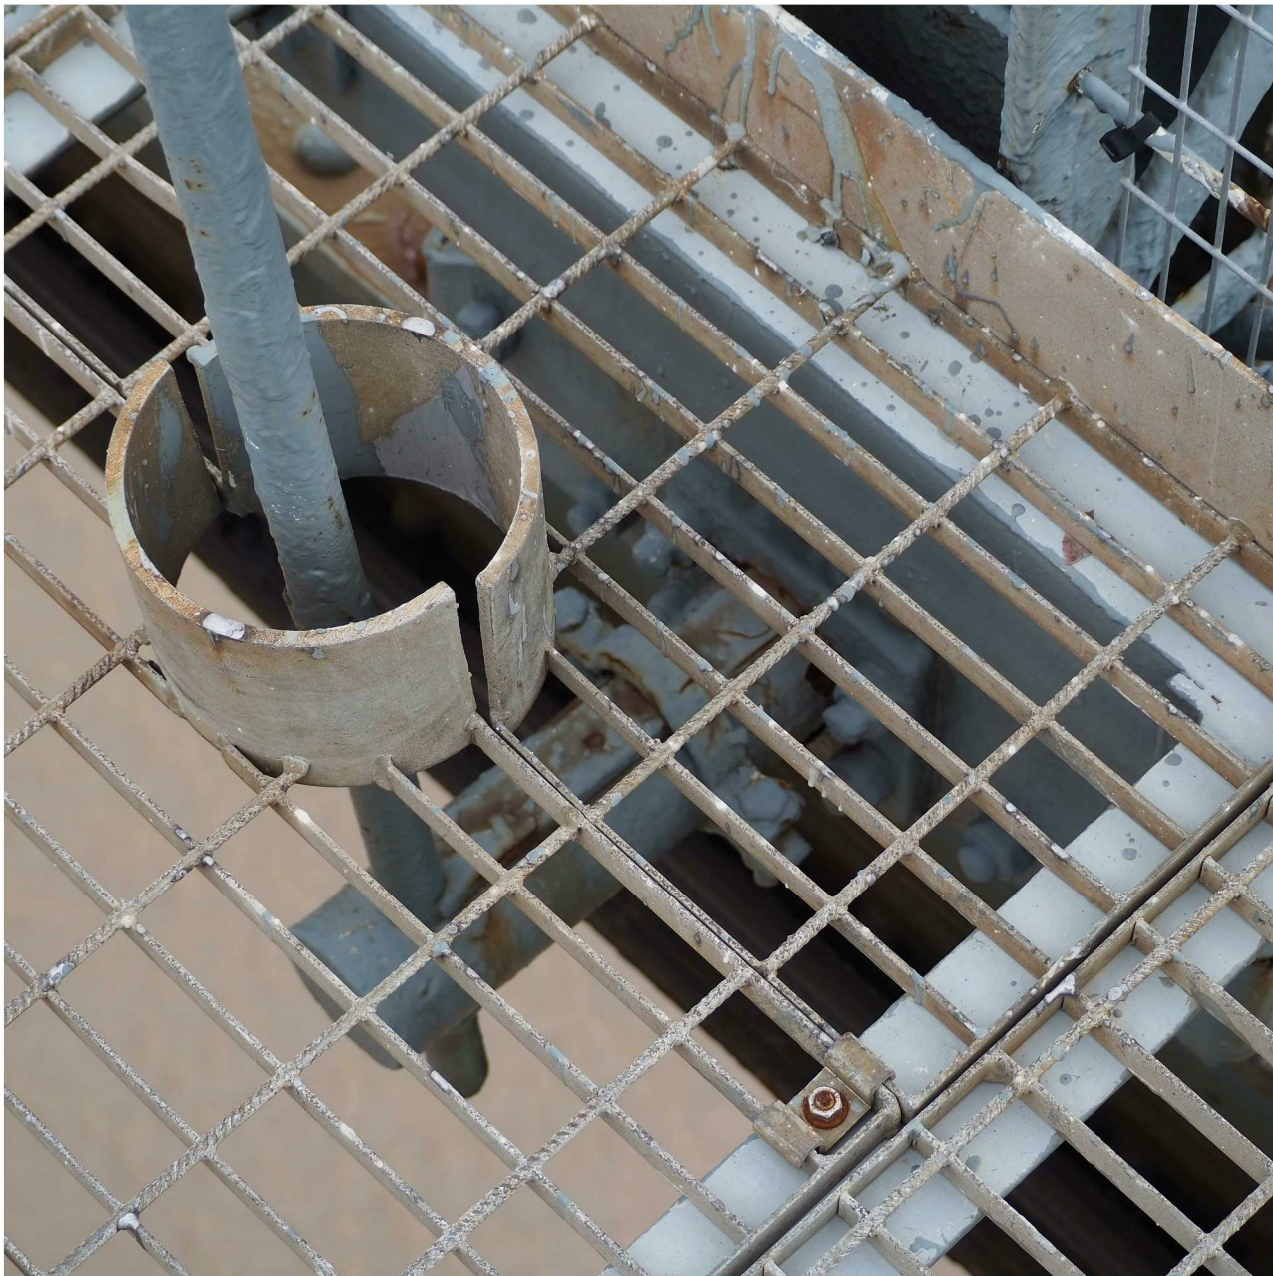
Typical In-situ condition

For typical repair detail of element  
shown refer to drawings  
B072084-CUR-ZZ-ZZ-SK-D-27114/115
