Project: **Newport Transporter Bridge**

Orig Title: **Proposed Repair Details Marking Plan**

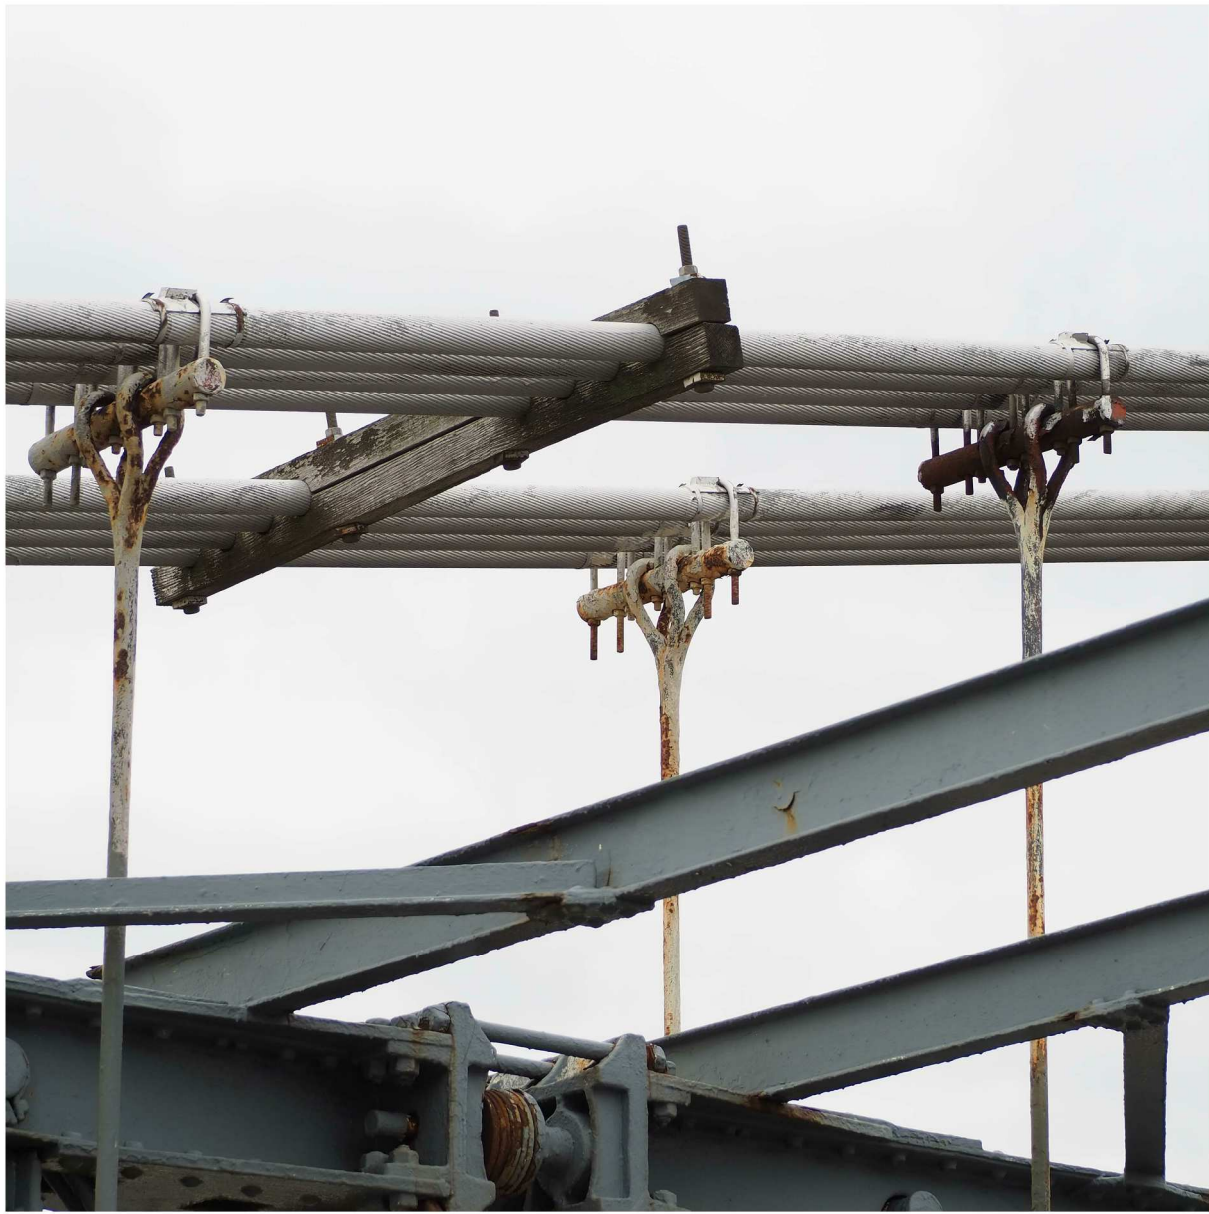
Typical In-situ condition  
For typical repair detail of element  
shown refer to drawings  
B072084-CUR-ZZ-ZZ-SK-D-27116/117

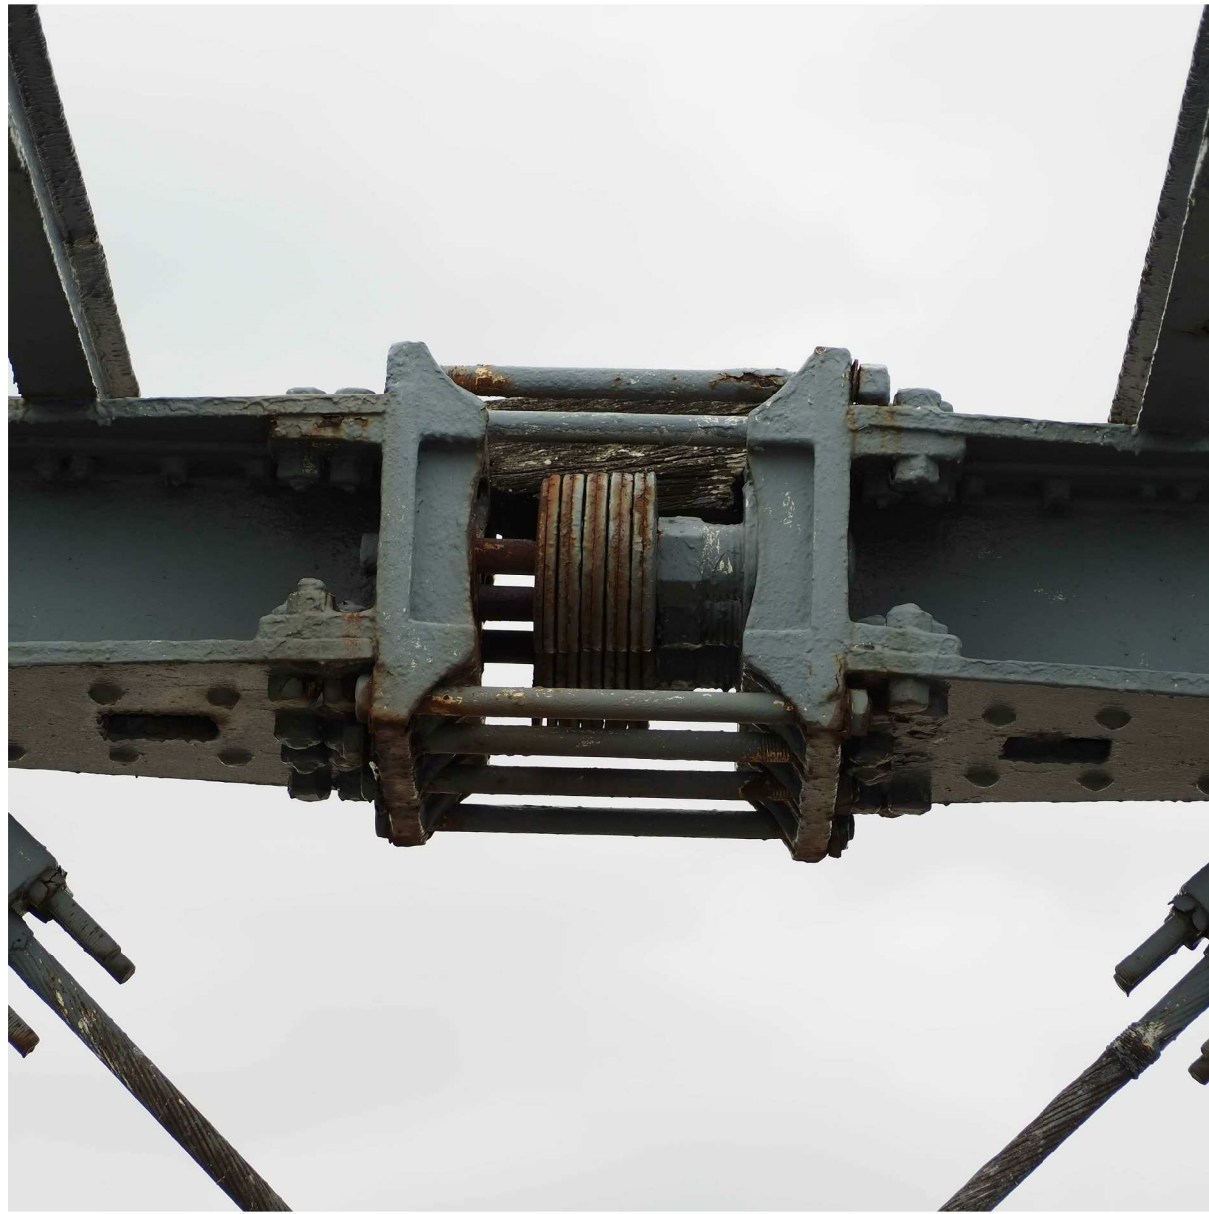
Typical In-situ condition  
For typical repair detail of element  
shown refer to drawings  
B072084-CUR-ZZ-ZZ-SK-D-27118/119
