Location	Type	Sub-type
ABERDOVEY, WALES, LL35 ORG	CAD Drawing	
Role	Sub-Role	Zone
Civil Engineer	Structures and Buildings	Wales Region
Phasing	Grip Stage	Region
	5	Western and Wales

Contract No.	Contract Title	Drawing Title
162906	Pant Eidal Bridge	EXISTING GENERAL ARRANGEMENT PLAN AND SECTIONS

162906-CGE-WLS-DJP-DRG-ECV-000003

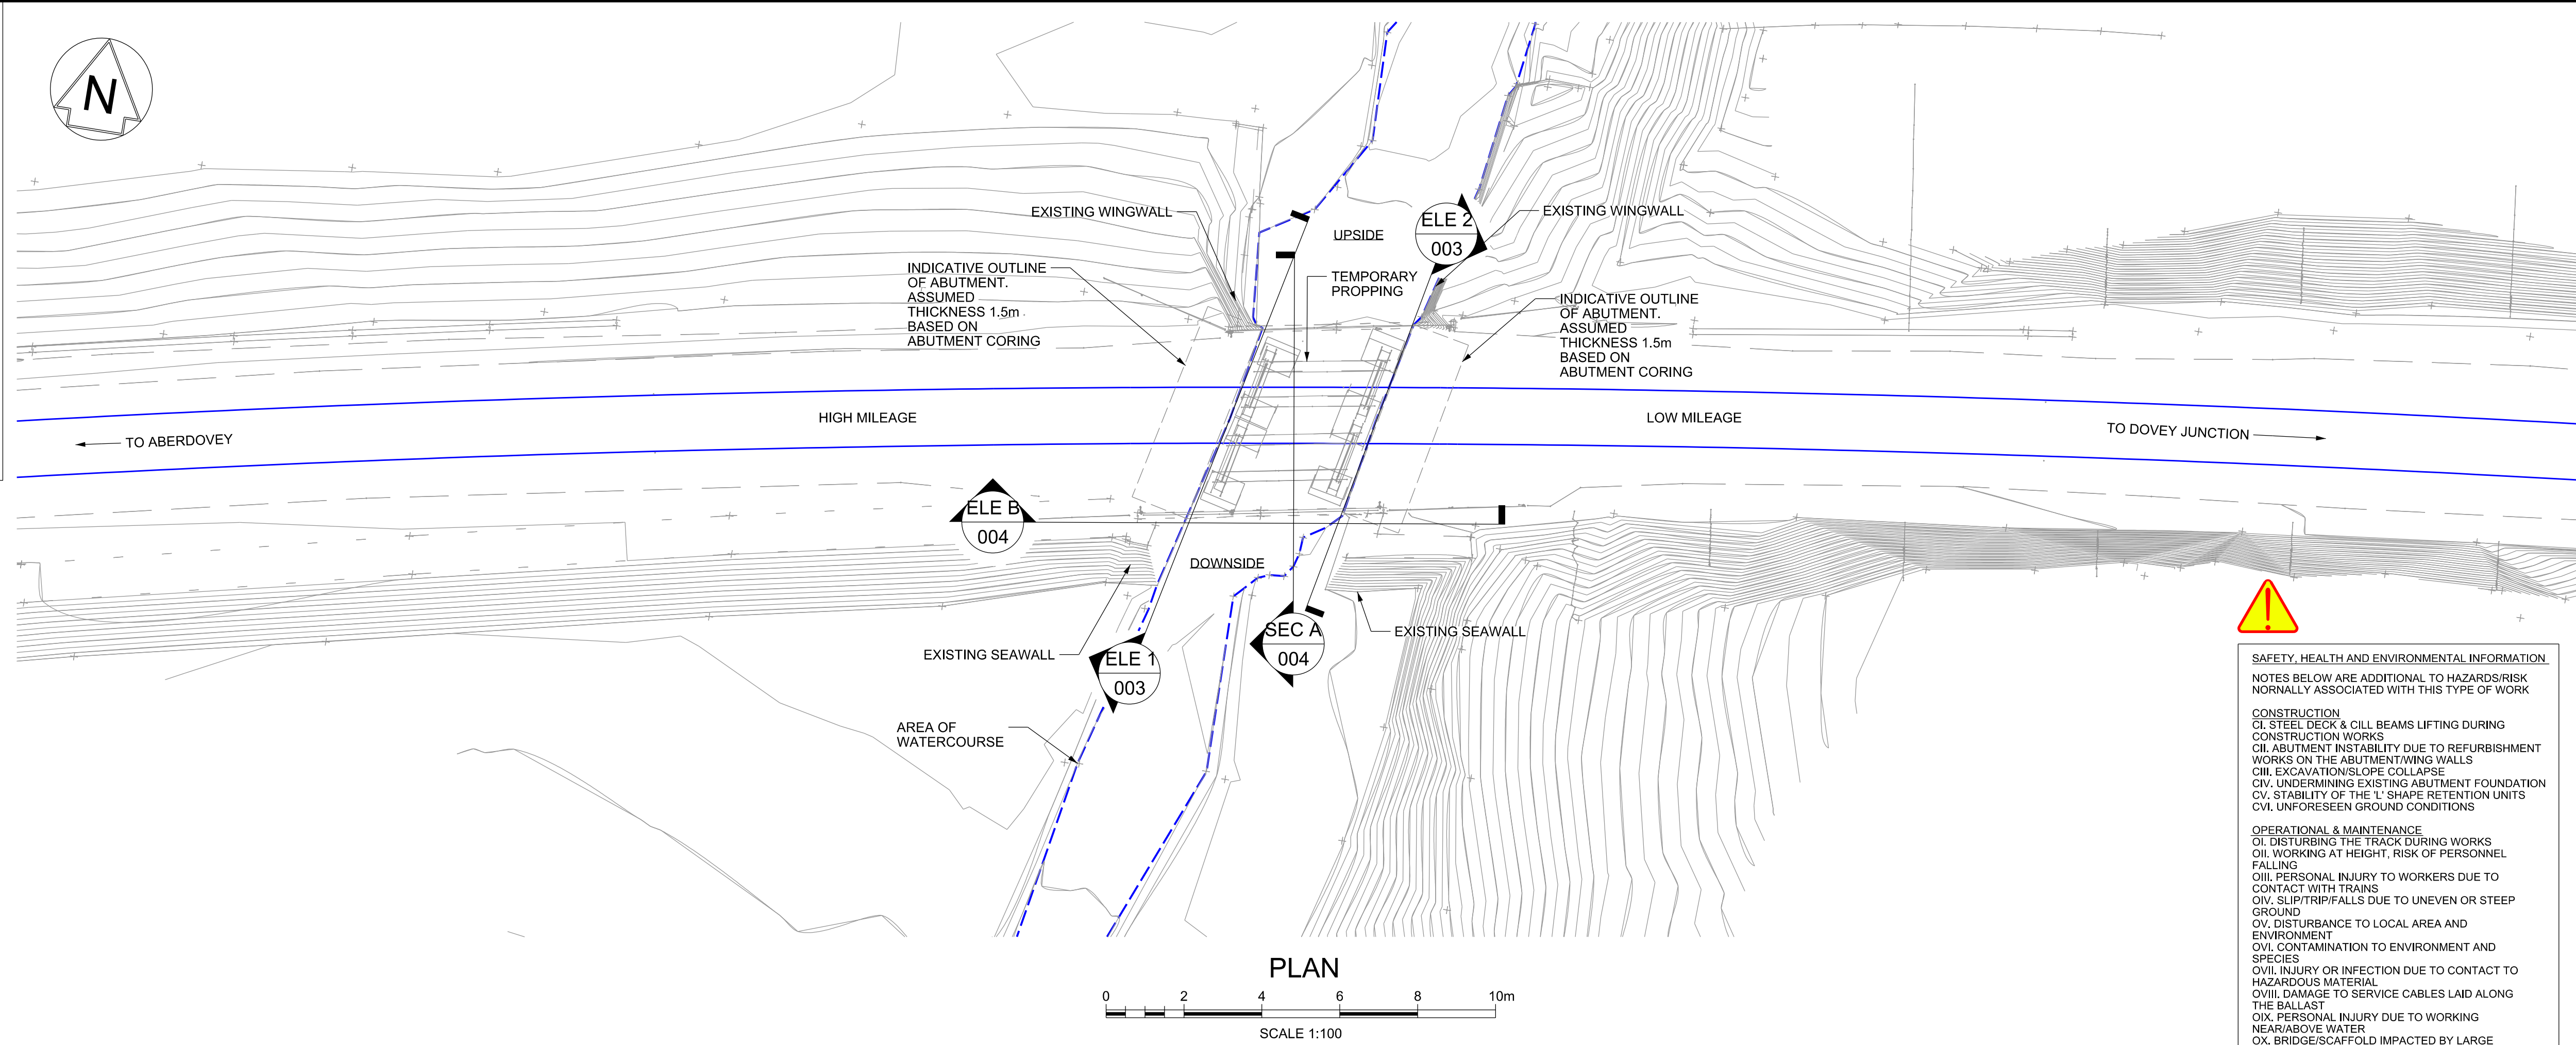
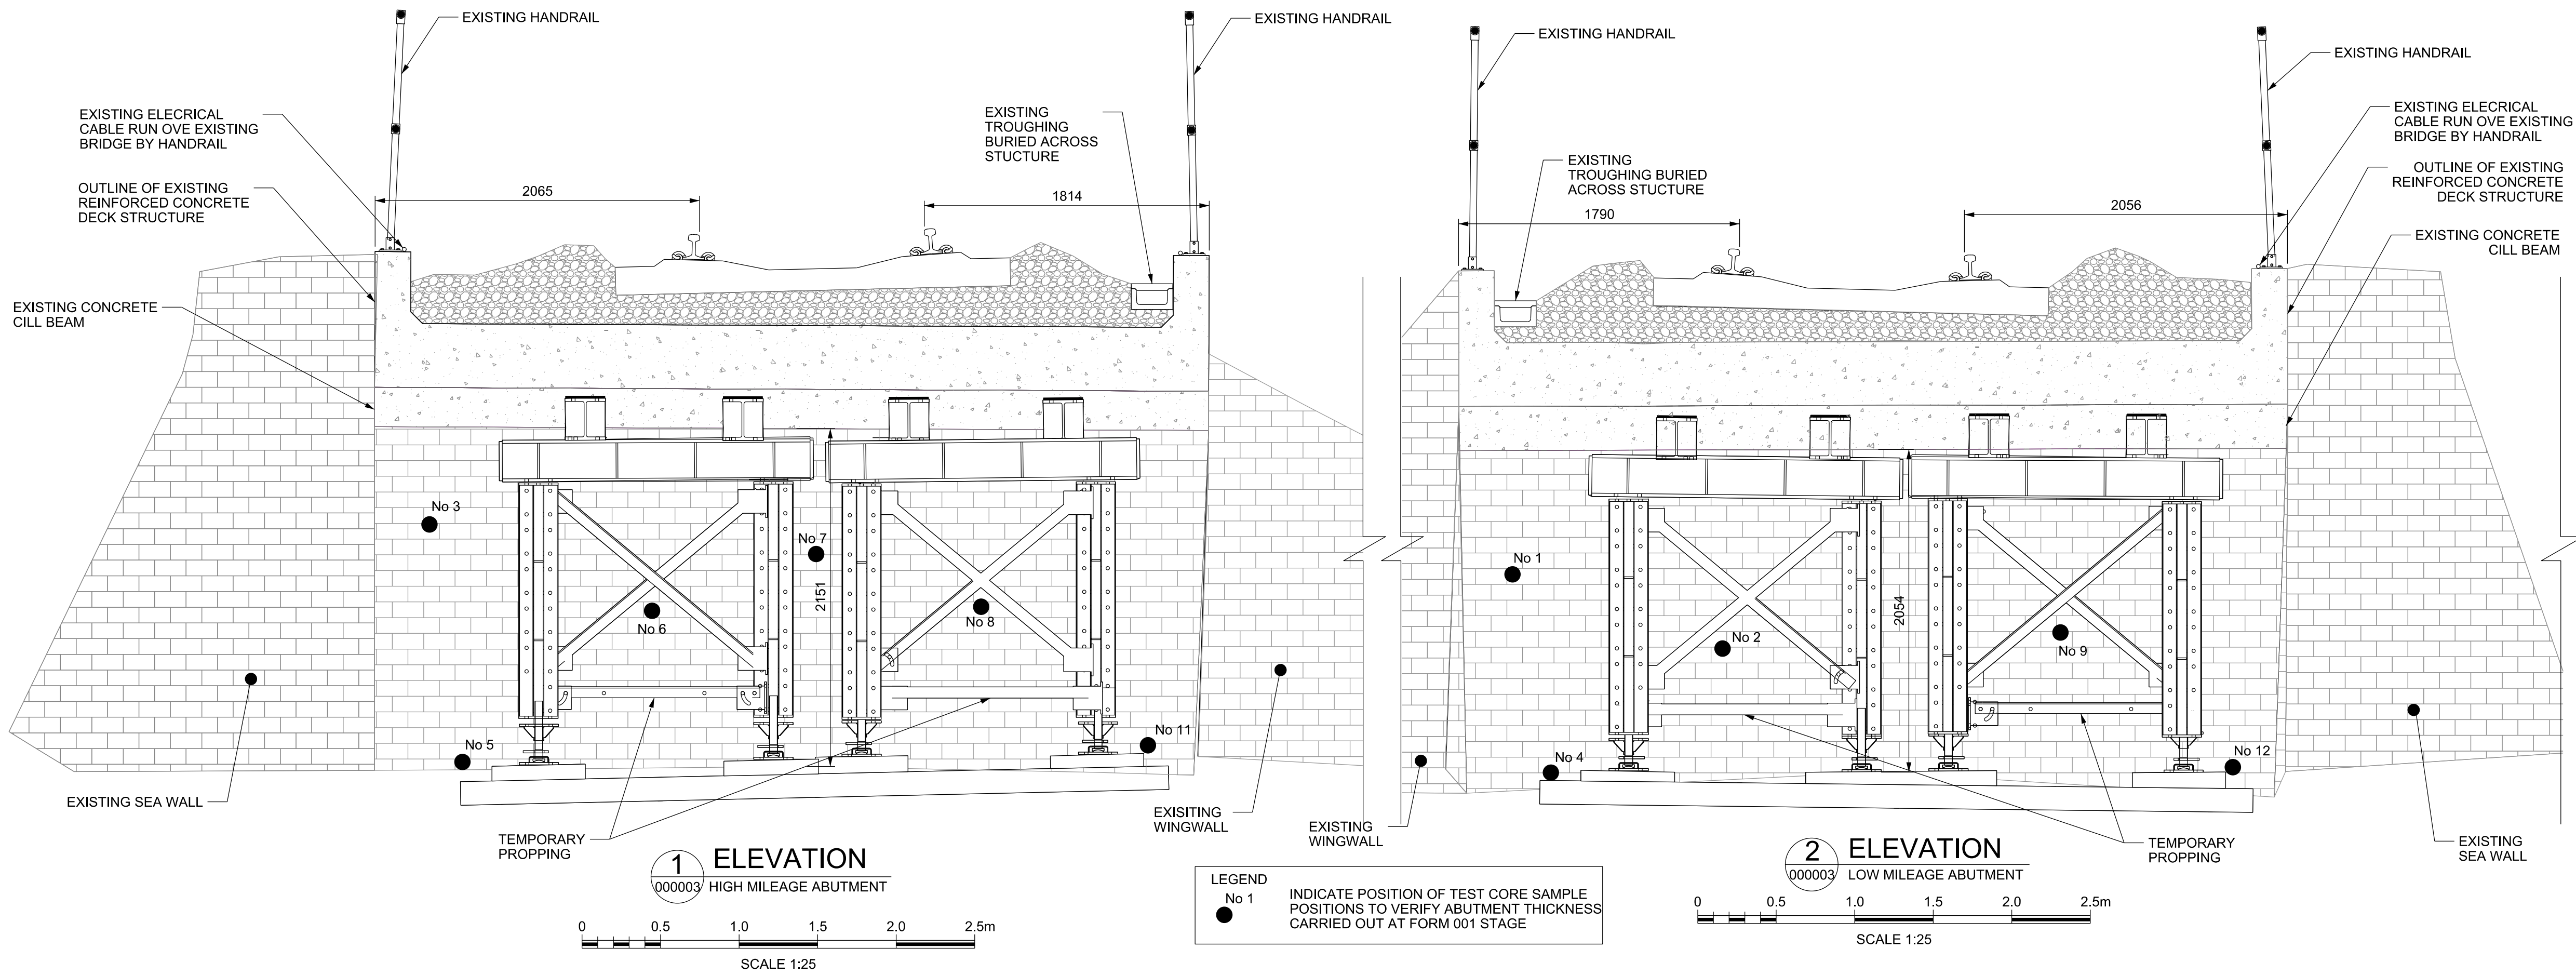
- EXISTING ABUTMENTS TO BE BROKEN DOWN TO APPROPRIATE LEVEL TO RECEIVE MORTAR BED AND PROPOSED NEW CILL BEAM
- EXISTING CABLES ON BOTH THE UPSIDE AND DOWNSIDE TO BE TEMPORARILY REMOVED, SUPPORTED AND REINSTATED IN CABLE ROUTES CONTAINED BELOW PROPOSED WALKWAYS

- EXCAVATION TO BE CARRIED OUT AT THE BACK OF THE ABUTMENTS DURING CONSTRUCTION. DECK TO BE FIXED TO THE ABUTMENT IN ORDER TO ACT AS A PROP IN THE PERMANENT STATE.

- TEMPORARY WORKS REQUIREMENTS TO BE DETERMINED AT DETAILED DESIGN STAGE
- BALLAST DEPTHS TO BE MINIMUM OF 250mm ACROSS THE STRUCTURE FOR WATERPROOFING PROTECTION
