Hendy Quarry Landfill: Permit Variation Application (EPR/BT1088ID)

For the addition of waste types and increase in
maximum discharge volume

Report reference:
62487R1, September 2018

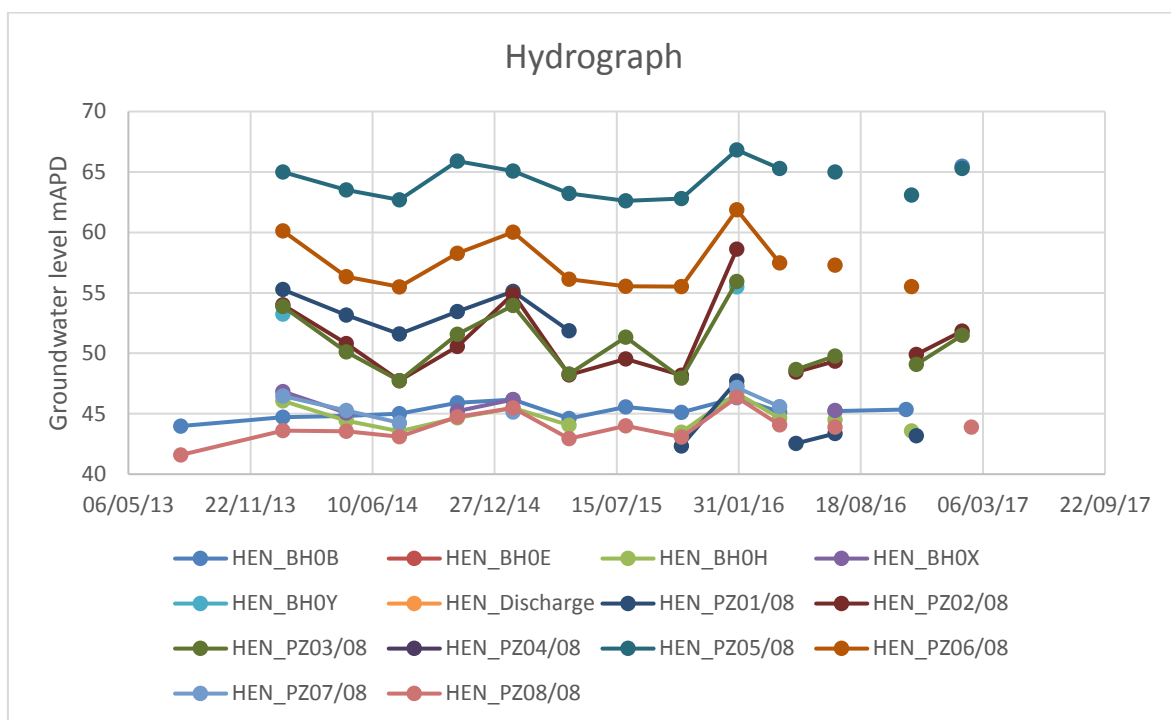
2.3.14 The base of the quarry is circa 45-46 mAOD. This is similar to the minimum water levels monitored within the up gradient boreholes which indicates that there is no significant (>1m) unsaturated zone beneath the base of the site, however there is no reported groundwater ingress within the base of the quarry.

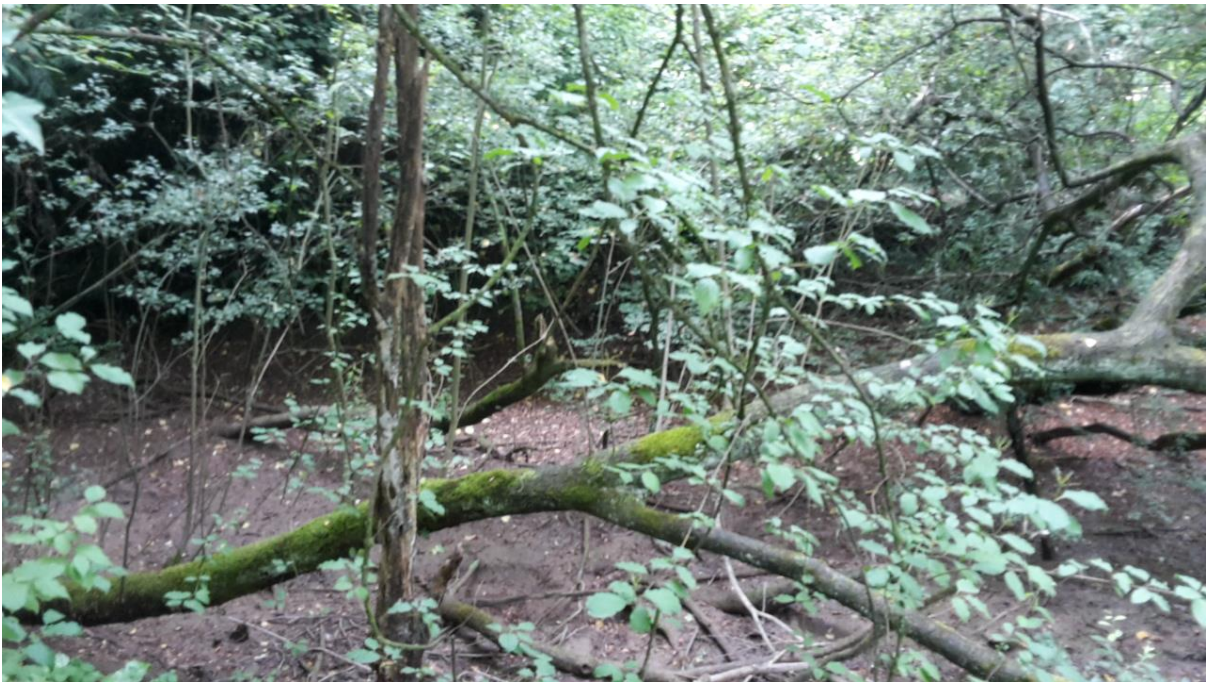
Hendy sump
