## Compliance Assessment Report CAR\_NRW0038550

**Permit being assessed:** FP3095ET.

For: Locks Yard, held by South West Wood Products Ltd

**Type of assessment carried out:** Site Inspection, Reason: Routine.

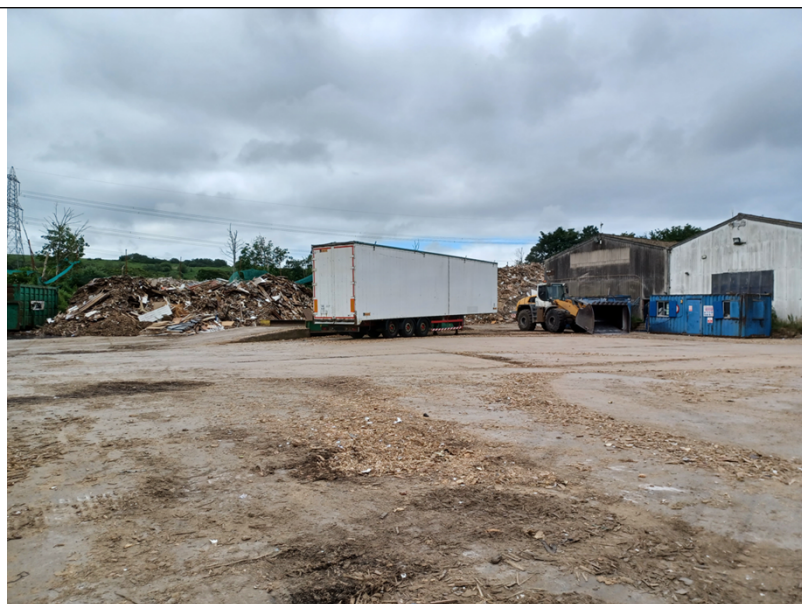
Officers observed during the visit a considerable amount of debris/fibres that had accumulated around site, as can be seen below. The Site Manager advised that a road sweeper attends site as and when required. Which if occurring regularly, officers would not expect to see this amount of build-up. With dry and windy weather conditions in combination with the high level of vehicle movements associated with the operations, this could lead to a significant dust problem. The Dust controls specified under 3.2 of the Dust Management Plan state ‘Roads and operational open yard surfaces will be kept free of accumulated dust/fibres. Under 3.6 Dust Control: General states’ ‘A bowser/road sweeper will be used on all engineered surfaces.’ And ‘A policy of good housekeeping will be adopted such that all ground and relevant mechanical surfaces will be kept free of accumulated dust/fibres.’

Furthermore, lorries going in and out of site are likely to pick this up in the tyre tread, causing it to escape from site, inadvertently depositing on roadways etc.

**ADVICE & GUIDANCE:** Please ensure operations on site are in line with the Management Systems in place, or if amendments are required to the sites operational procedures, including but not limited to the areas outlined in this CAR form, please revise the associated documents accordingly.

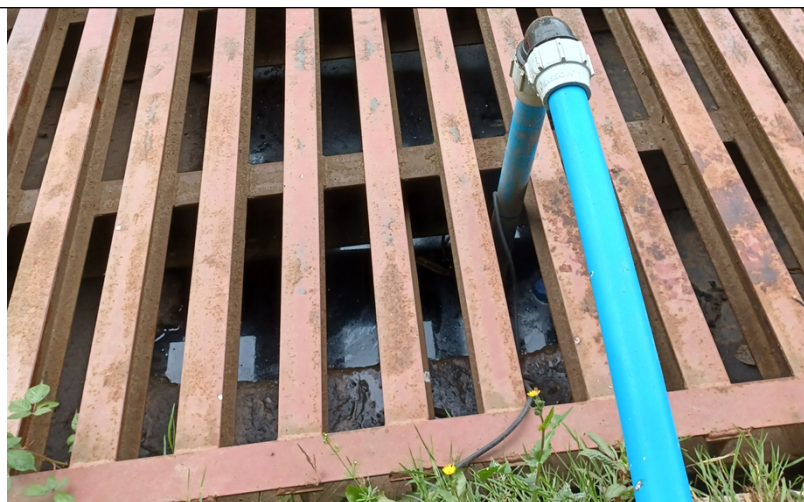
As you can see from the photograph, the water within the sump contains oil residue which is apparent from the visible sheen on the water. As per the comments made by the FRS on FPMP v2, this water may not be deemed suitable for recirculation in the event of a fire, as spraying contaminated/stagnant water from the tank in close proximity of FRS crew could present a health and safety issue, as well as introducing water containing oil to a wood waste fire.

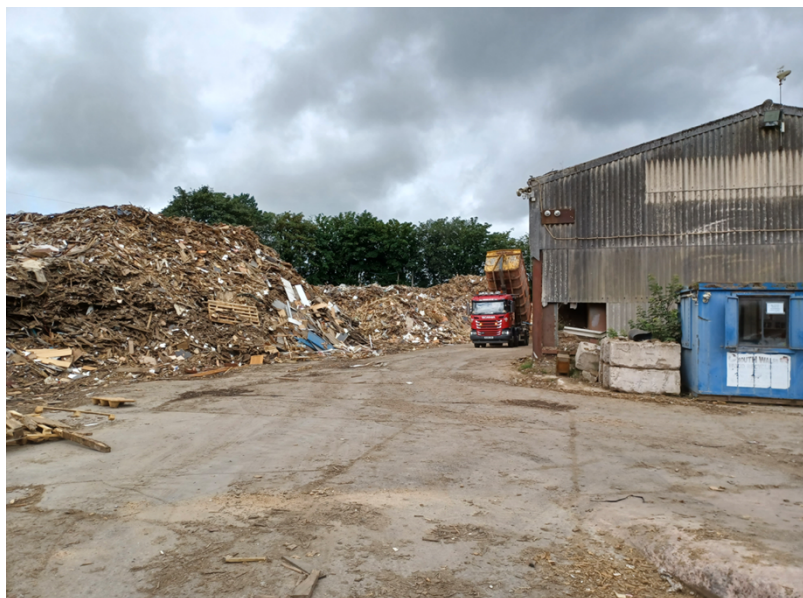
- The site appeared to be over capacity and unable to store in accordance with the Fire Prevention and Mitigation Plan guidance.
- The stockpiles appeared to be well in excess of 4m in height.
- Insufficient firebreaks as stockpiles had merged creating a continuous stack at the rear of the site.
- As a result, the risk posed/potential impact to the environment has increased since the last inspection.

Officers were advised that the site being over capacity was due to a breakdown a few weeks prior at the primary outlet for the site, which had led to over stocking at the yard.

In the event of a breakdown at the primary outlet, to avoid non-compliance issues in terms of waste storage, alternative procedures should be implemented to ensure operations on site are compliant with the sites permit. The Management Systems detail diverting wood to other sites, however, appears there is no provision or viable procedure in place at present, if other sites are at full capacity.

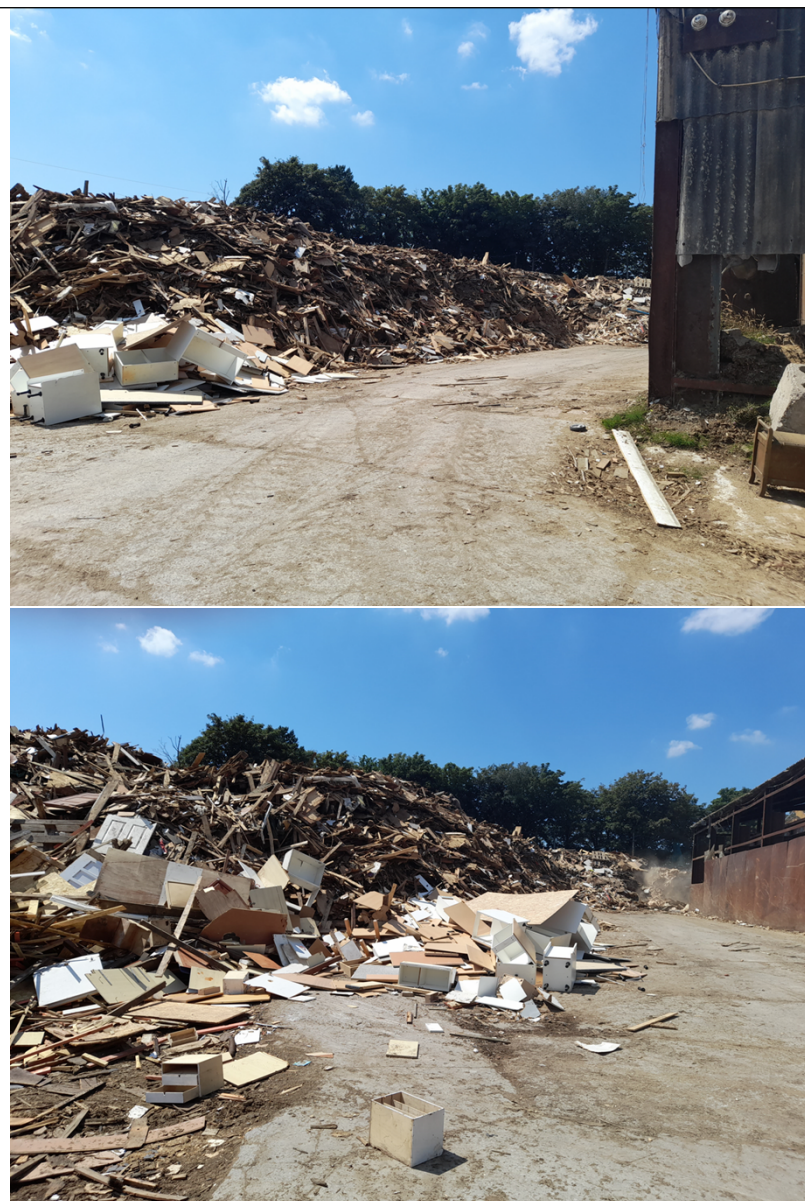
Since the visit, NRW have been provided photographs (19/07/21) by the Site Manager that aim to show that the stockpile heights have been addressed following the inspection. However, we have not been provided any evidence to demonstrate how much waste has been removed from site to show that volumes have reduced to within the site's capacity. This remains a significant risk and breach.

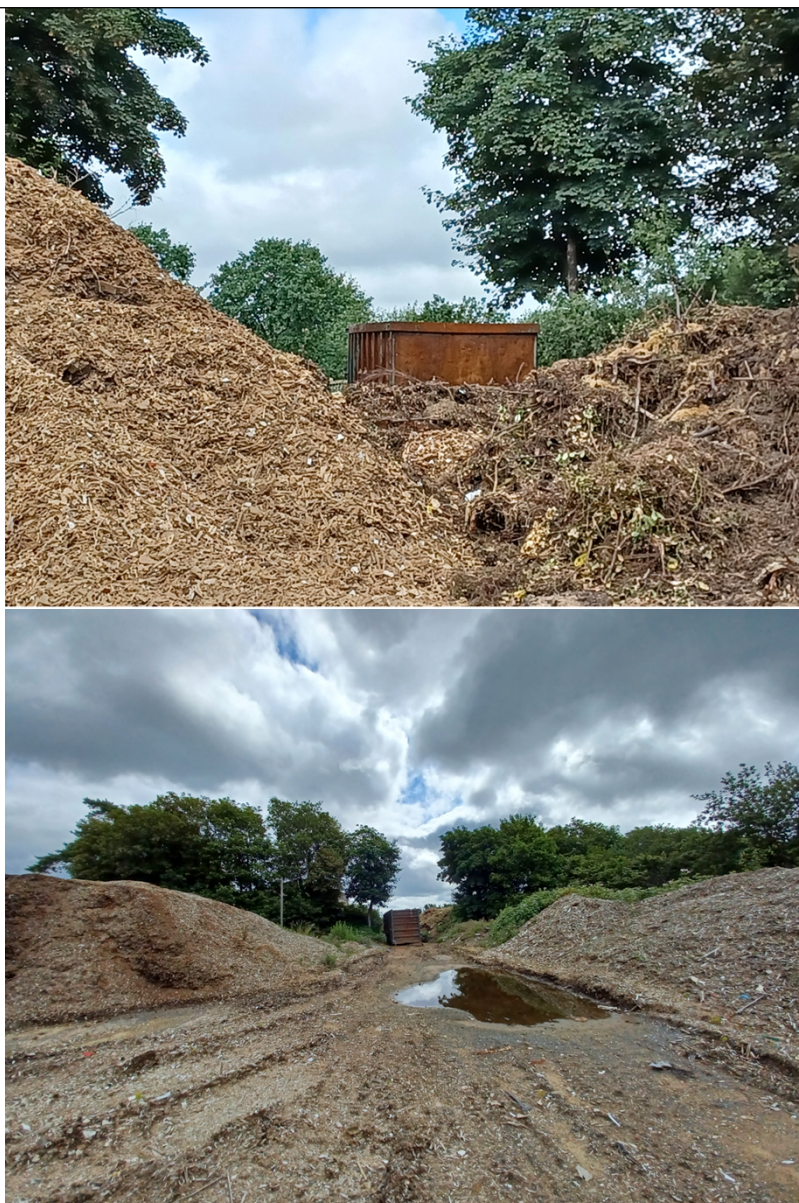
We wish to acknowledge the efforts made by the Site Manager and plant operatives whilst officers were on site, in clearing the alternative emergency access route, which was blocked off by processed wood waste, as can be seen from the photographs below. This alternative access is outlined in Figure 4 shown in blue of FPMP v2, as per the Fire Prevention & Mitigation Plan guidance which states, 'Your FPMP must include: how safe access to the site for fire and rescue services and other emergency responders is achieved' and a site plan which includes 'main access routes for fire engines' '& any alternative access points' on a site plan. However, operations on site are non-compliant with The Fire Prevention & Mitigation Plan guidance.

As despite clearing the processed wood waste, we observed that a storage unit was blocking this alternative route, which has been outlined by the operator in the FPMP's submitted to date as an emergency access route. Officers did note this route is also blocked off further back, therefore please ensure the FPMP v3 takes this into account, detailing the procedures that are in place, to ensure that this access route is viable in the event of an emergency should a fire occur, as access to and from the site, as well as the water-supply available on site and quarantine area could be restricted if the main entrance has been bunded to contain firewater.

**ACTION REQUIRED:** Regulation 36 Notice to follow.
