**3.1 Site Layout**

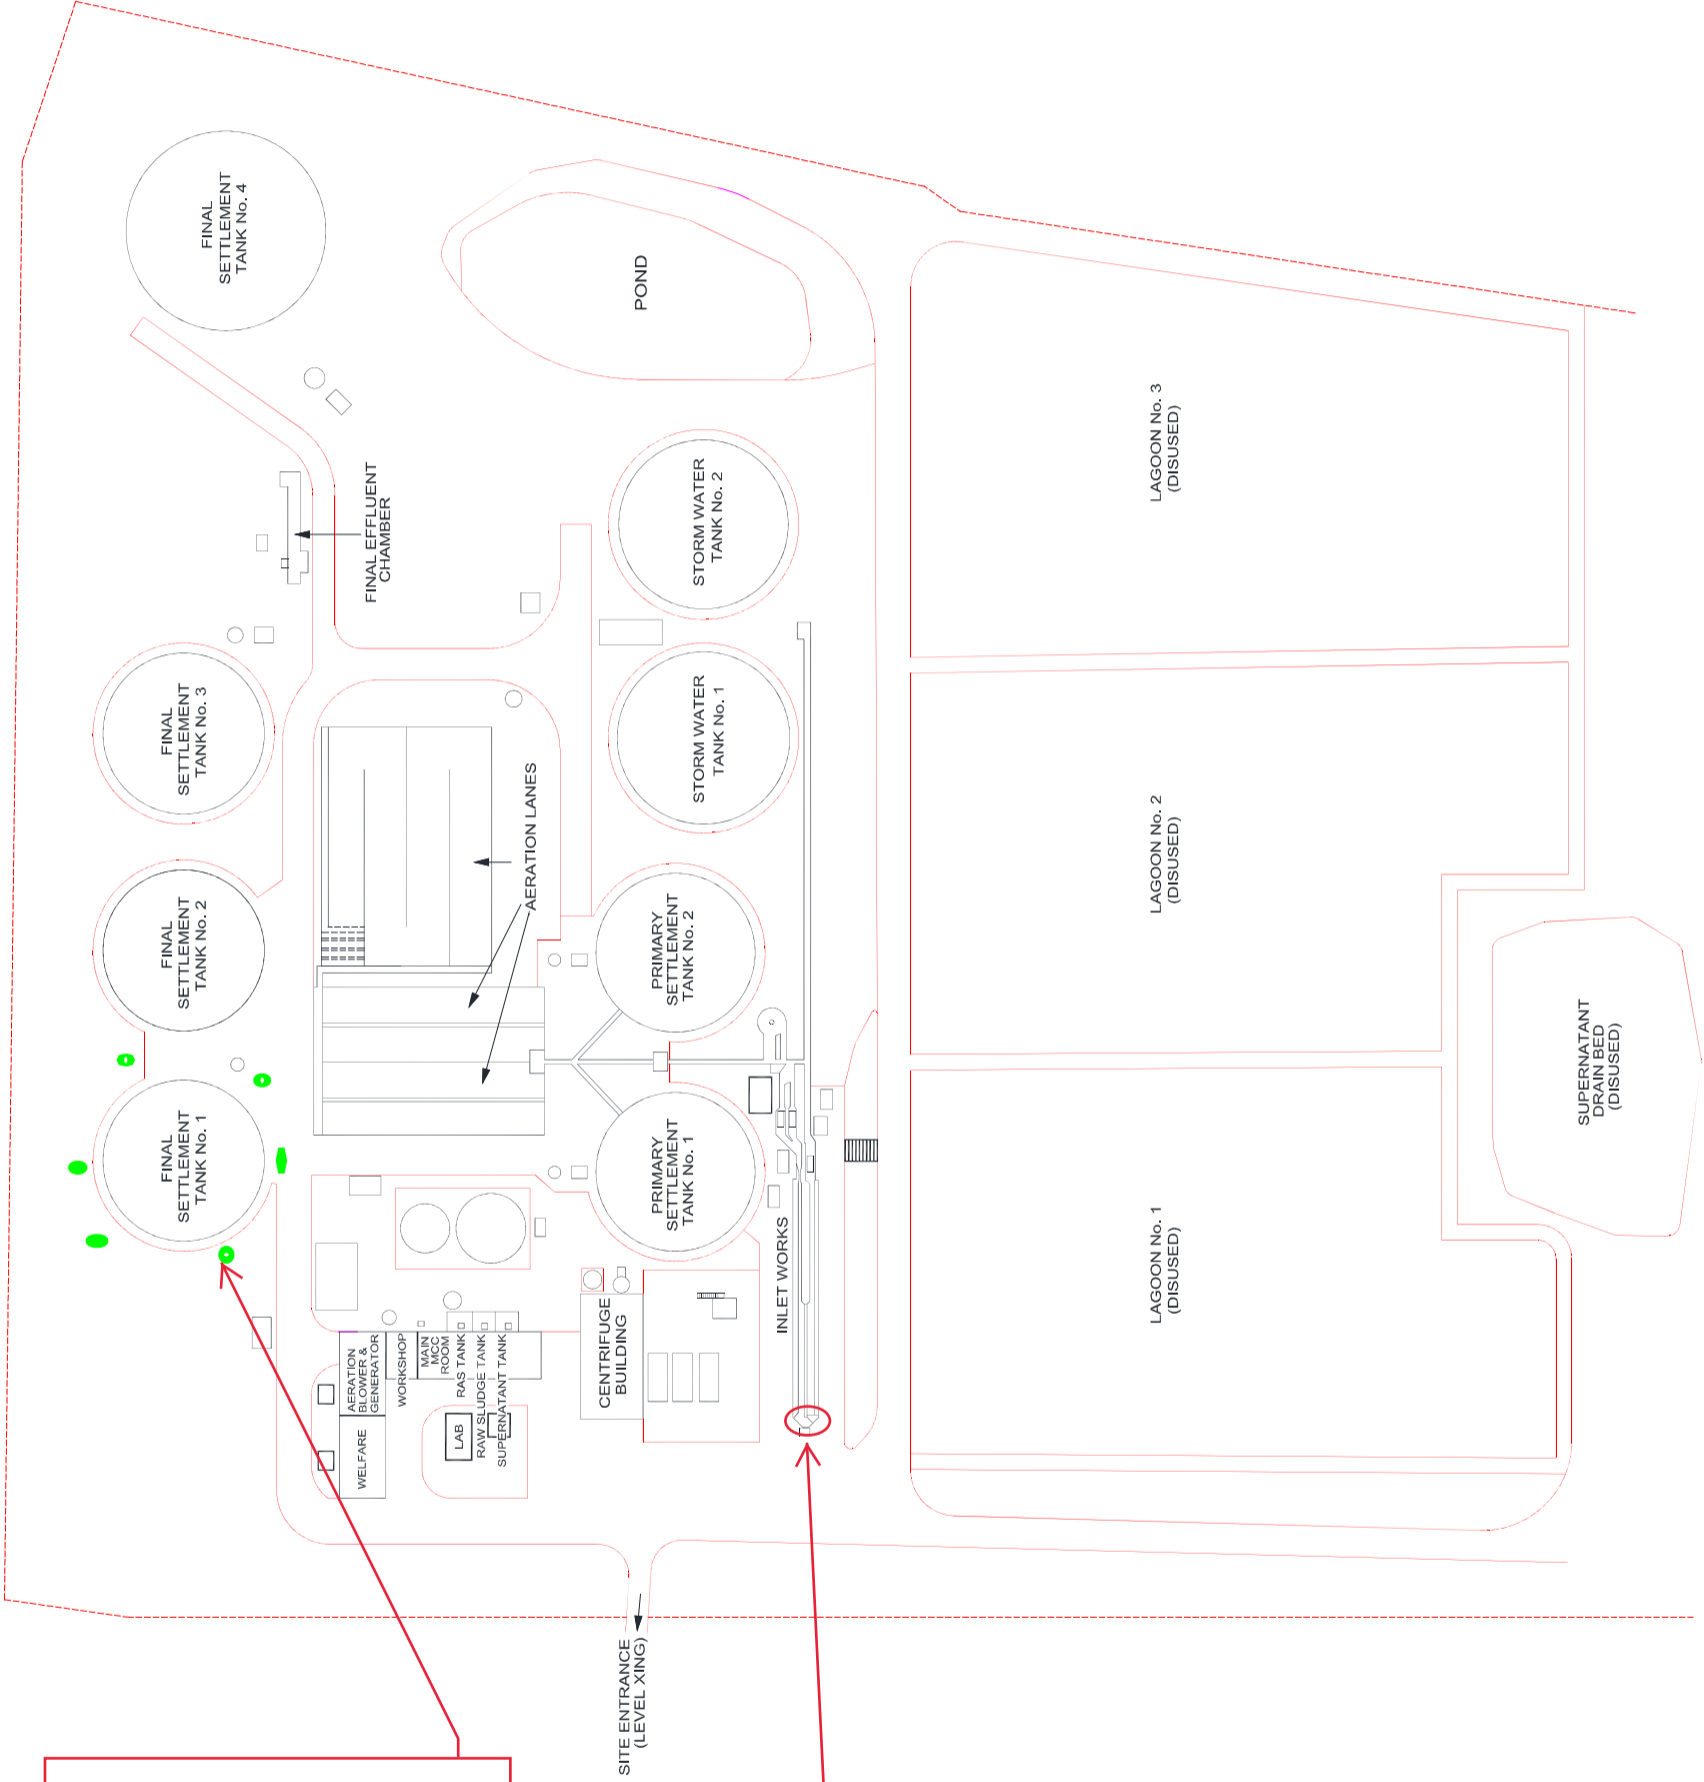
Extraction bore  
holes located  
around the  
settlement tank to  
be repaired

Discharge  
point to  
existing inlet  
works max  
flow 8ltrs/Sec
