## Compliance Assessment Report CAR\_NRW0038862

**Permit being assessed:** BX9455IF.

For: Bedwas Plant , held by Hydro Aluminium UK Ltd

**Type of assessment carried out:** Site Inspection, Reason: Routine.

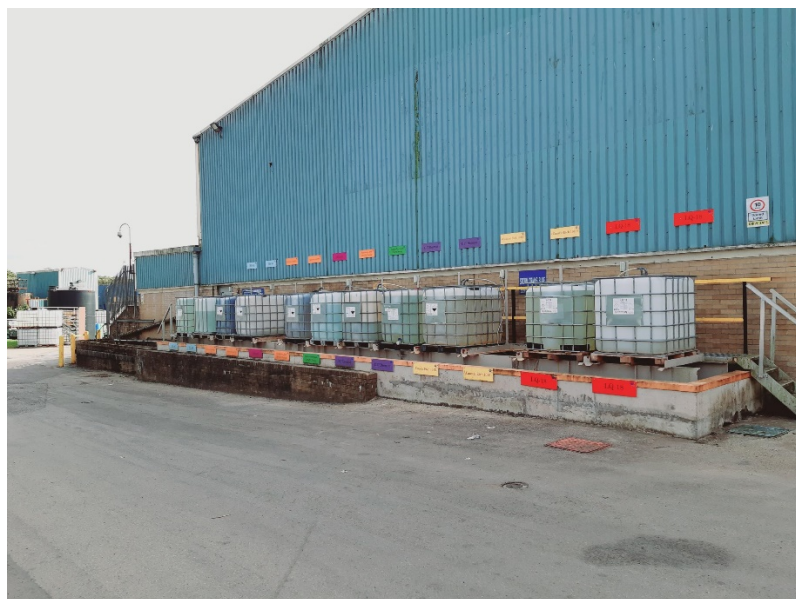
**Image 1**

The IBC chemical storage area comprises a purpose made bund running parallel to the northern elevation of the building, shown in image 1 below.

Some aspects of good practice were observed in that IBCs are placed above ground, the bund appears to have sufficient containment capacity for the volumes stored and is of good construction with the top edge of the bund wall capped by a steel girder preventing accidental damage through fork lift truck activity.

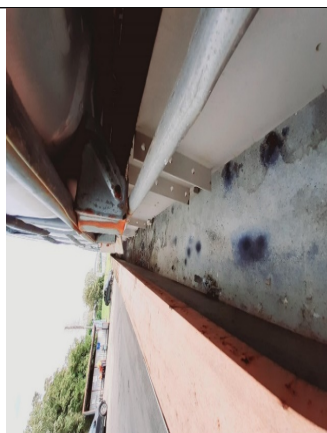
Image 2

However, for a bund to be effective, conform to CIRIA 736 and be compliant with regulations, its base and walls must be impermeable to the liquid it is designed to hold. Even though the bund is constructed to a high standard, the floor sealant is showing clear signs of erosion, as shown in images photographs 2 and 3. If left untreated, this could affect the integrity of the bund resulting in spilled materials leaching leading to an adverse impact on the environment.

**Action 2: Within 1 month from the date of this CAR form, Hydro shall submit in writing to NRW a floor repair plan for the IBC bund. Hydro shall carry out and complete the repairs in accordance with the agreed plan within 3 months from the date of agreement being reached.**

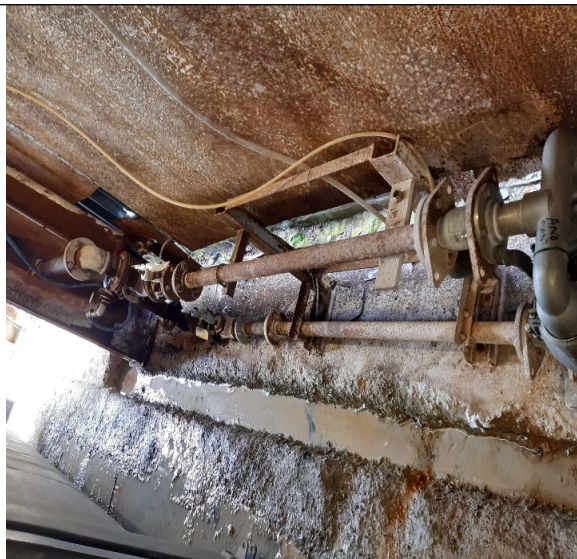
Condition 2.3.5 of the permit places a requirement on the operator to maintain all plant and equipment in good operating condition, the failure of which could lead to an adverse impact on the environment. This includes pipework inside the ETP building and associated ETP bund.

Dealing firstly with the pipework serving the ETP, shown in images 4 and 5 below, it is heavily corroded and susceptible to perforation, which if left untreated will result in spillage of liquid which could lead to an adverse impact on the environment.

**Image 4 - Corroded pipework**

**Whilst NRW welcomes the planned improvement works to the ETP building, the pipework as identified below requires urgent attention, details of which are set out in Action 3 of this CAR form.**

**Action 3: The corroded pipework shown in images 4 and 5 of this CAR form shall be replaced with new within 1 month from the date of this CAR form being issued.**

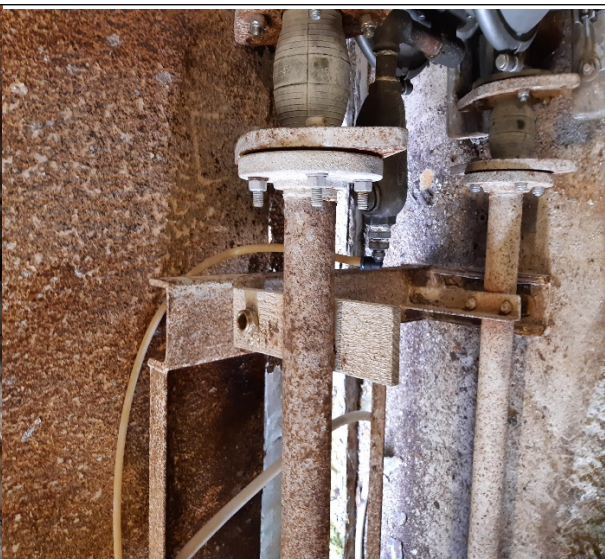
**Image 5 - Corroded pipework**

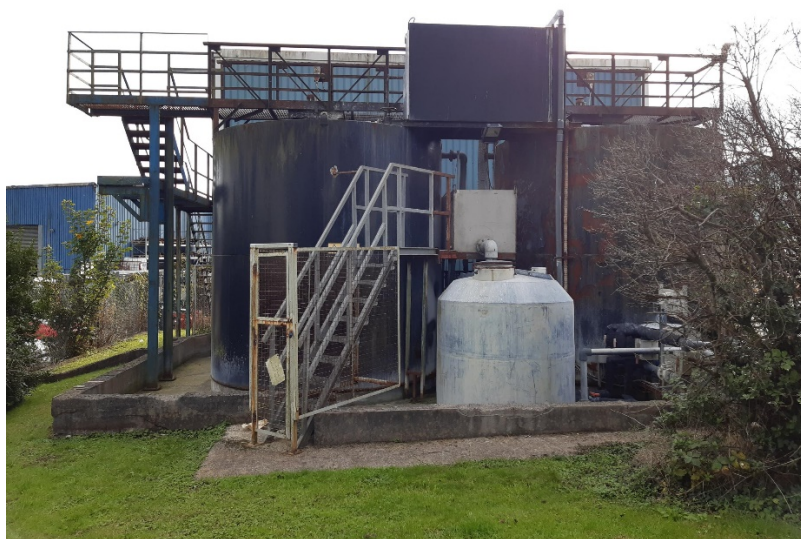
The bund serving the ETP is shown image 6 below.

**Image 6 – ETP bund**

The wall of the bund is of breeze block and render construction, lined with fibreglass, and therefore no longer conforms to CIRIA 736.

**Action 4: Within 1 month from the date of this CAR form, Hydro shall submit a bund repair and improvement plan for written agreement to NRW taking into consideration the advice and guidance regarding design, construction and capacity as set out in document CIRIA 736. Hydro shall carry out and complete the repairs and improvements in accordance with the agreed plan, within 3 months from the date of agreement being reached.**

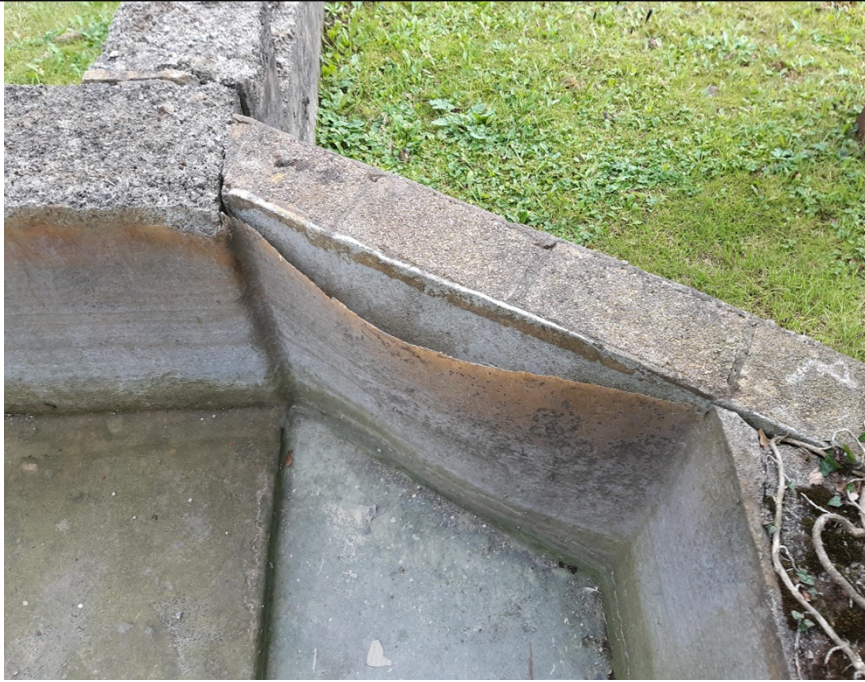
Images 7 – 9 demonstrate some of NRW most serious concerns, namely bund wall construction showing corner weakness / joint separation / exposure of the fibreglass lining / damaged block and render.

**Image 7 – Wall joint and fibreglass lining separation**

Based on the information obtained during the site inspection, it is evident that the equipment for the ETP and bunds identified above have not been maintained to a good standard contrary to the requirements of 2.3.5 and 2.3.6 of the permit, which has resulted in consolidated Category 3 and Category 4 non compliances being recorded. Actions 2, 3 and 4 of this CAR form seek to address these matters.

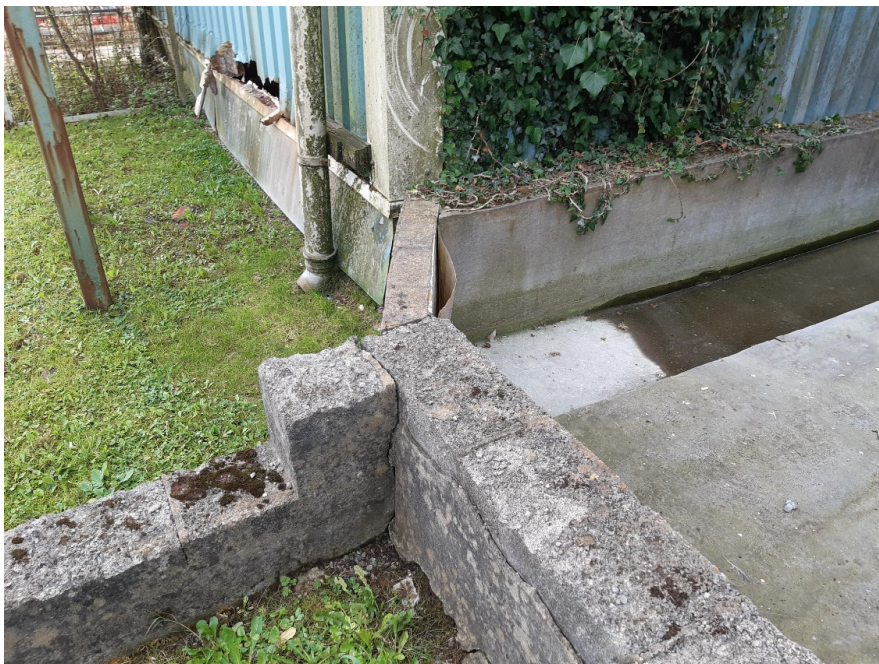
**Image 8 – Bund walls not cast in situ and joint separation, block wall and render damage**

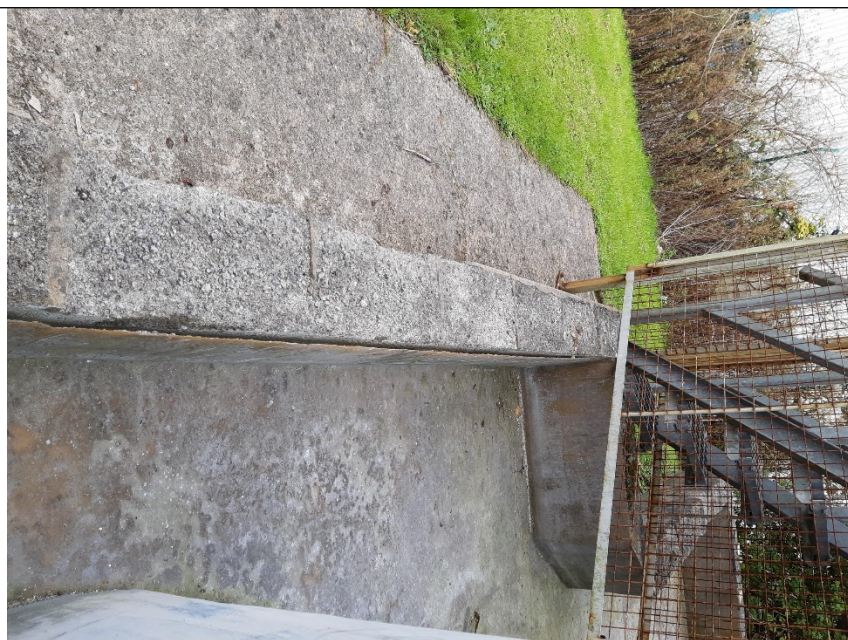
**Image 9 – Fibreglass lining separation from bund wall.**
