Site	Magor Brewery EPR/BX7282IS	Permit Ref	BX7282IS	
Operator/Permit holder	AB InBev UK Ltd			
Regime	Installations			
Date of assessment	04/10/2016	Time in	09:30	Out 13:30
Assessment type	Audit			
Parts of the permit assessed	Containment, AMP			
Lead officer's name	Willey, David			
Accompanied by	Lansdown, Ashley			
Recipient's name/position	Kathryn Fowler/ ES Manager	Date issued	12/12/2016

CAR Form following site visit on 4th October 2016

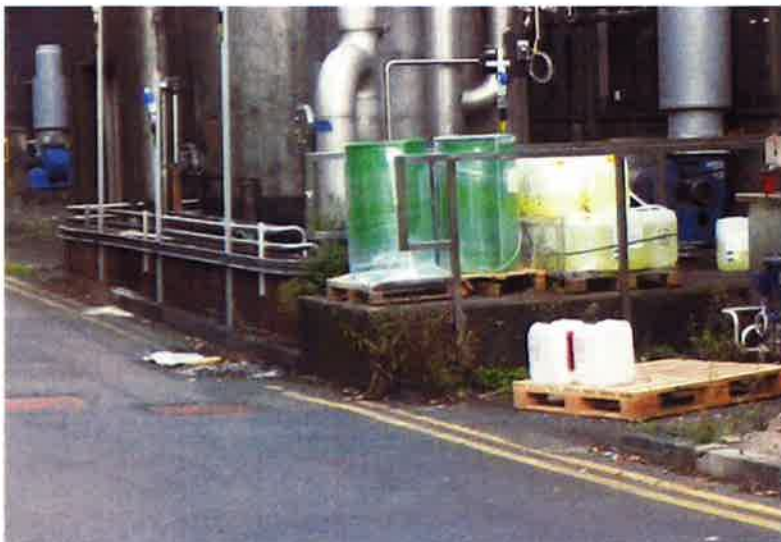
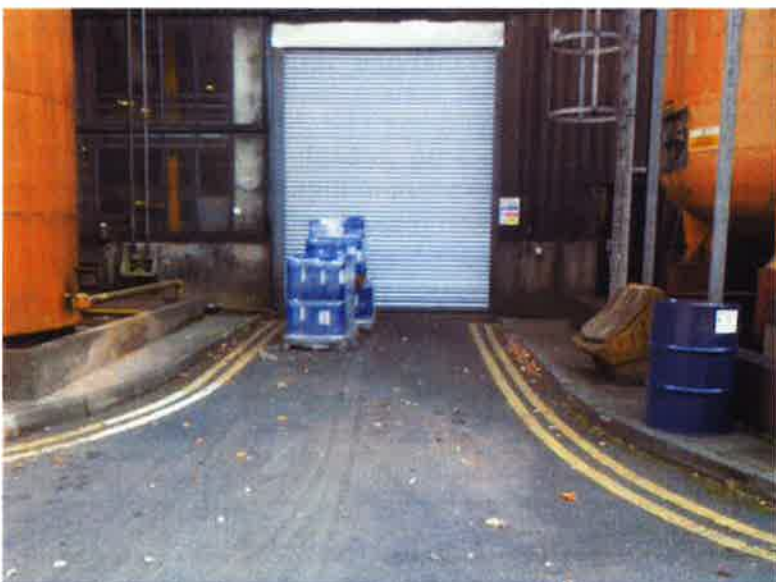
Photo 1: Temporary storage of chemicals

Chemicals are stored temporarily before being taken inside the building for use. There is a surface water drain close to this area with no spill kits in the immediate area. NRW are aware that these drains currently feed into the onsite effluent treatment plant.

There are surface drains in this area (coloured blue) where there is the potential for chemicals to enter. The surface drains at the moment flow to the onsite effluent treatment plant prior to discharge so any spillage would be contained. If the site proposes to discharge to surface water in the future then further improvements need to be made to reduce the potential of accidental releases

ACTION: AB InBev to provide spill kits and look into alternate arrangements to delivering the chemicals to the building. If this is not practicable procedures should be in place to minimise the time the chemicals are stored in this area with associated measures to avoid release to surface water drains.

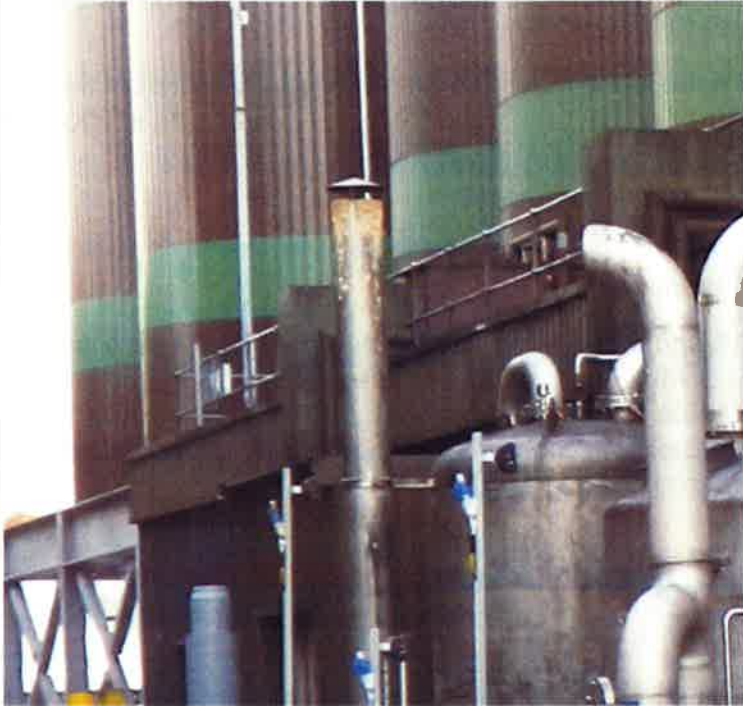
Photo 3: Overflow of foam

Overfilling of the fermentation tanks led to increased foam generated with the sites anti foaming kit unable to cope with the flow. This led to foam spilling from the over flow on the kit and collecting within the bunded area. **Considered a category 4 breach of permit condition 2.1.1. for in process controls where there was no risk to the environment.**

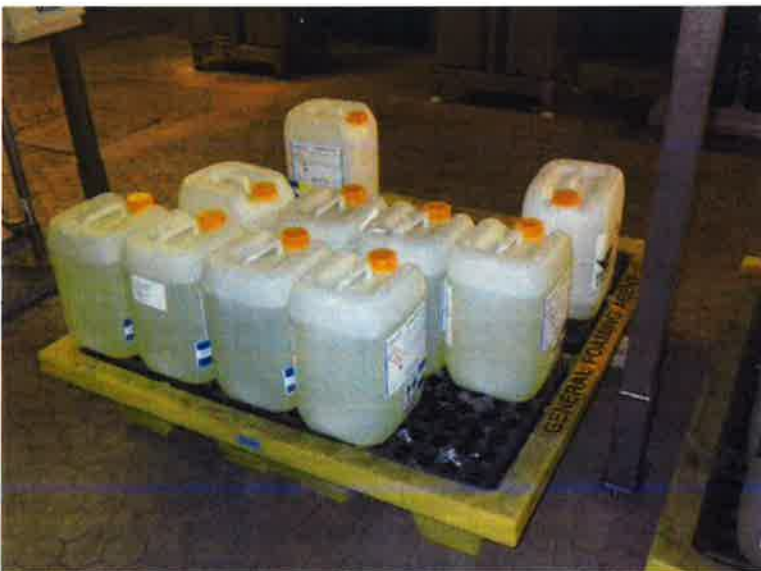
Photo 4: Storage inside building

Suitable storage of chemicals within the process area.

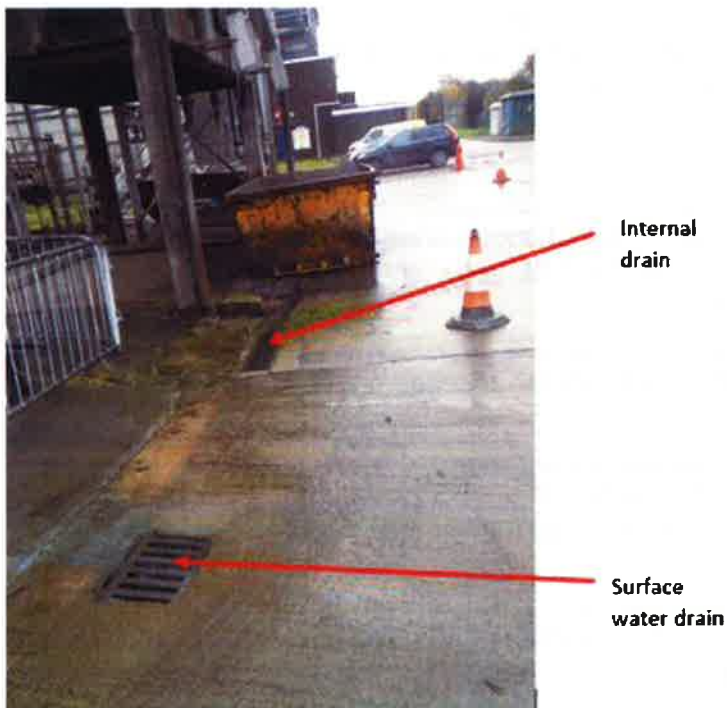
Photo 5: Surface water drain location

The unauthorised discharge of effluent via W3 is considered to be a category 3 breach of permit condition 2.2.2.3 where only emissions identified in Table 2.2.4 are permitted. The impact on water quality had a minimal effect with the impact localised around the point of discharge.

The screens were blinded leading to the effluent backing up from the sites internal drains as the pump did not have the capacity to recirculate the amount of effluent accumulating. This led to the internal drains backing up and spilling in to the nearby surface water drain located at a slightly higher gradient but in relative close proximity to the treatment area.

ACTION: AB InBev to provide the results of the monitoring undertaken upstream of discharge point W3 from the day of the incident.

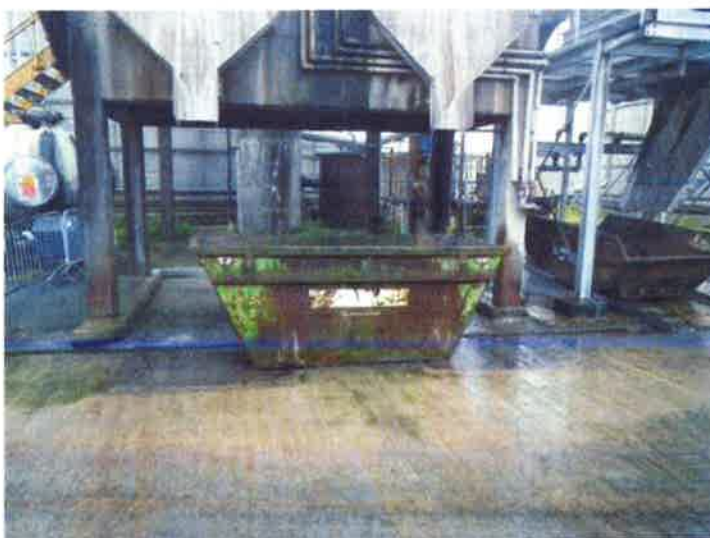
Photo 6: Waste skip and screens

Alarms for low / high flow at the ETP and at the sump would have triggered an investigation and avoided the pollution from occurring. **This is considered to be a Category 3 breach of permit condition 2.8.1 where telemetry at the site would prevent a risk of pollution.**

Other contributing factors to the incident include there being only one skip present at the time of the incident, this was due to a change in contracts and the site awaiting new skips from the new contractor as well as the location of the surface water drain. AB InBev / SUEZ have identified these within their report and have associated actions.
