## SILENT VALLEY LANDFILL SITE

# 2015 Biological Monitoring of Nant Merddog Stream

**Report Number** 13514190712.501/B.0

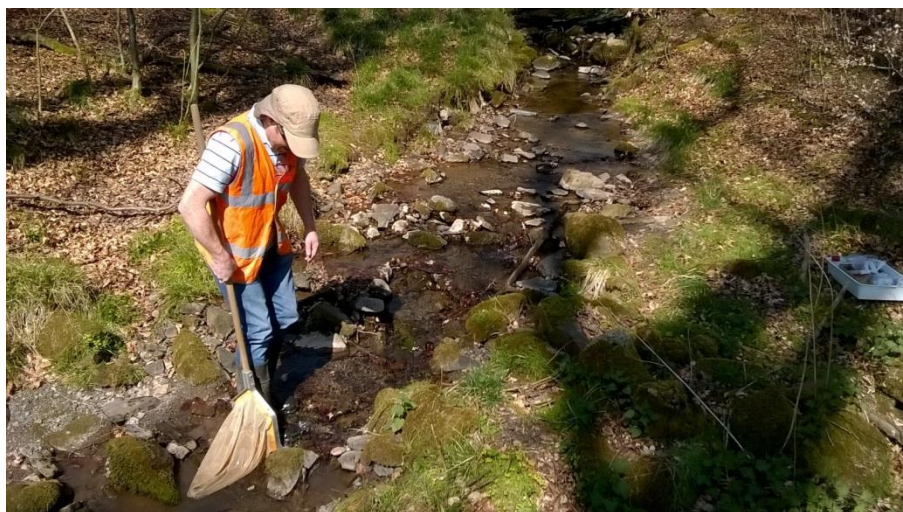
*Plate 1: Collecting samples at Reach 2.*

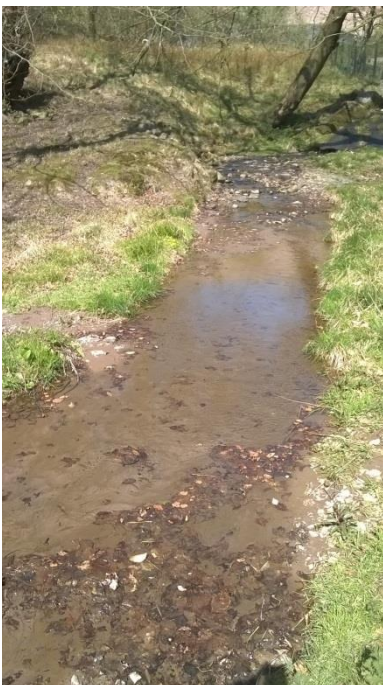
Water levels within the Nant Merddog Stream were indicative of what could be considered ‘normal’ flow conditions from the surveyor’s experience. Sediment deposits were observed at reaches 1 and 2 resulting from ongoing restoration works on the landfill site. Leaf detritus was present at all reaches, being particularly abundant at reach 1.

*Plate 2: Sediment deposition from upstream works.*
