Neal Soil Suppliers Ltd

Ty to Maen Farm
Wentloog

AUDIT REPORT FORM

Permit number	EAWML 30348 EPR-VP3095FS	Site name	Neal Soil Suppliers Ltd (NSS)
Date(s) of audit	7 th & 10 th December 2015	CAR ID No.	NP3336FD/0256694
Lead auditor	Gareth Danter-Hill	Other auditors	Lara Moggridge

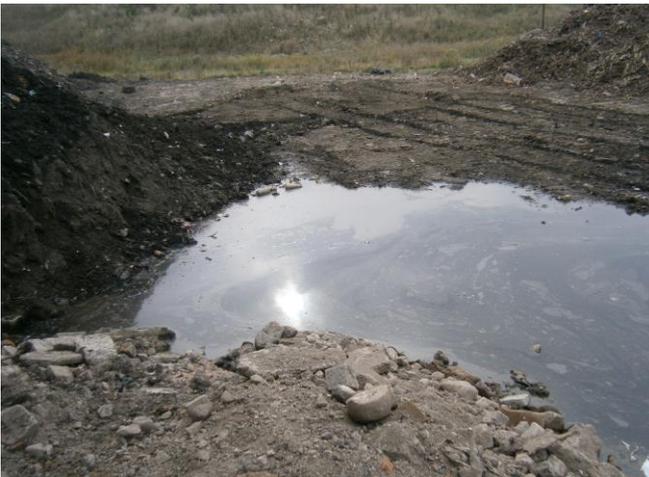
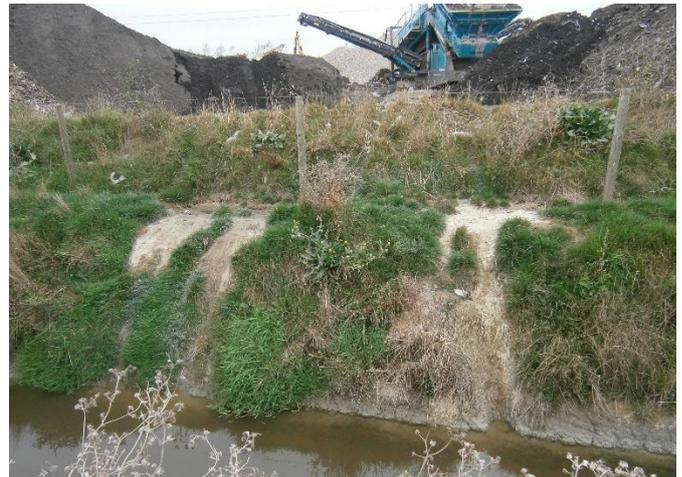
(*location identified in Plan A*)

As detailed in CAR NP3336FD/0251267, the waste storage of road sweeping wastes, sewage grits, transfer station fines and metal contaminated wastes continues to be a problem. The wastes are stored on unmade ground and permit condition 2.1.1 requires they are stored on an impermeable surface with sealed drainage (*locations of storage are identified in Plan A*).

Dark, black leachate was seen pooling on the made ground in the immediate vicinity of the road sweeping waste and sewage grits (*location identified in Plan A*). This leachate was seen overflowing from the storage area and flowing down a bank into a cut off ditch to the rear of this area of the site, near SW20. Significant bleaching of the grass on the banking was also seen in this area. It was evident that the leachate was present within the cut off ditch due to black staining along the top of the water line in the ditch, emphasising the importance for correct and compliant infrastructure for the storage of wastes. The overflowing leachate from the waste, if allowed to continue over prolonged periods of time could result in a pollution risk to the SSSI and ground through seepage/infiltration or overtopping in periods of wet weather. Leachate and the pollution of the ground has also been seen around the edge of the area towards the front of the wash plant storage area (near to WS11).

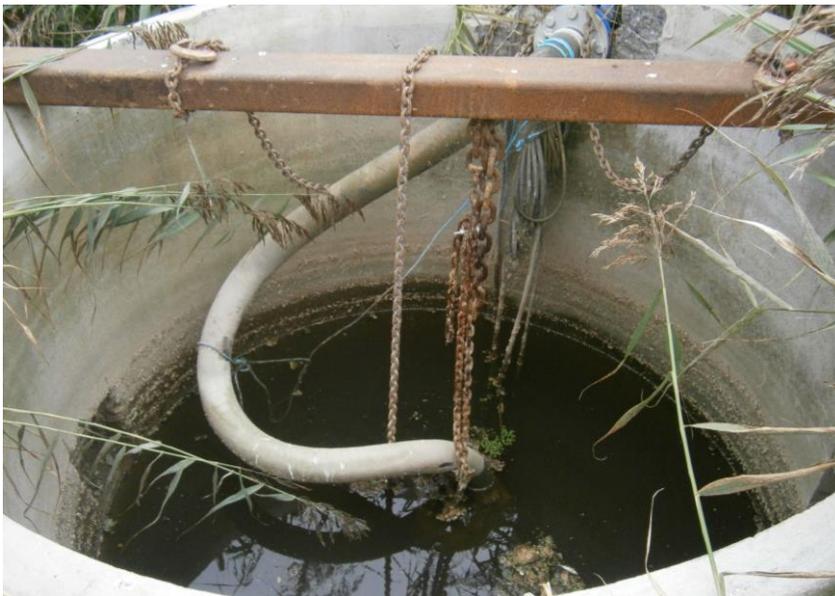
Contaminated water from the ditch mentioned above was seen entering a sump within the drainage ditch and into an operational pump (*location identified in Plan A*). At the time of this inspection the end destination was unknown. The operator informed NRW following the onsite audit that the pump was the top up feed for the wash plant water. This water was very odorous and sewage fungus could even be seen within the sump and around the inlet of the pump.

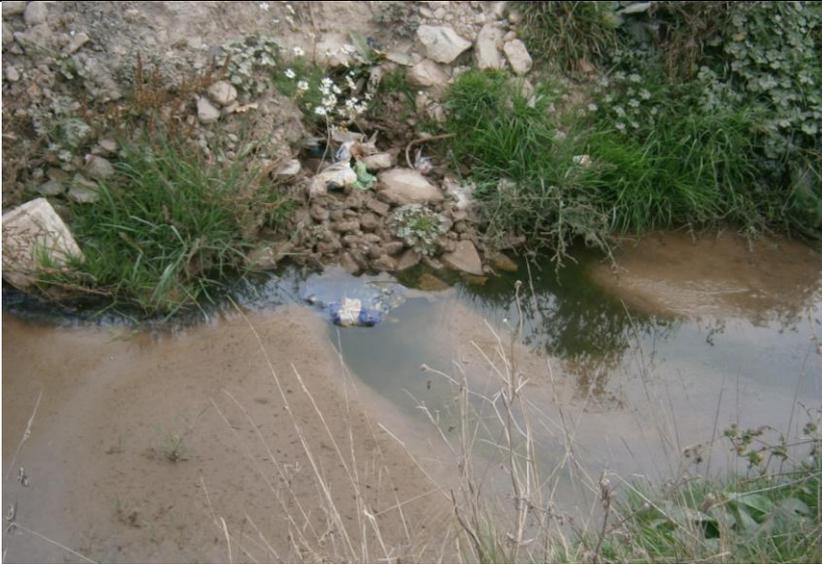
As noted in CAR NP3336FD/0251267 on the 19th October 2015 an unknown discharge flowing from a submerged pipe into a cut off ditch to the west of the wash plant storage yard has been observed (*location identified in Plan A*). During the onsite audit a black odorous discharge was seen actively flowing out of this pipe at a consistent rate. This cut off ditch does not benefit from any standard of infrastructure which would be expected to receive a discharge of this type. As of the date of this audit no investigation works have been carried out to locate the source of the discharge, despite requests. The flow

from the pipe was stronger on the date of this audit than previously seen. It is also worth noting that the pump mentioned above was switched off during the inspection on the 19th October but was operational during the audit inspection, suggesting that there may be a link between the wash plant operating and the discharge.

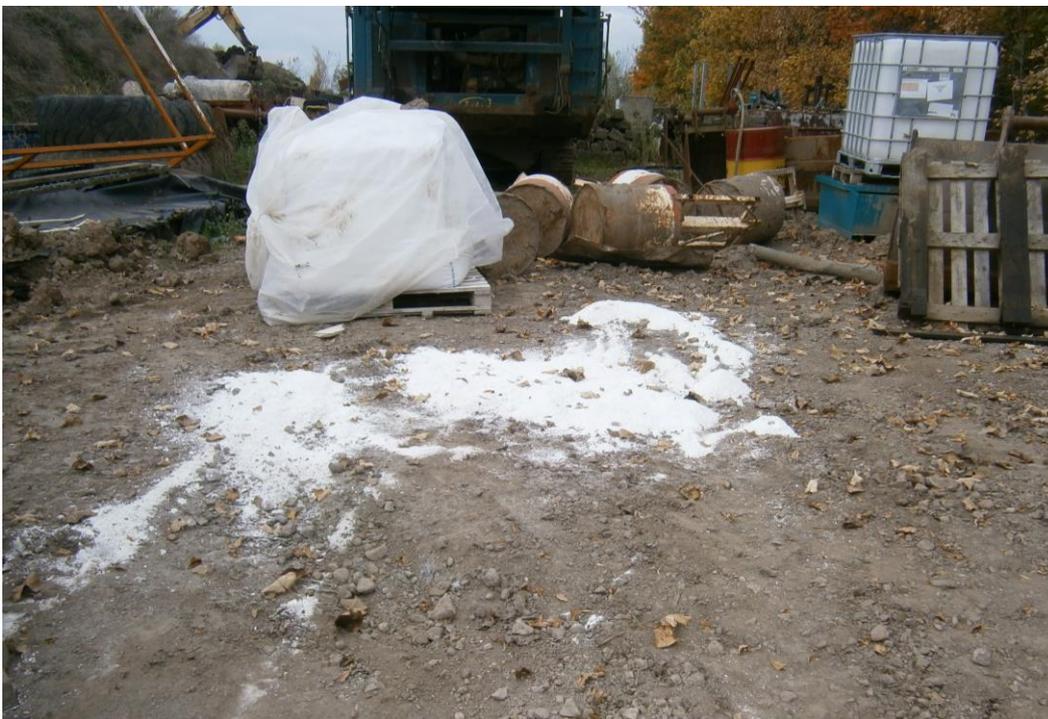
The storage of the chemicals for the wash plant treatment are currently being held in the transfer station area of the site, which does not benefit from any standard of infrastructure. It is expected that storage of these chemicals would be on sufficient infrastructure to prevent any pollution occurring or harm to human health – for example, an impermeable surface with sealed drainage and secondary containment.

- Ensure these chemicals are stored in an appropriate manner.

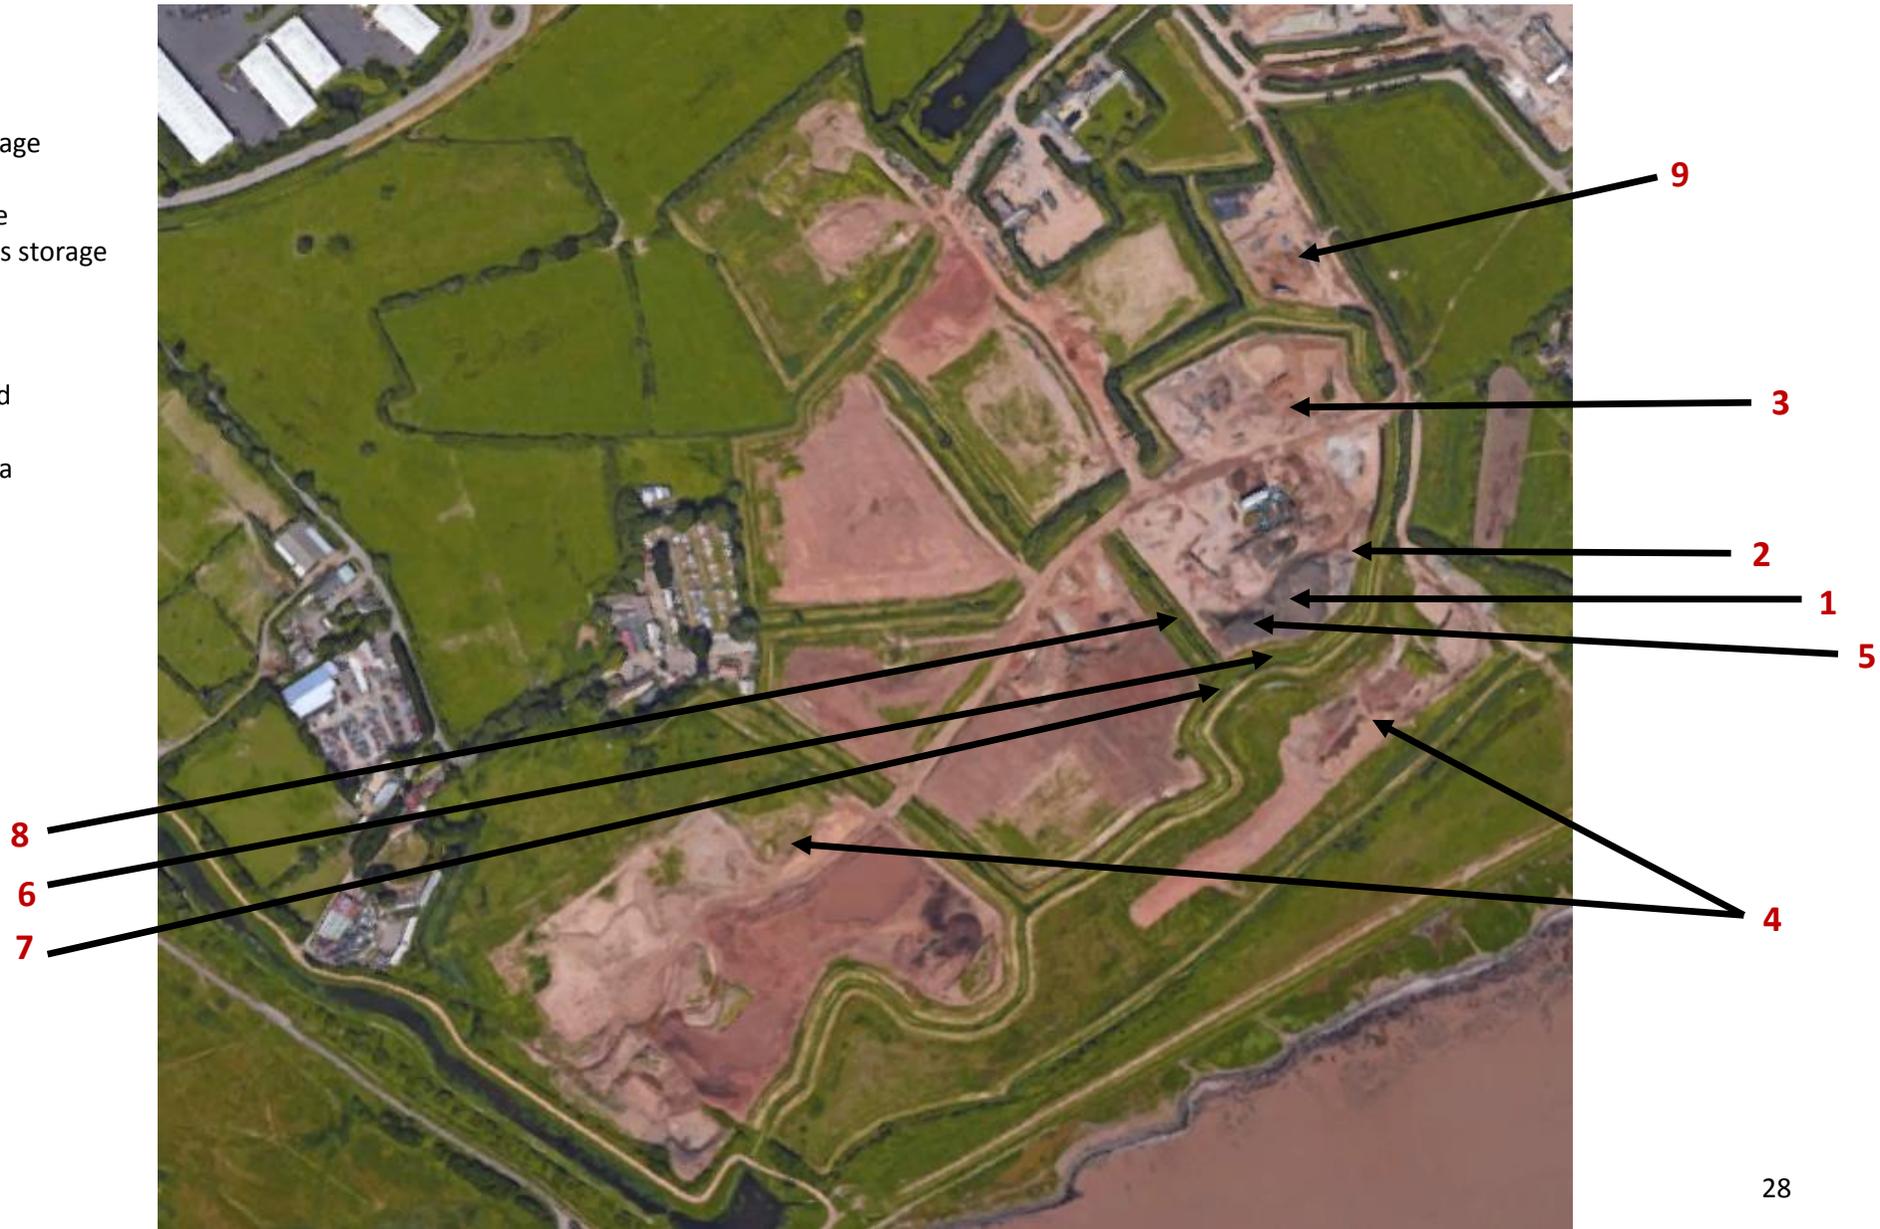
KEY:

- 1—Road sweeping storage
- 2— Sewage grit storage
- 3—Metal waste storage
- 4— Transfer station fines storage
- 5—Pooling leachate
- 6—Bleached banking
- 7—Sump and pump
- 8—Submerged pipe and discharge
- 9—Transfer station area
