Site	Docksway Landfill	Permit Ref	DP3733BK	
Operator/Permit holder	Newport City Council			
Regime	Installations			
Date of assessment	23/06/2016	Time in	10:30	Out 15:00
Assessment type	Report/Data Review			
Parts of the permit assessed	Fugitive emissions			
Lead officer's name	Willey, David			
Accompanied by	Ward, Tyrone			
Recipient's name/position	Jonathan Davey/ Site Manager	Date issued	13/07/2016

Docksway site visit – 23rd June 2016

An emissions review survey was undertaken by Ty Ward and David Willey with Jonathan Davey from NCC. The scope of the assessment was to identify potential releases of methane. The initial assessment involved a random walkover of the site with the use of a Gazomat Inspectra TDL analyser . The results of which can be seen in the below tables.

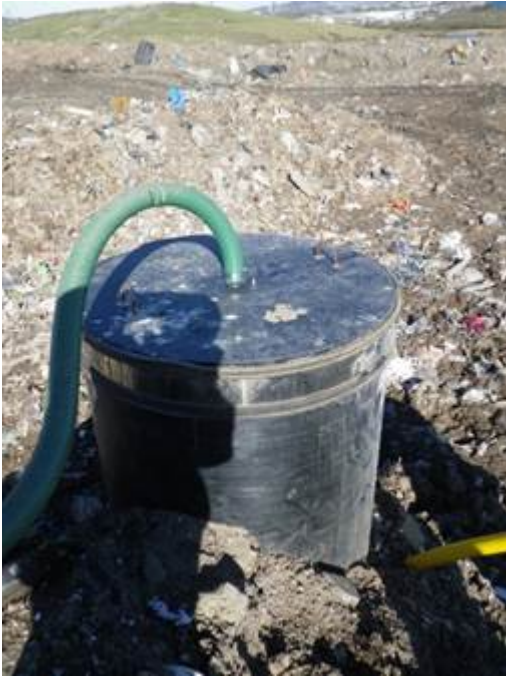
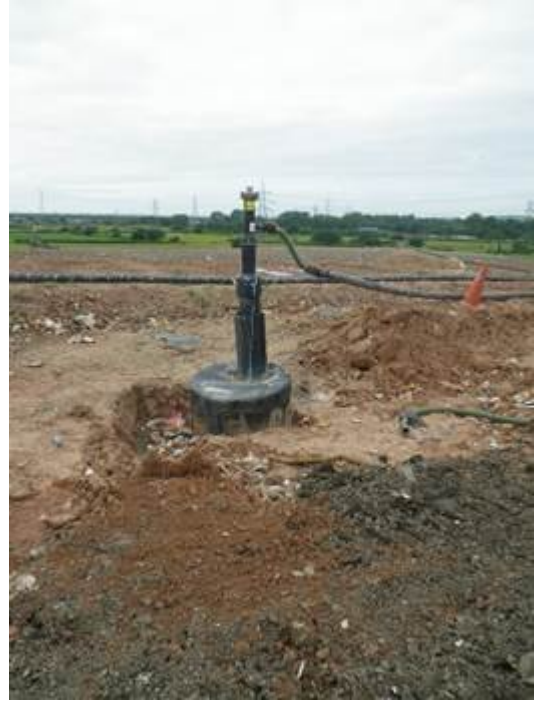
Figure one

The leachate well chambers have had work undertaken on them to limit the amount of LFG released as well as improving health and safety when leachate samples are taken. Photos below are some examples of the wells before and after the work.
