Site	Docksway Landfill	Permit Ref	DP3733BK	
Operator/Permit holder	Newport City Council			
Regime	Installations			
Date of assessment	07/10/2016	Time in	10:00	Out 14:00
Assessment type	Audit			
Parts of the permit assessed	Capping, gas extraction			
Lead officer's name	Willey, David			
Accompanied by	Ward, Tyrone			
Recipient's name/position	Jonathan Davey/ Landfill manager	Date issued	31/10/2016

Docksway site visit – 7th October 2016

**Report ID:
CAR_NRW0026549**

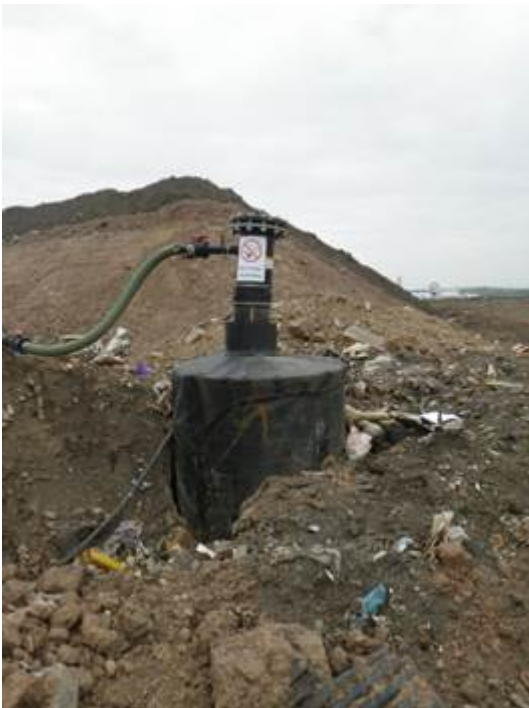
Photo 1: No smoking sign on leachate well

ACTION: (Reference location 32, 33 and 35) *NCC to ensure that all employees are aware that no naked flames are permitted in this area.*

Completed. See photo below of sticker on leachate well.

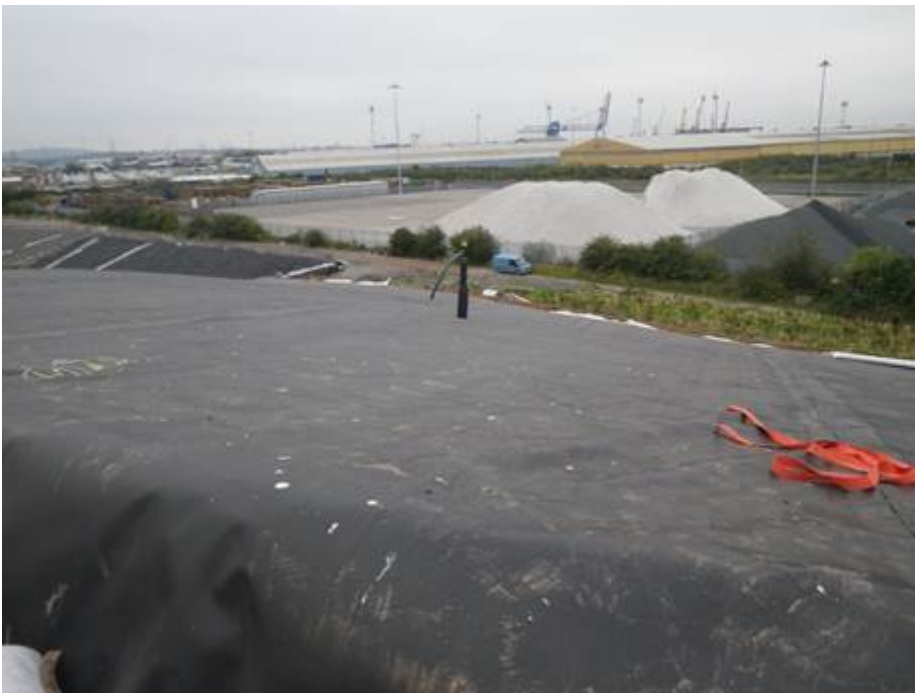
Photo 2: View along capped east flank

Permanent capping at Area 2 has commenced with temporary capping to be laid on the north east flank of cell 2 where high fugitive emissions were previously monitored. The permanent capping will extend around the perimeter of the cell across the upper flanks in accordance with the drawing Cells 1 & 2 Capping 2016, Overall Scheme Extents drawing number: 2511_GA_01.

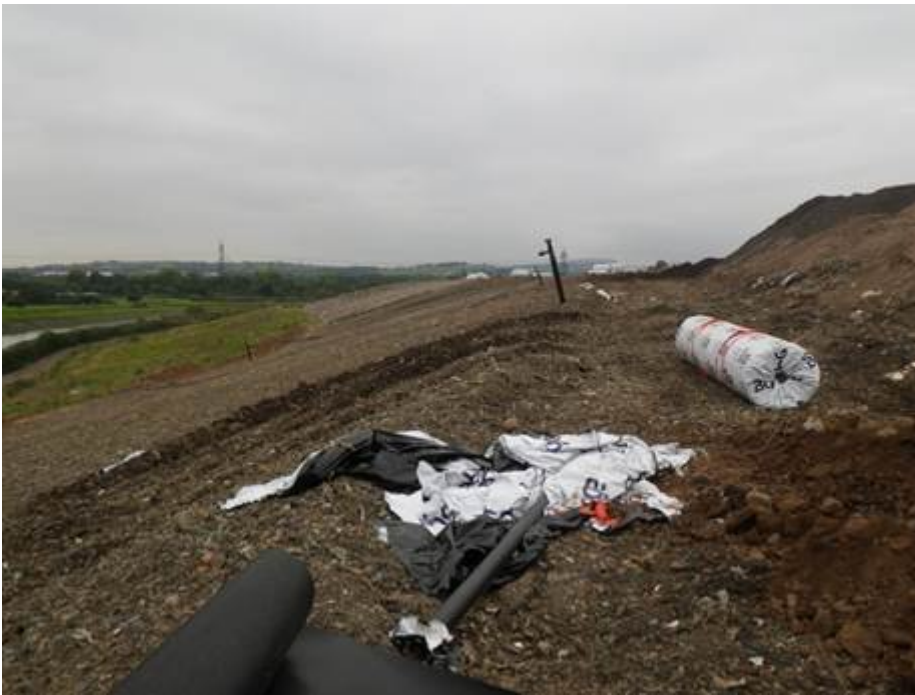
Photo 3: View west along flank to be capped over the laid regulation layer

The Upper flank areas are graded to final profiles with a placement of a 300mm min regulation layer consisting of screening fines. On closer inspection by NRW the regulation layer was not considered to be best practice. The aim of the regulation layer is to provide a uniform, smooth and firm layer on which to place the protective geotextile.

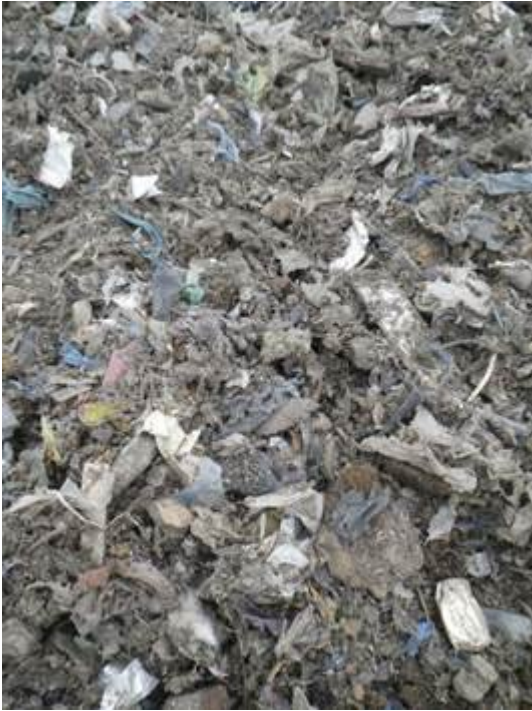
Photo 4: Regulation layer

During the inspection NRW found several pieces of sharp plastic, and there is the potential for other items (nails, screws) to be present if not separated out by a magnet.

ACTION: NCC to confirm the use of this regulation layer with the geotextile manufacturer to ensure suitability. NCC to increase the frequency of visual inspections of the regulation layer to ensure the layer is suitable and avoid the potential of damage to the membrane.

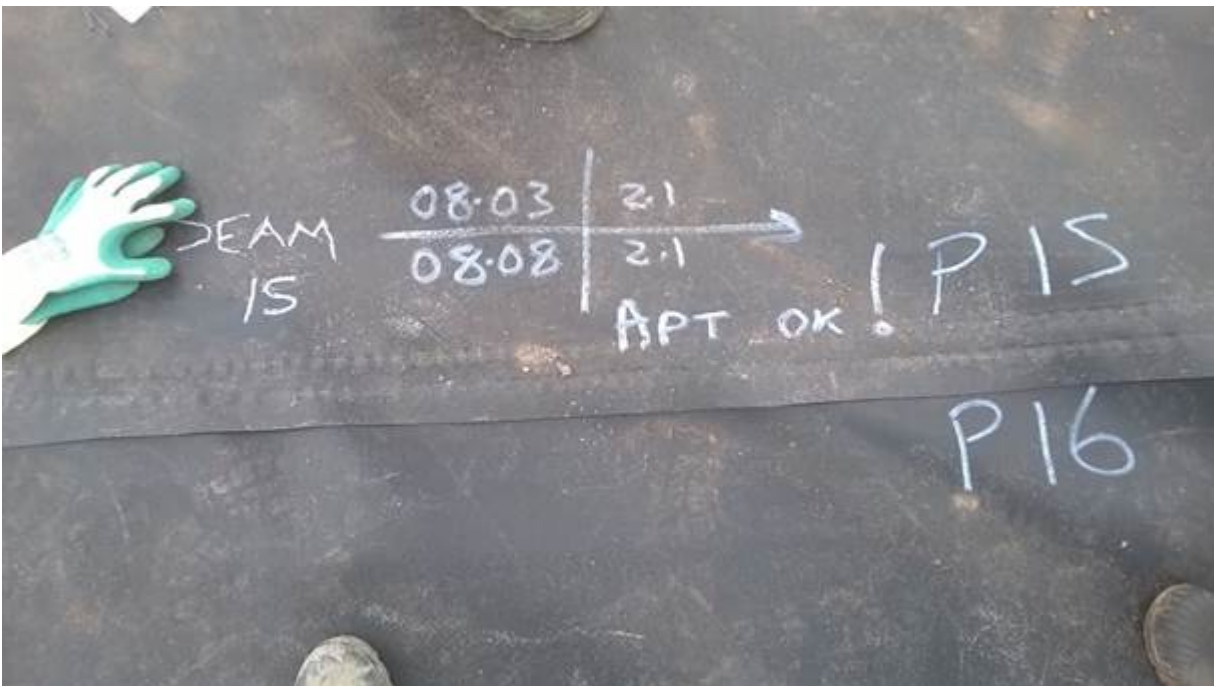
Photo 5: Photograph of APT (air pressure testing) checks

NRW discussed capping works with NCC including on-site supervision and the completion of daily CQA check sheets. Non-conformances will be included in the validation report.

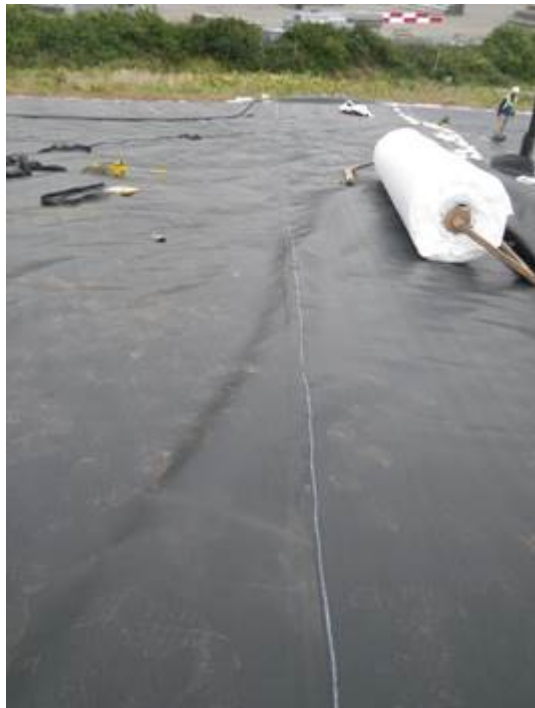
Photo 6: Spreader bars resting on membrane

NRW observed that spreader bars were being placed directly onto the LLDPE membrane. This is not considered to be best practice. NCC informed the contractor immediately.

Breach of permit condition 2.5.3 where the construction proposals will not impact on the performance of the element of the design. **Considered a category 4 breach of the permit as there was no damage made to the liner with immediate action taken by NCC.**

Criteria Ref.	CCS Category	Action required/advised	Due Date
See Section 1 above			
B1	C4	Bring back into compliance.	31/01/2017
B1	C3	Bring back into compliance. Improvement condition in place.	31/01/2017
E2	C4	Ensure compliance.	31/10/2016
B1	C4	NCC to ensure no equipment is stored on the membrane.	31/10/2016

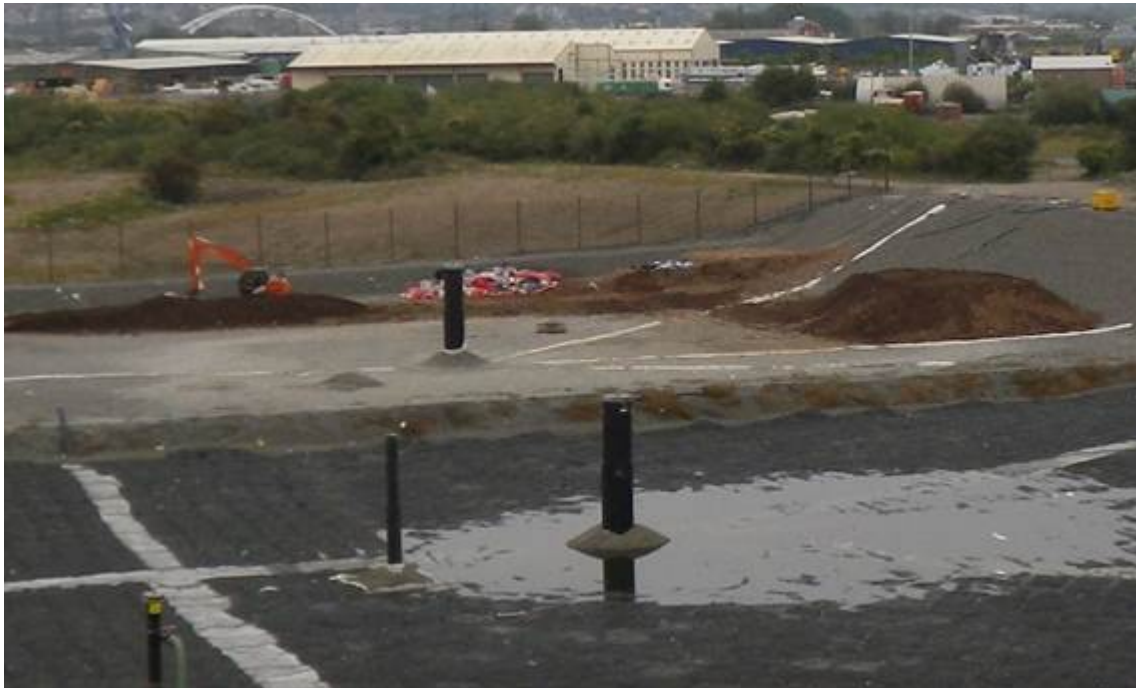
Photo 7: Asbestos waste accepted to site prior to being covered

The new asbestos cell is now active with asbestos waste being accepted at the site. NRW witnessed waste being accepted to site and subsequently disposed and covered.
