| | <p>Q1 Landfill Groundwater Sampling Results 2015<br/>Dow Corning Ltd<br/>Barry</p> | <p>Quarter 1 2015</p> |

## **Q1-2015 Landfill Groundwater Sampling Results**

The impact of bulk storage of materials on the landfill and its performance was monitored in quarter 1 of 2015 and the results shown in this report.

The quarterly sampling plan satisfies both SPMP (Site Protection and Monitoring Programme) and Landfill licence requirements (ref URS design of a site monitoring programme, 44382681, July 2006 and Dow Corning landfill CMS review, 49310733, October 2008).

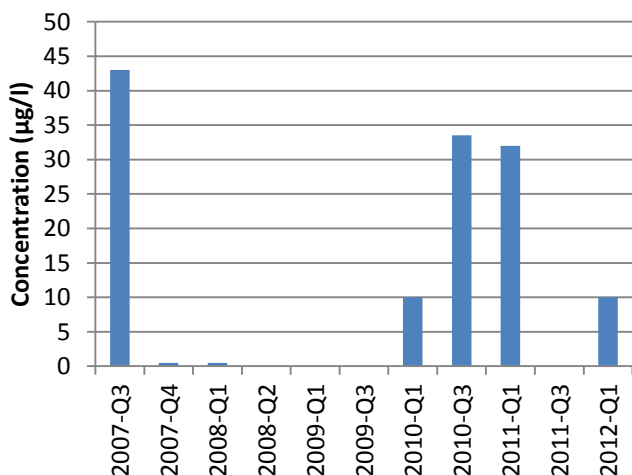
### Copper monitoring - E2S

Some of the boreholes were not sampled during Q1 2015 due to being inaccessible due to high water levels. These were: E2S, E2D, LF1 and LF6. These boreholes show no results on the charts.

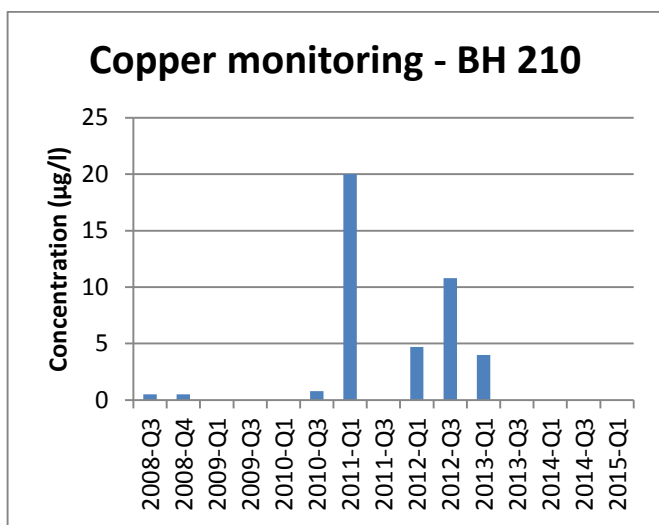
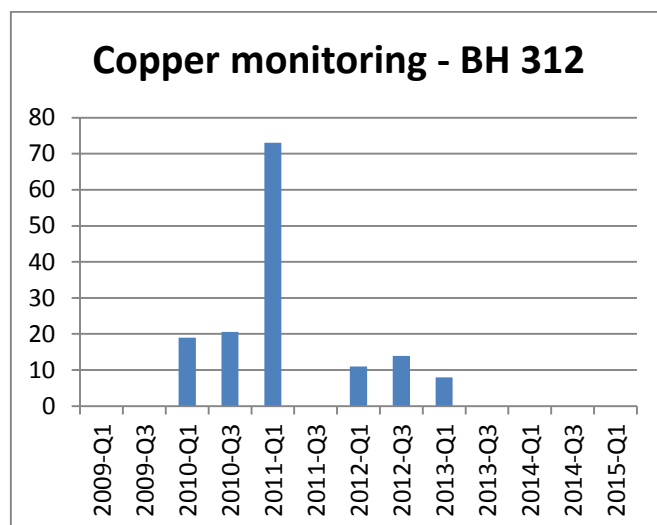
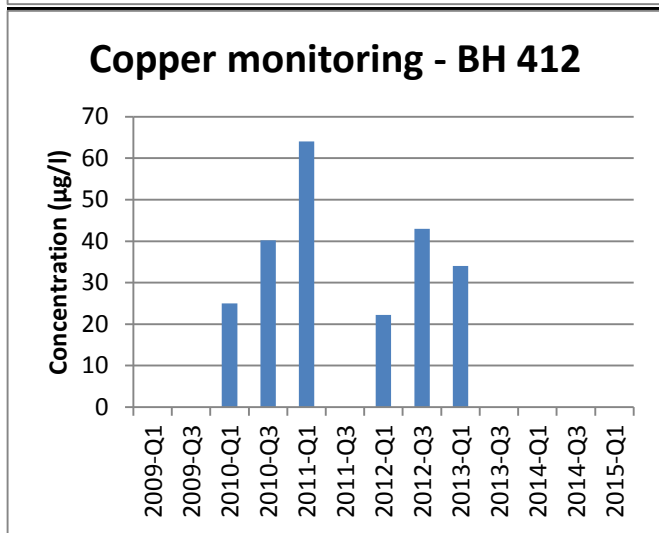
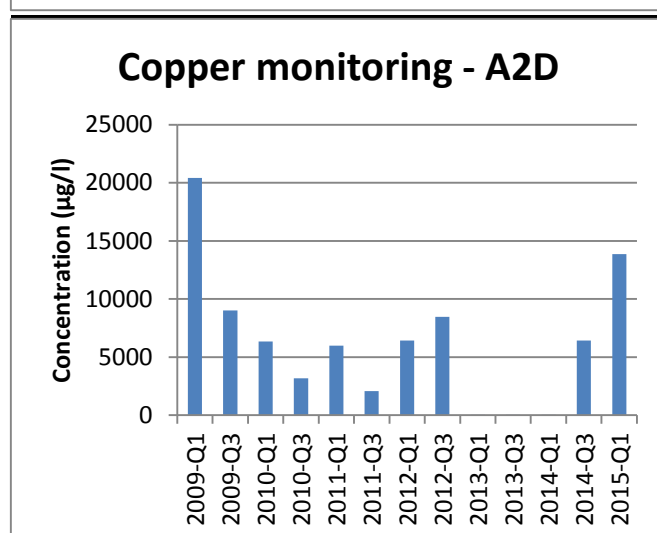
1. As mentioned in the previous reports the results over the past 3 years appear to show fluctuation in the copper levels. It was suspected that the weather could play a part in the variation of the copper levels in the boreholes. Investigation of the weather data in combination with the sample days has been carried out but no specific trends have been identified.

2. Some analysis of the pH of each of the samples versus the copper levels has been carried out. Whilst some boreholes have shown a weak correlation of lower pH showing increased copper, other boreholes show no correlation at all.

3. All results of the sampling this quarter fall within the normal range of the sampling data.
4. The only borehole which measured a significant value for copper was A2d. The value was not as high as it has been in previous reporting periods. This borehole is situated in the middle of the site and therefore poses no risk to local sensitive receptors.

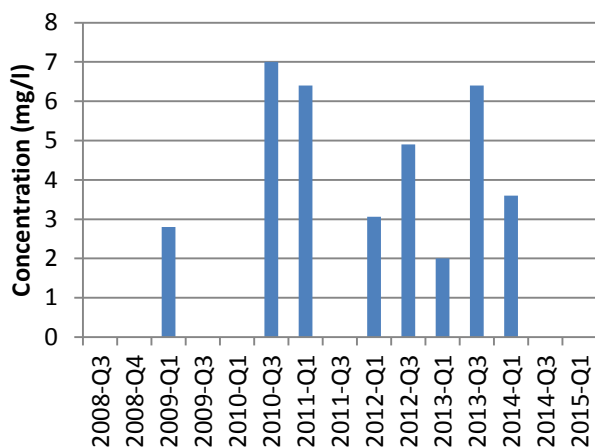
**TMS monitoring - BH 210**

1. No boreholes show significant TMS concentrations this quarter.
2. The results of sampling the boreholes shows the usual fluctuations.
