# **GEOMORPHOLOGICAL ASSESSMENT**

**TO INFORM THE CUMULATIVE IMPACT OF THE  
GALEDFFRWD HYDRO ELECTRIC POWER SCHEME  
ON THE AFON GALEDFFWRD, BETHESDA, NORTH  
WALES**

September 2018

**HYDRO-MORPH**  
Water & Geomorphology Services

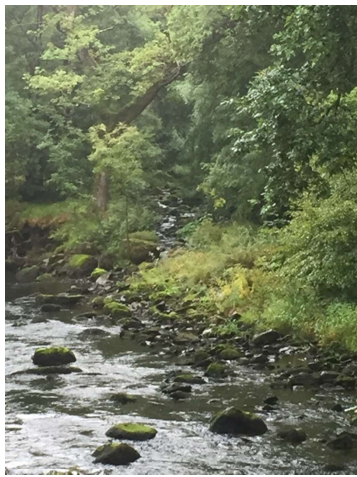
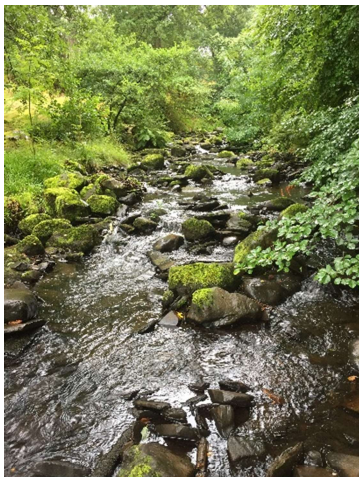
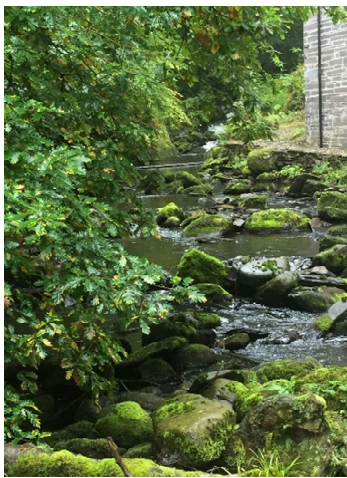
A1. Confluence with the Afon Ogwen	A2. Downstream channel Afon Galedffrwd	A3. Moss covered boulders in downstream channel

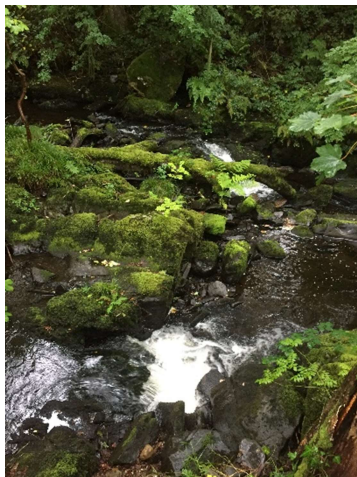
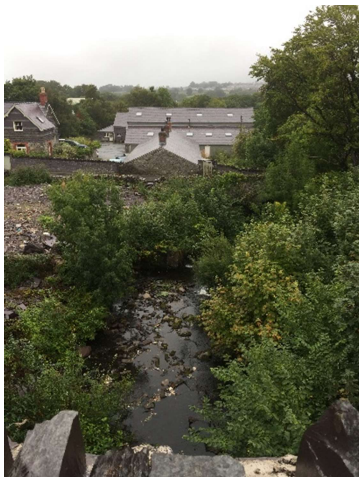
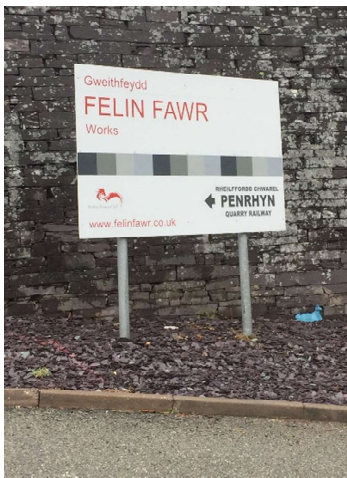
A4. Moss covered boulder weirs	A5. Felin Fawr former Slate Works – view looking d/S to large weir.	A6. Felin Fawr site – channel is culverted.

This assumption is supported by evidence collated during the initial feasibility investigations for the project. It is understood the Environment Agency carried out river survey in May 2010 and confirmed the downstream end of the river is used by migratory fish, with the upstream limit being the weir just upstream of the culvert through the Felin Fawr site, adjacent to the proposed outfall<sup>6</sup> (see figure 2.1 and photo A7 in appendix A).

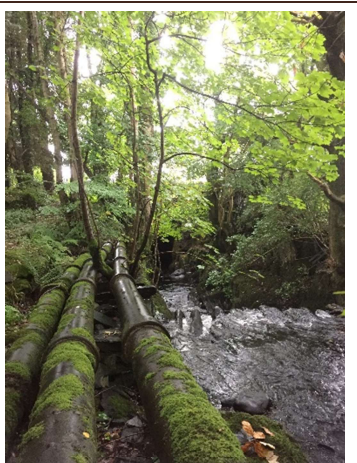
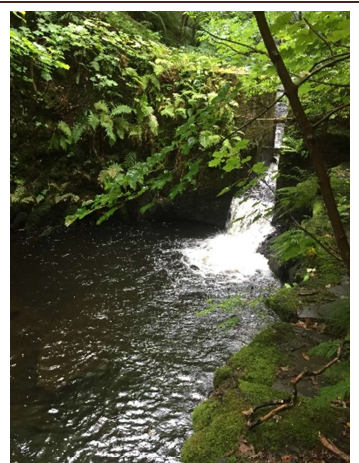
A7. Former pipeline adjacent to the channel upstream of Felin Fawr	A8. Coed Y Parc lower dam	A9. Coed Y Parc upper dam

Further downstream there are two more dams located directly along the Afon Galedffrwd watercourse. The lower dam is located approximately 30m upstream from the culvert of the former slate works. During the site visit it was observed the dam was not retaining any impounded flow behind it. However, the dam is a significant barrier across the full width of the water body, with flow maintained through a very narrow (1m wide) weir that cuts through the dam. It is therefore likely that during high flows, water will be impounded behind the structure and sediment transport, particularly bedload transport, will also be severely impeded.

Immediately upstream from the lower dam there is another second, much larger dam, which creates a waterfall some 10m in height. The weir impounds the Afon Galedffrwd for approximately 100m upstream, creating a narrow flooded valley. The bed substrate is notably different along this short stretch of channel with a greater degree of fine sediment deposition due to the impounded, slow flow conditions (see photo A10 in appendix A). There is also a much higher degree of channel turbidity within the impounded reach. In terms of impact, this modification is probably having the most significant impact on the waterbody in terms of reduced sediment transport and uncharacteristic bed substrate and riparian habitat quality and type.

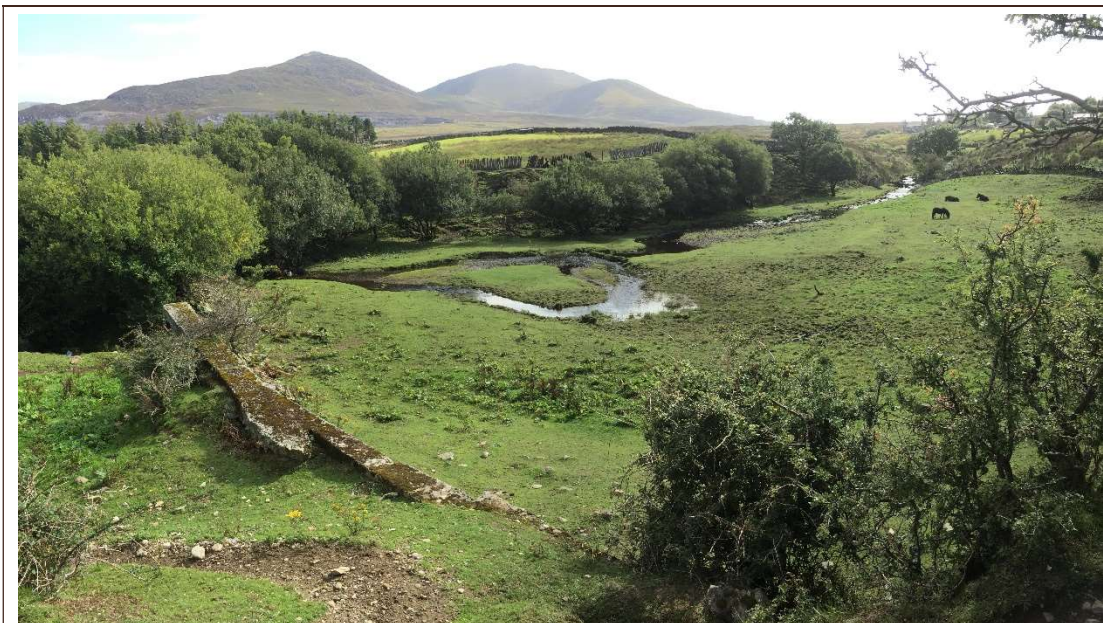
A20. Channel upstream of the road bridge, culvert and historic dam. Landuse rough pasture. Notably change in character as floodplain widens.

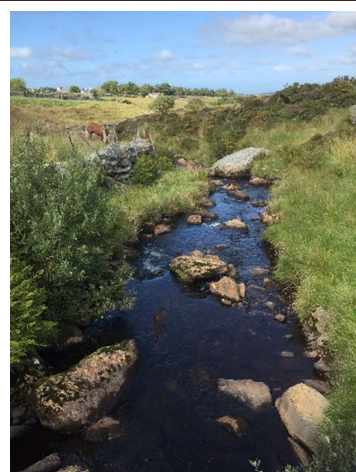
A21. Shallow boulder stream cut through heath and moorland

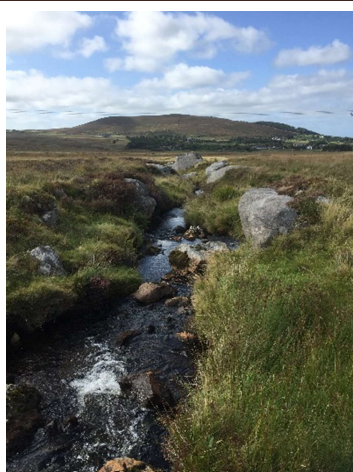
A22. Upstream tributary

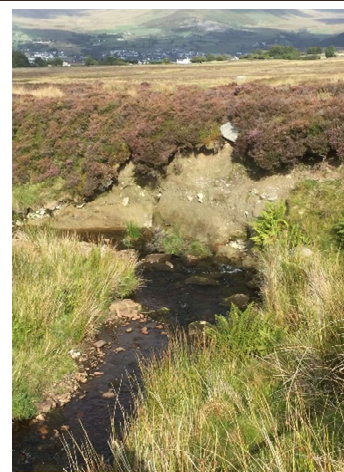
A23. Heavily eroded banks along one of the upstream tributaries. Source of fine gravel and silt.

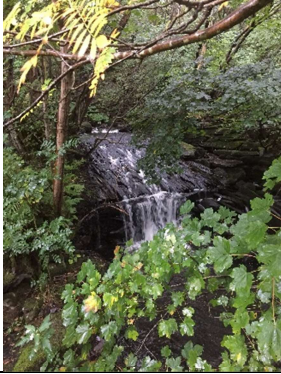
Ref. No.	Location	Grid Ref.	Pressure / modification	Description / Photo	Barrier to sediment transport (Y/N)
1	90m upstream from the Afon Ogwen confluence (downstream of the B4409 road crossing)	261584, 366540	Weir - 4m drop

No – bed upstream is level with the weir crest
2	B4409 road crossing	261563, 366429	Bridge	Channel under bridge not observed.	Unknown – but unlikely
3	Downstream of the Coed-y-parc (Site of the former Felin Fawr Slate Works)	261553, 366429	Weir – 6m drop

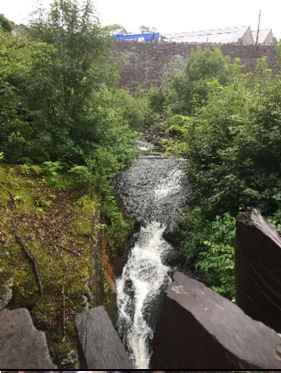
No – bed upstream is level with the weir crest
4	Coed-y-parc (Site of the former Felin Fawr Slate Works)	261506, 366349	Culvert - 215m in length

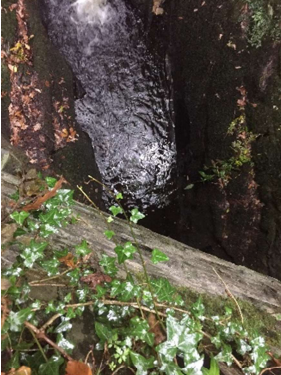
No
5	Upstream of the Coed-y-parc (Site of the former Felin Fawr Slate Works)	261472, 366280	Weir – 3.5/4m drop

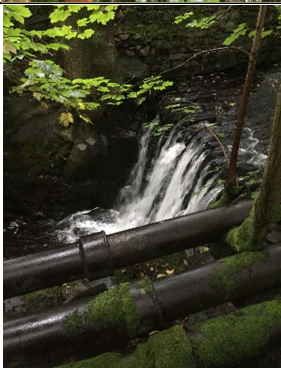
No – bed upstream is level with the weir crest

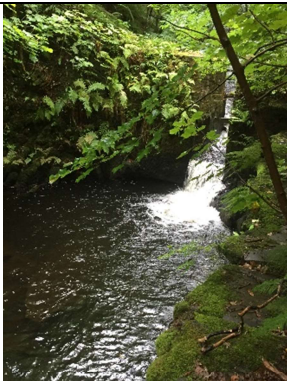
6	Lower dam  30m upstream from the culvert of the former Slate Works (Coed Y Parc Reservoir)	261445, 366247	Old dam and slot weir – approx. 1m wide and 2m drop.  Observed during low flow so no observed impoundment behind the dam

Yes – due to the narrow offtake through the dam
7	Upper dam  90m upstream from the culvert of the former Slate Works (Coed Y Parc Reservoir)	261412, 366196	Reservoir and dam, outlet over a large weir - 10m drop  Weir impounds 100m length of channel

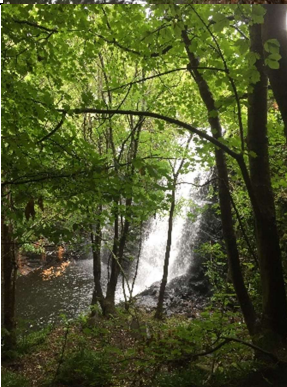
Yes – behind dam and within the impoundment
8	370m upstream from the culvert of the former Slate Works	261234, 366058	Stepping stones	Public footpath crosses the river (not observed)		Unlikely
9	680m downstream from Pont Galedffrwd road crossing	261091, 365904	Footbridge	Public footpath crossing the river		No
10	Pont Galedffrwd road crossing	260606, 365485	Bridge and culvert (x2 openings)  Minor road crossing

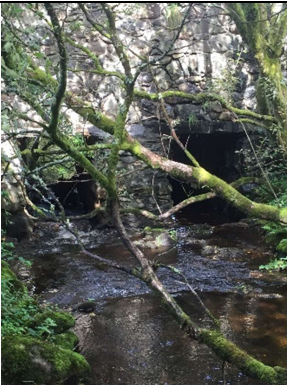
Yes – due to debris accumulation within both culverts

The two culverts located approximately 60m upstream of the proposed intake (under the road bridge) are considered a restriction to sediment transport due to their narrow size across the channel. During the site visit it was observed woody debris had built up within both culverts slightly blocking them (see photo A18 in appendix A). It is likely high flows would wash accumulated woody material further downstream but, given the small size of the culverts, the same high flows are unlikely to transfer any significant amounts of sediment further downstream.

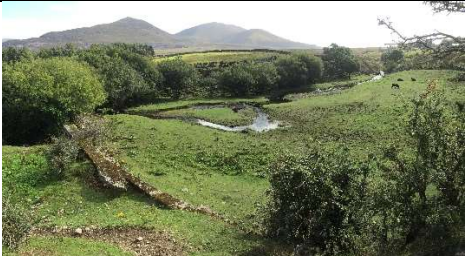
11	Pen y Bont - 65m upstream from Pont Galedffrwd bridge	260559, 365448	Historic reservoir and dam.  Confined flow through a gap in the dam

Yes – though the dam is breached flow is confined to a small opening in the structure

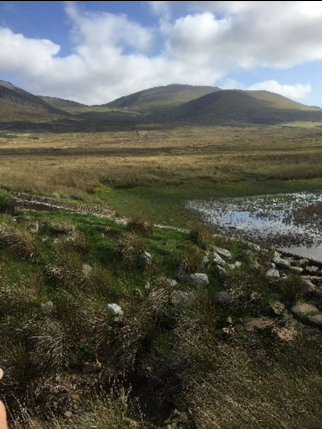
Upstream Tributaries						
12	Head of the western tributary  Llyn Newydd  Historic dam and reservoir	261051, 364660	Historic reservoir and dam, breached narrow flow outlet

Yes – though the dam is breached flow is confined to a small opening in the structure
13	Eastern tributary (Afon Marchlyn-Mawr)  Lyn Owen-y-ddol  Historic dam and reservoir 500m upstream from Pont Galedffrwd bridge	260025, 364792	Reservoir and dam, breached weir at outlet  Area 0.4ha

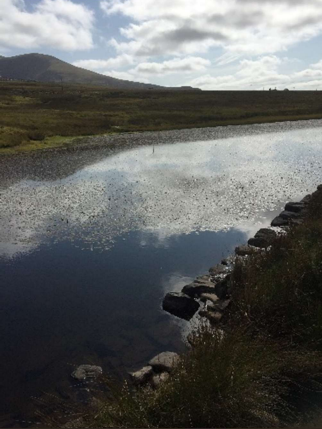
Yes - due to creation of an impoundment behind the dam but only at normal to low flows as the outfall is likely to be breached at higher water levels
14	Eastern tributary (Afon Marchlyn-Mawr)  Marchlyn Bach  Owned and operated by Welsh water to supply a water treatment works	260664,362642	Reservoir, dam and culvert  Area 4.8ha

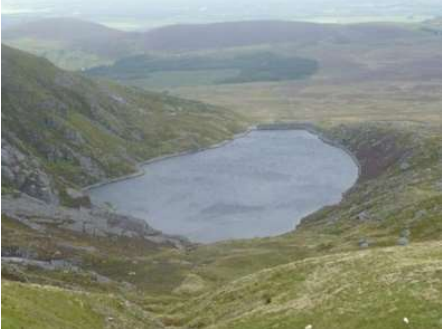
Yes – due to creation of an impoundment behind the dam
15	Eastern tributary (Afon Marchlyn-Mawr)  Marchlyn Mawr  Supplies water to the Dinorwig Hydro-Electric Power Station	261377, 362026	Reservoir, dam and culvert  Area 26.3ha

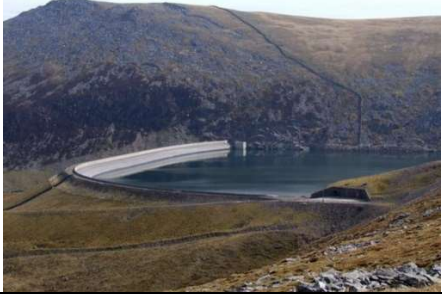
Yes – due to creation of an impoundment behind the dam
