Project Name:
**SALMON FOR TOMORROW
PHASE 2
HONDOU FORGE**

Drawing Title:
PROPOSED GENERAL ARRANGEMENT

Suitability:	Suitability Code:
FOR CONSTRUCTION	A
Internal Project Number: 277161	Scale: 1:200
Drawing Number: 277161-ARP-03-XX-DR-XX-0004	Rev: C01

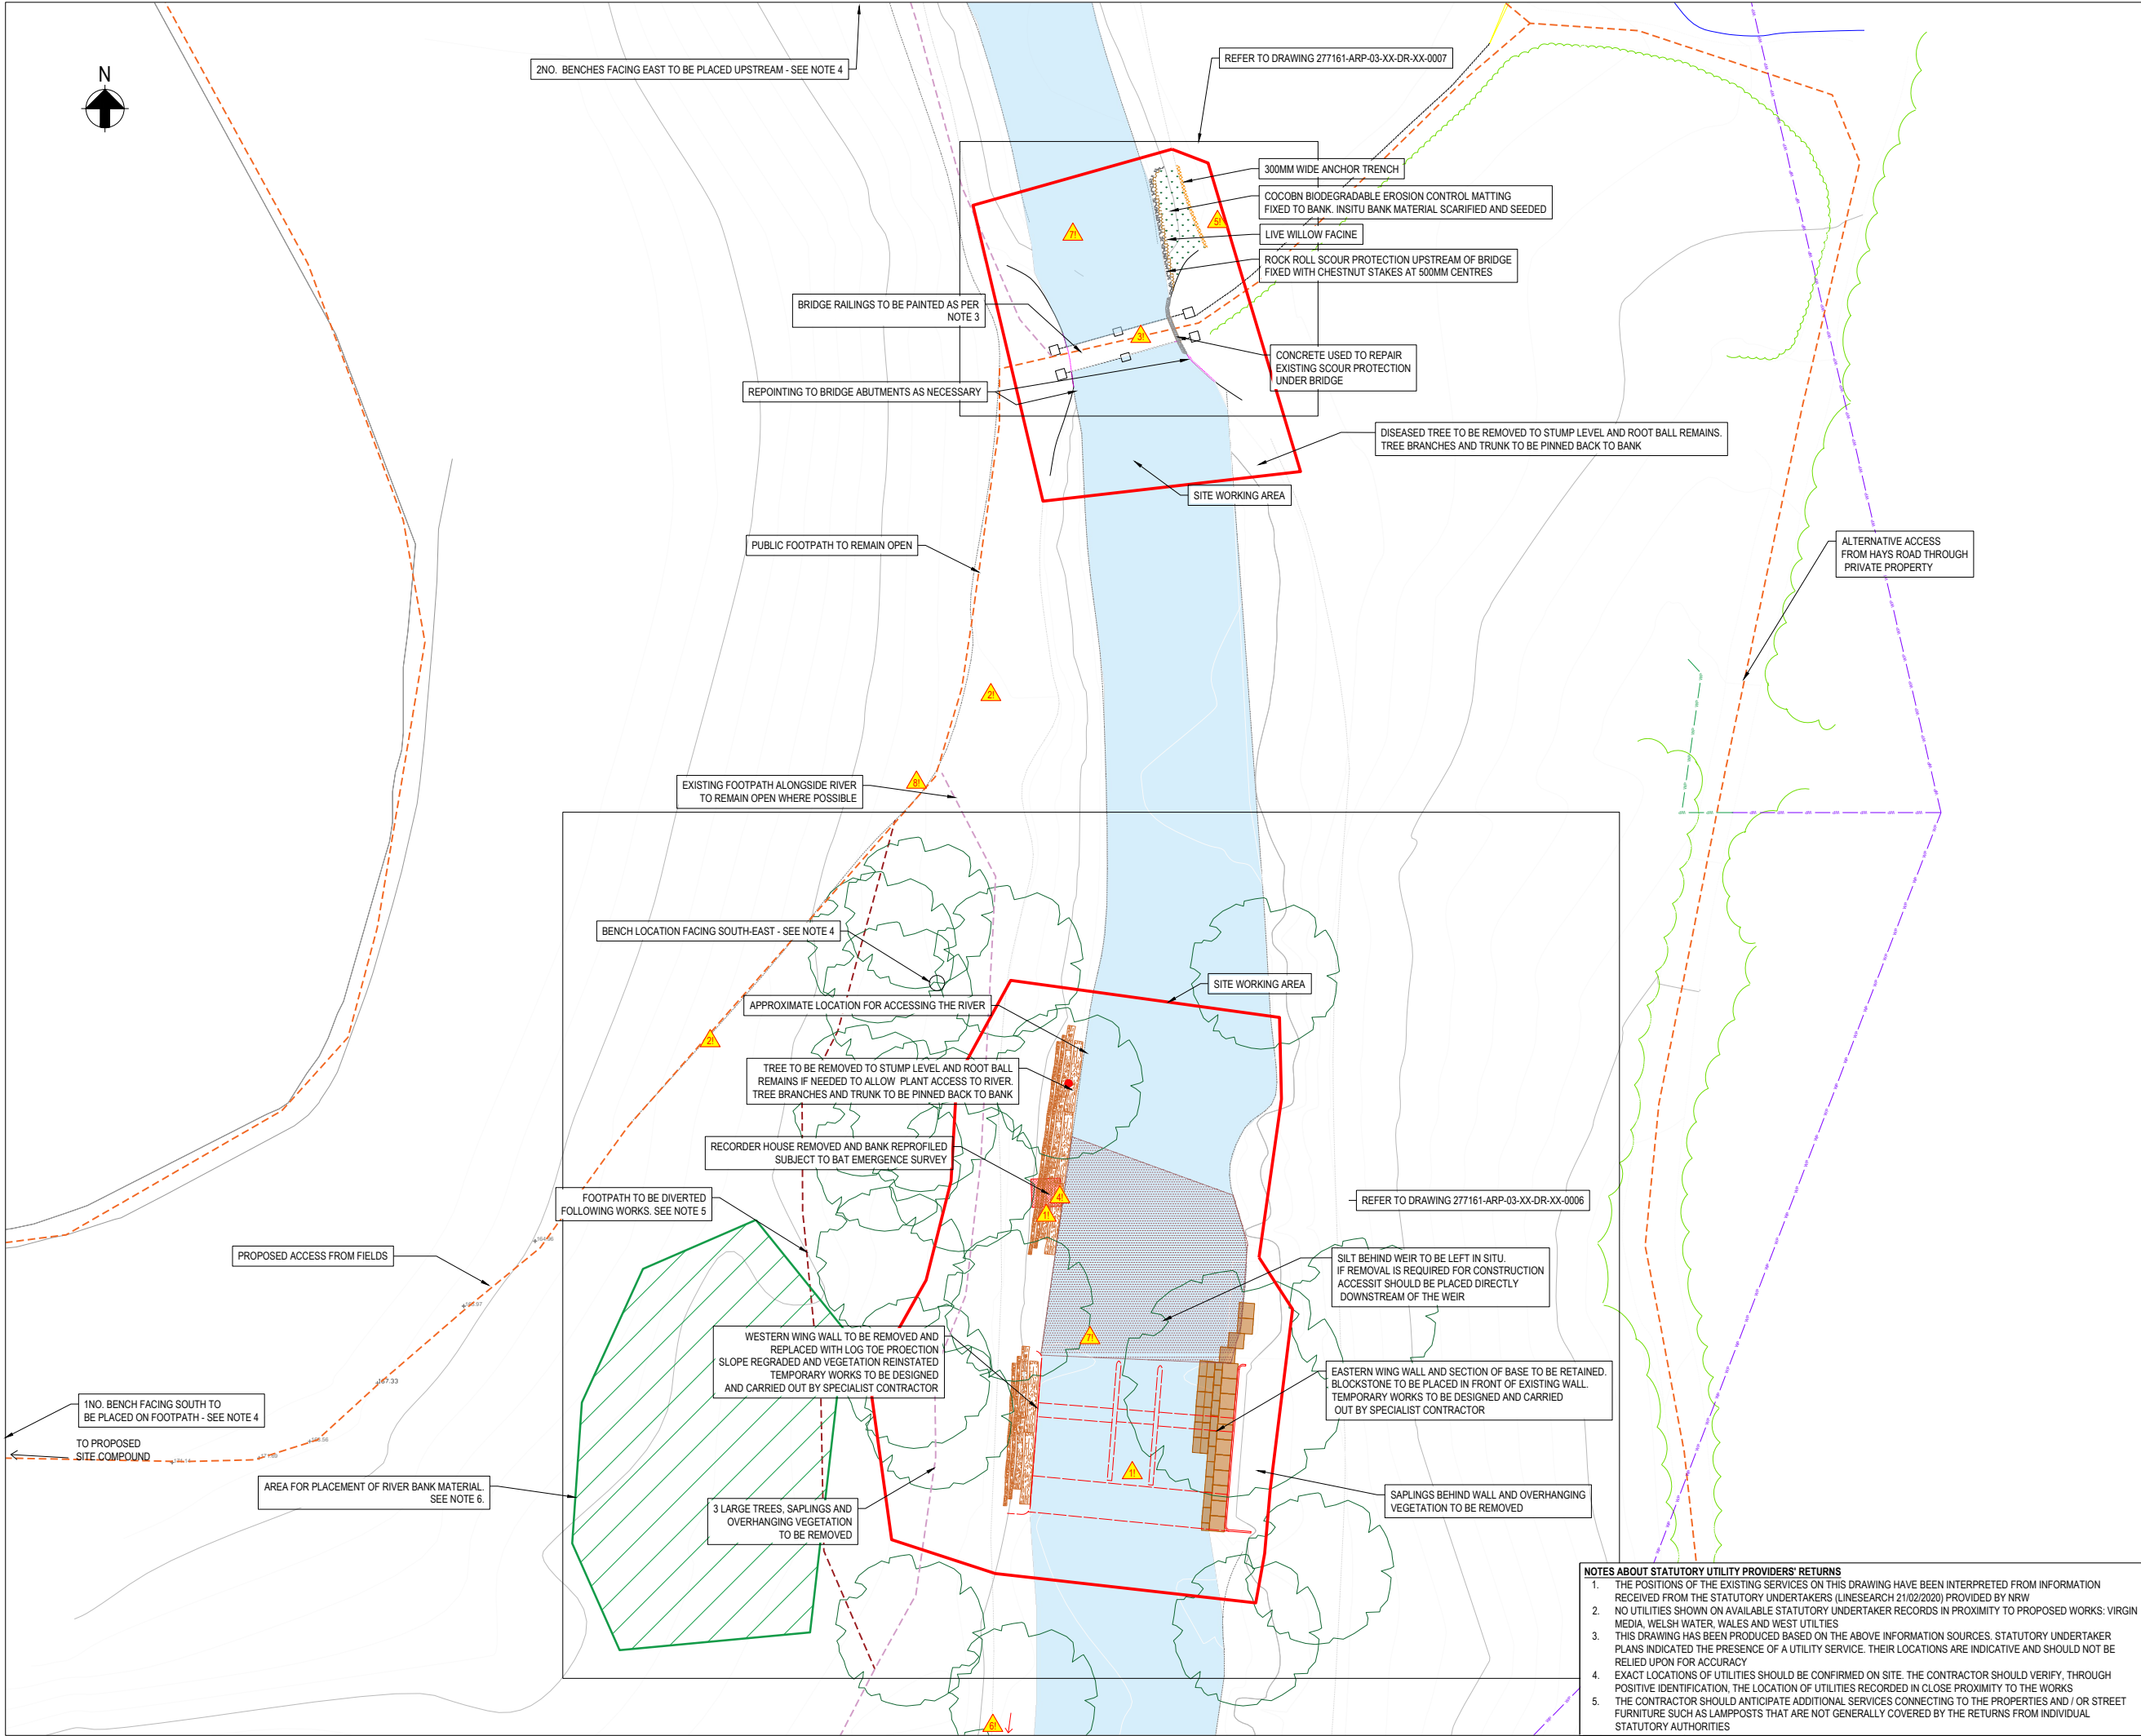
NO GROUND INVESTIGATION HAS BEEN CARRIED OUT. IT IS ASSUMED THAT THE RIVER BED IS FORMED OF GRANULAR MATERIAL ON THE BASIS OF VISUAL INSPECTION. BEDROCK IS VISIBLE IN THE CHANNEL IN THE PROXIMITY OF THE WORKS, AND IT IS POSSIBLE THAT ROCKHEAD MAY BE ENCOUNTERED DURING THE REGRADING WORKS. THE CONTRACTOR IS TO CONFIRM THIS PRIOR TO COMMENCING WORKS AND INFORM THE PROJECT MANAGER IF THIS IS NOT THE CASE.
 - PAINTING**

FOOTPATH TO BE REINSTATED ON ROUTE SHOWN IN LINE WITH CRUSHED STONE SURFACE DETAIL ON DRAWING TD-L-004
 - LANDSCAPING**

AREA INDICATED ON DRAWING IS A DISUSED QUARRY TO BE USED FOR THE PLACEMENT OF MATERIAL TAKEN FROM THE WEST RIVER BANK FOLLOWING REGRADING. SUBJECT TO ECOLOGICAL SURVEYS.
 - REFER TO DRAWINGS**
