## Compliance Assessment Report

Report ID:  
CAR\_NRW0034700

| Site | Tip Top Toilets Waste Transfer Station | | Permit Ref | BB3098HH | |

### Tip Waste Transfer Station, EPR/BB3098HH) – 07/02/2019

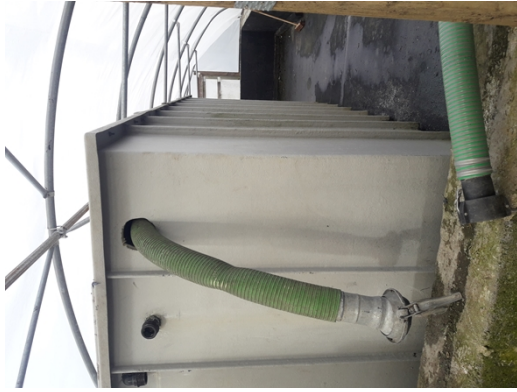
- The waste storage area is now compliant with the permit: the waste is stored in a sealed container, located on an impermeable surface with a sealed drainage surrounded by a bund with a storage capacity larger than 110% of the volume of the tank. As it can be seen in Picture 1 the tank is undercover and closed with lock. This represents a great improvement from before. A Spill kit is provided in the waste storage area 1 as shown in picture 2.

Figure 1 Bunded volume and spill kit.

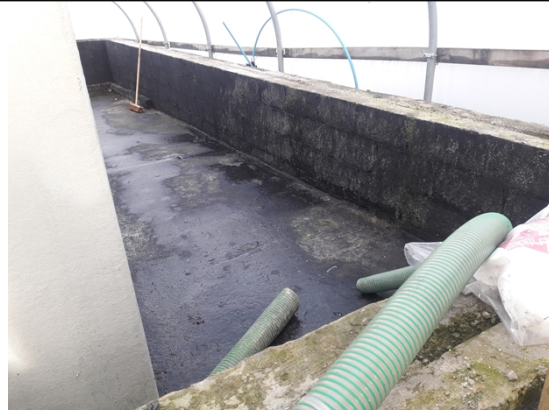
Figure 2 Waste storage area 1

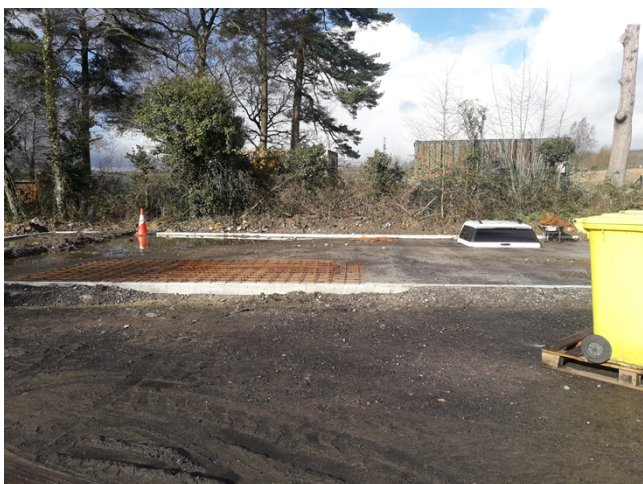
- The washing area is not yet been completed and it's not working, this represent a serious breach of the permit. Michael said they are having problems in completing the works due to weather conditions. They require a period of dry weather to manage to dig the hole for the drainage tank to be set down. At the moment in place we can see only the incomplete concrete platform as shown in picture 3. The waste containers are now washed on the pavement with no controlled drainage, the fluids are therefore dispersed uncontrolled in the environment. This is a breach and represents a potential impact on the environment. The risk is not as big as it could be, because the winter season sees less activity than in summer. When asked the operator about the time needed to complete the infrastructure, Michael replied that it would take only 2-3 weeks to complete the works once started.

Figure 3 Unfinished concrete slab for the washing area.

We have asked the operator to finish to build the washing area as soon as possible, **the breach recorded is a Category 2, the score will be active for now, but if they demonstrate to solve this issue in the next 4 weeks we will be able to suspend it.**

| Criteria Ref. | CCS Category | Action required/advised | Due Date |
|---|---|---|---|
| B3 | C2 | Build the infrastructioure as soon as possible | 17/03/2019 |
