Hendy Quarry Landfill: Permit Variation Application (EPR/BT1088ID)

For the addition of waste types and increase in
the maximum water discharge volume

Report reference:
62487R1rev2, March 2019

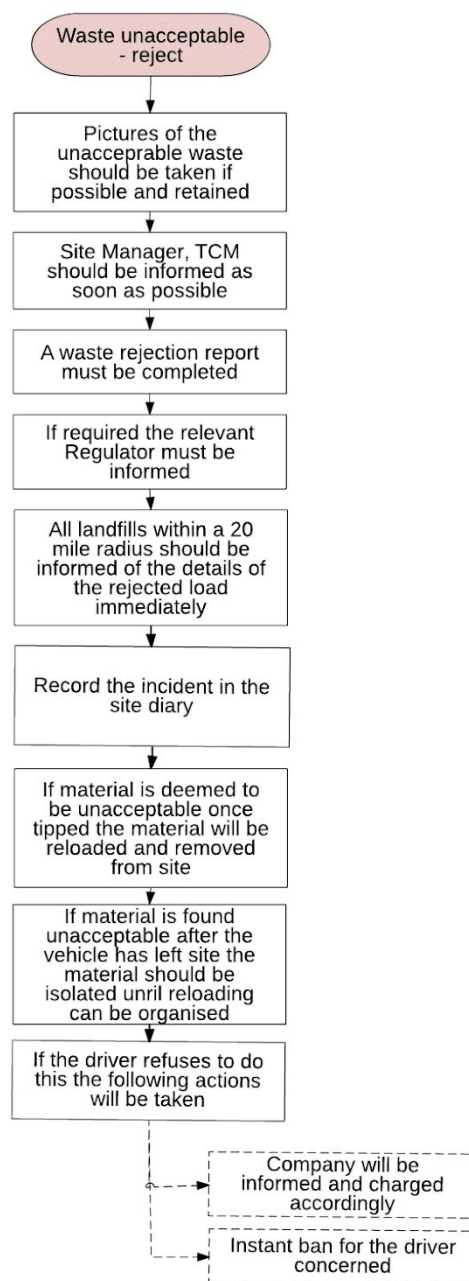
The below flow diagram should be consulted:

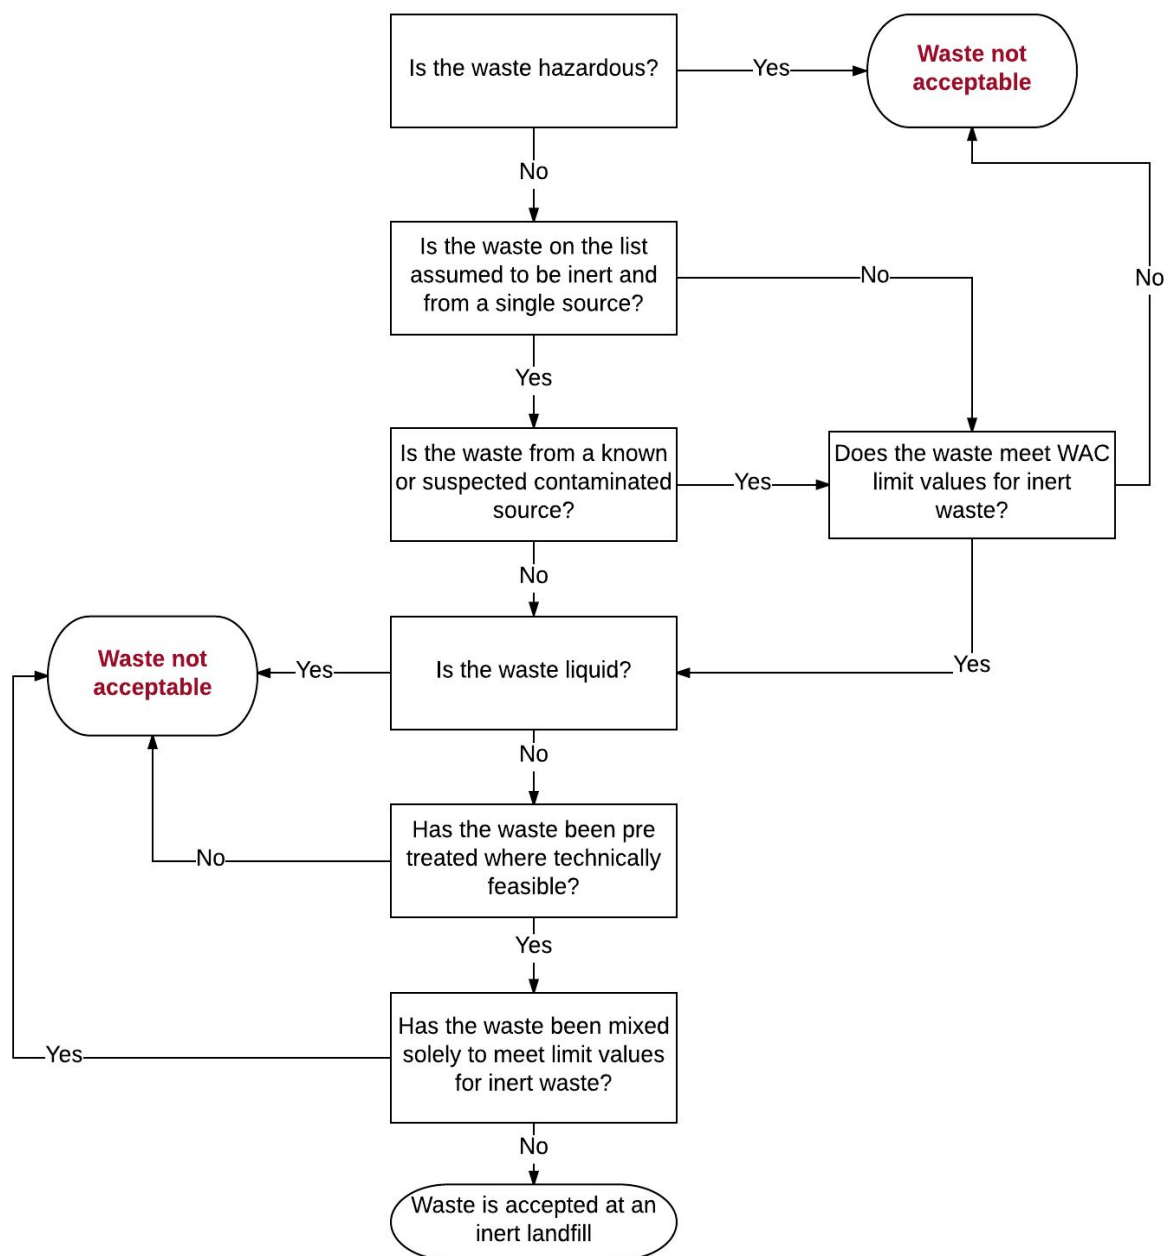
The below process flow must be followed for determining any waste that can be received into an inert landfill:

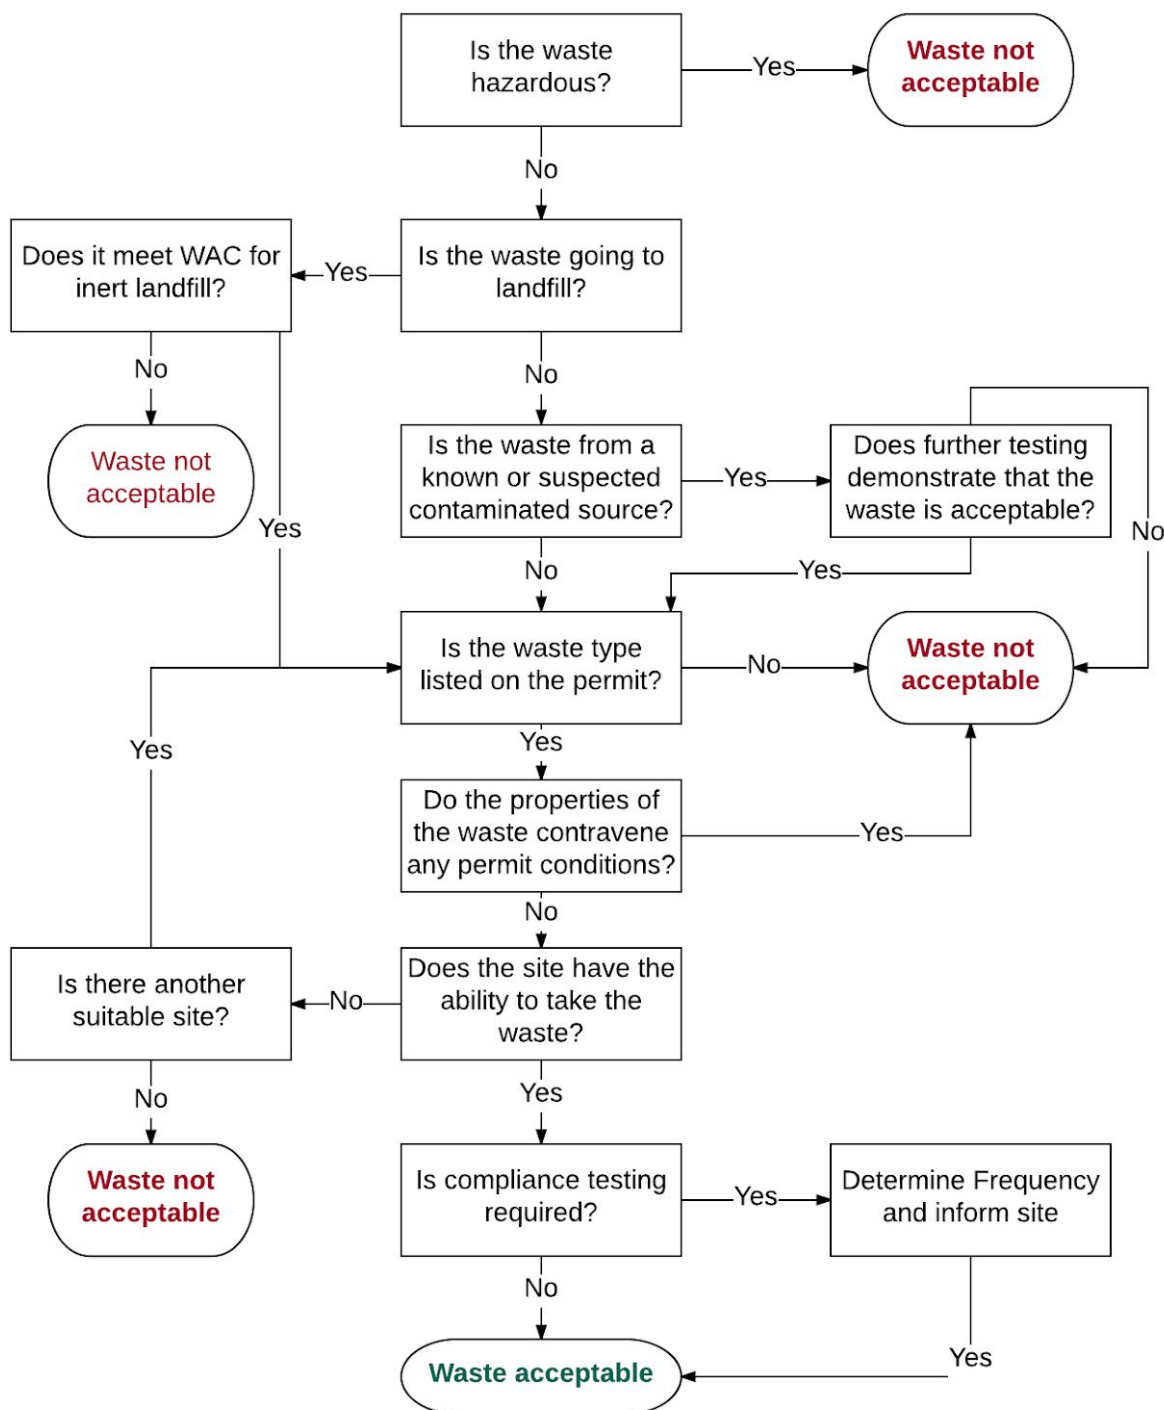
The below process flow must be followed for any waste being received into an inert landfill:

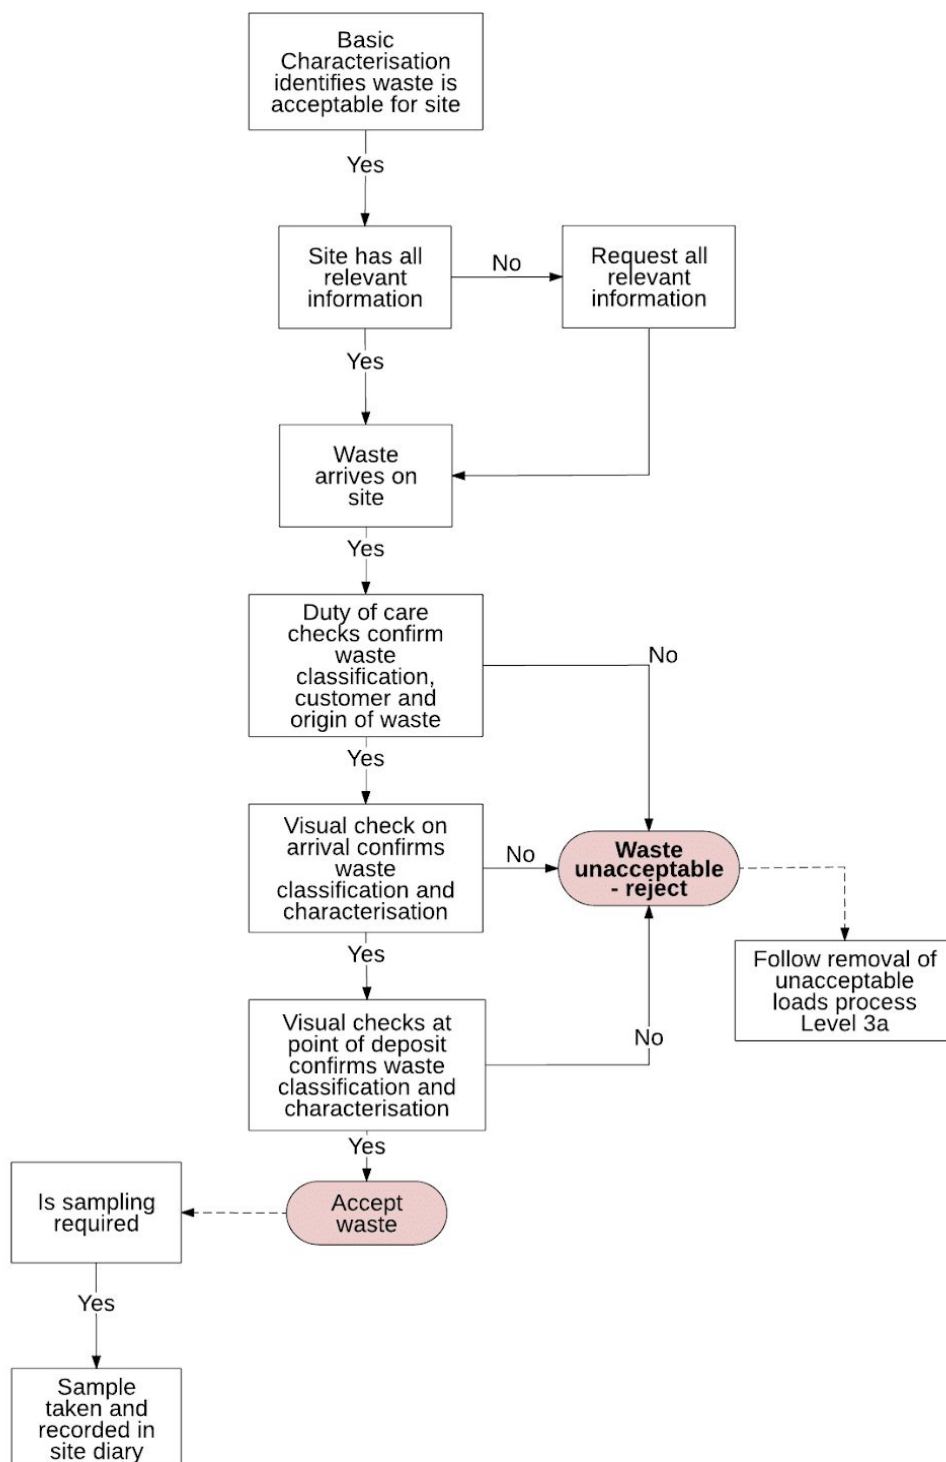
The below processflow must be followed for any waste being received into an inert landfill:

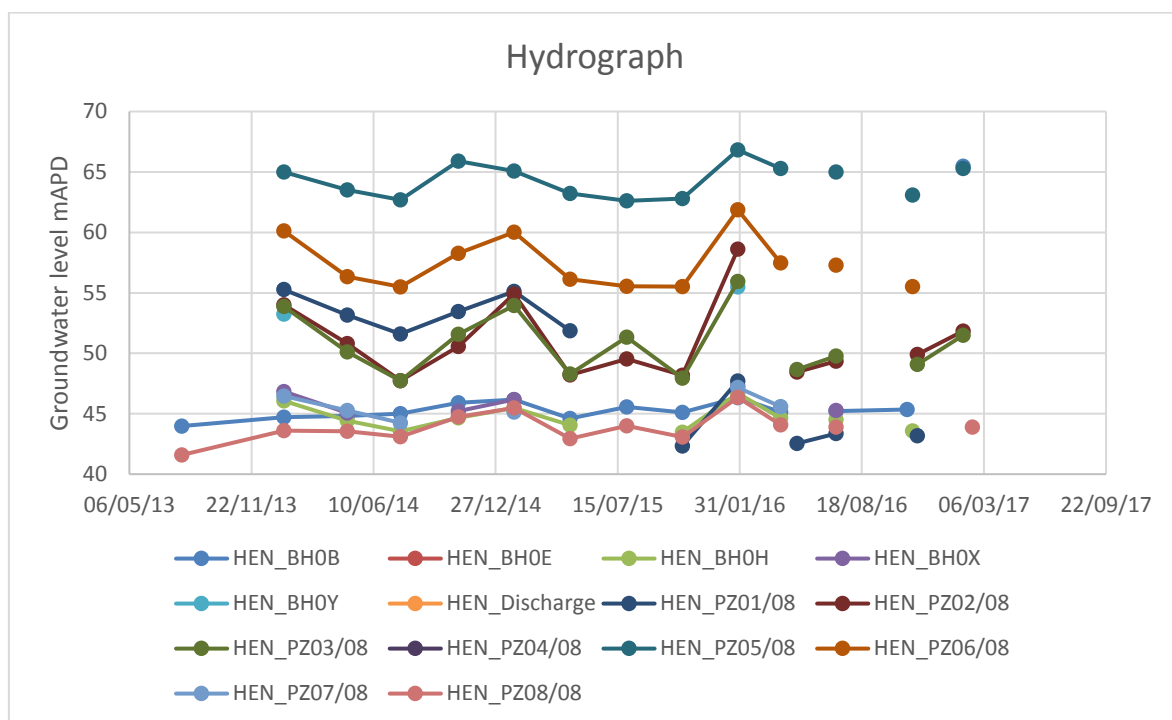
2.3.14 The base of the quarry is circa 45-46 mAOD. This is similar to the minimum water levels monitored within the up gradient boreholes which indicates that there is no significant (>1m) unsaturated zone beneath the base of the site, however there is no reported groundwater ingress within the base of the quarry.

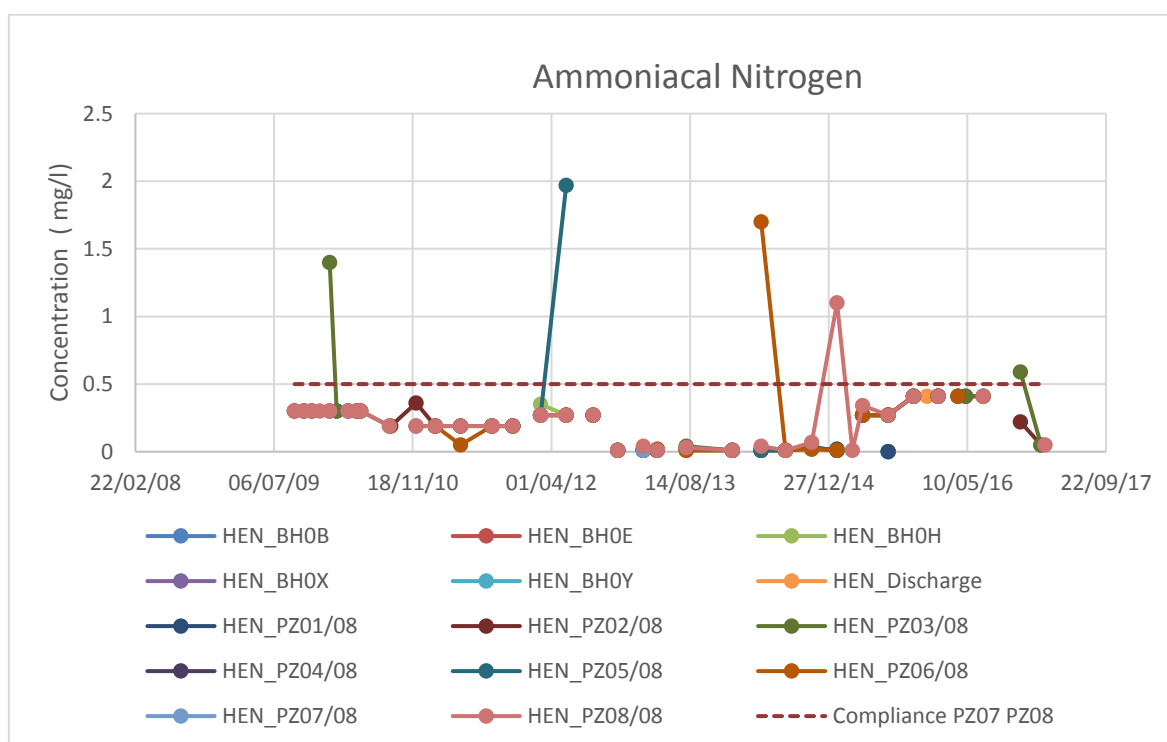
2.3.23 A second exceedance was observed in December 2014 with a value of 1.2 mg/l. The timeseries graphs below also show that this was not part of any prolonged deterioration in groundwater quality nor associated with any of the 'spikes' in non-compliance borehole, neither is it associated with any increase in chloride concentrations within the borehole. Therefore it is very unlikely that this result is due to an impact from waste deposited under the conditions of the Permit.

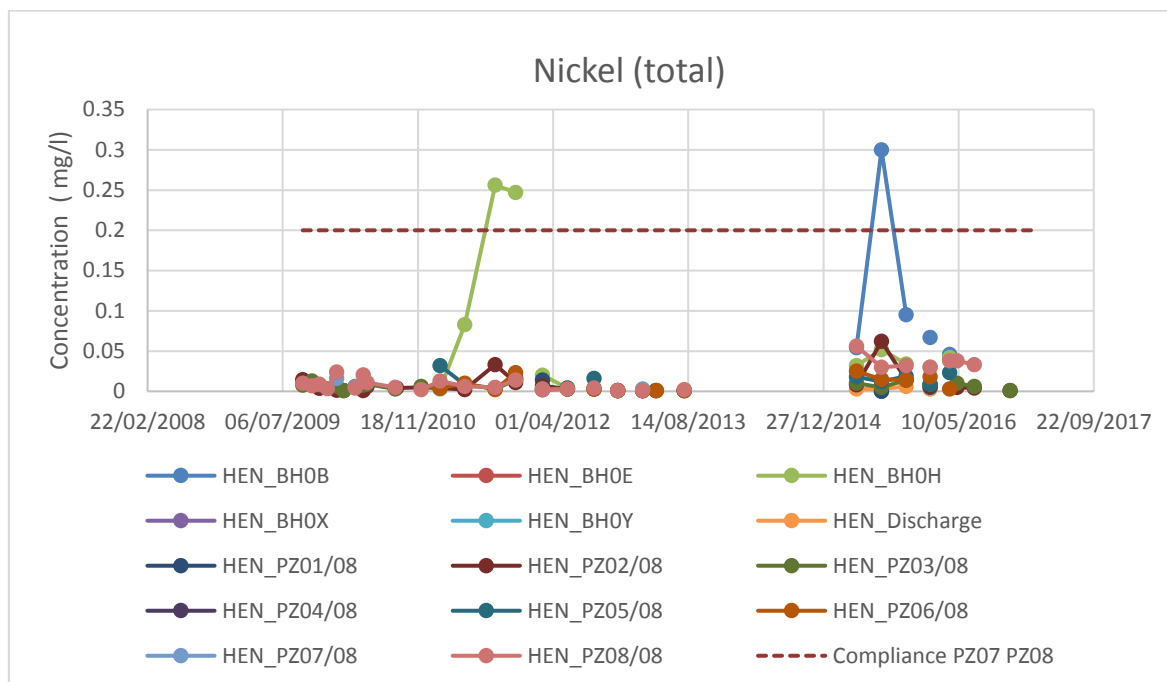
for total metal concentrations. It is therefore not considered to be representative of dissolve pollution within the groundwater.

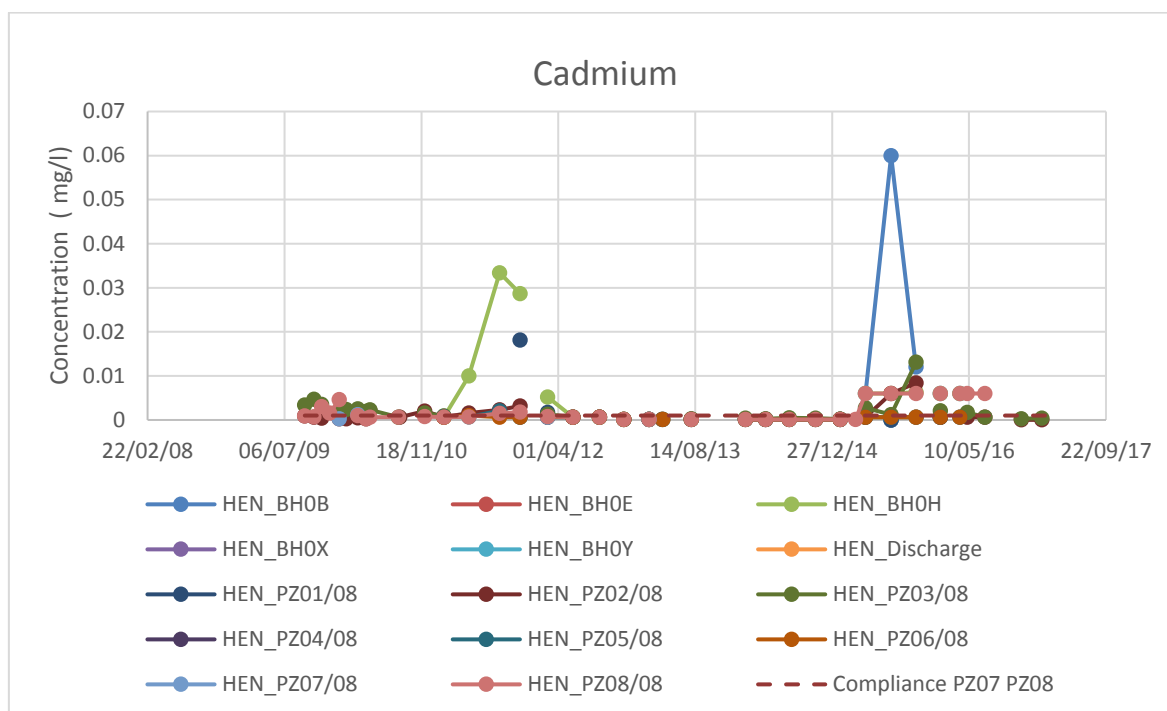
2.3.27 A review of the cadmium monitoring data indicates that prior to 2013 the cadmium concentrations were more varied across the site. No limits of detection are present in the data between 2009 and 2013 and therefore all concentrations are recorded as 'real' results. The most apparent feature is a spike in cadmium in borehole BH0H. The cause is unknown however it appears to mirror the nickel concentrations and may be due to sediment within the sample.

2.3.28 Post 2013, the boreholes with the exception of PZ03/08 generally record cadmium below the detection limit with only one recorded concentration in BH0H (0.0063 mg/l) and two recorded concentrations in PZ02/08 (0.006 mg/l and 0.0084 mg/l). In contrast, the results for PZ03/08 only have one result recorded as being less than the detection limit over the same time period with all other results marginally above the detection limit range between 0.0002 mg/l to 0.0131 mg/l). This is consistent with the conclusions of the previous HRA review which identified relatively higher concentration of cadmium in PZ03/08 compared to the remaining boreholes.

2.3.29 The data within the graphs are presented at their detection limit and therefore the spike portrayed for BH0B in July 2015 is misleading as this value is less than the detection limit.

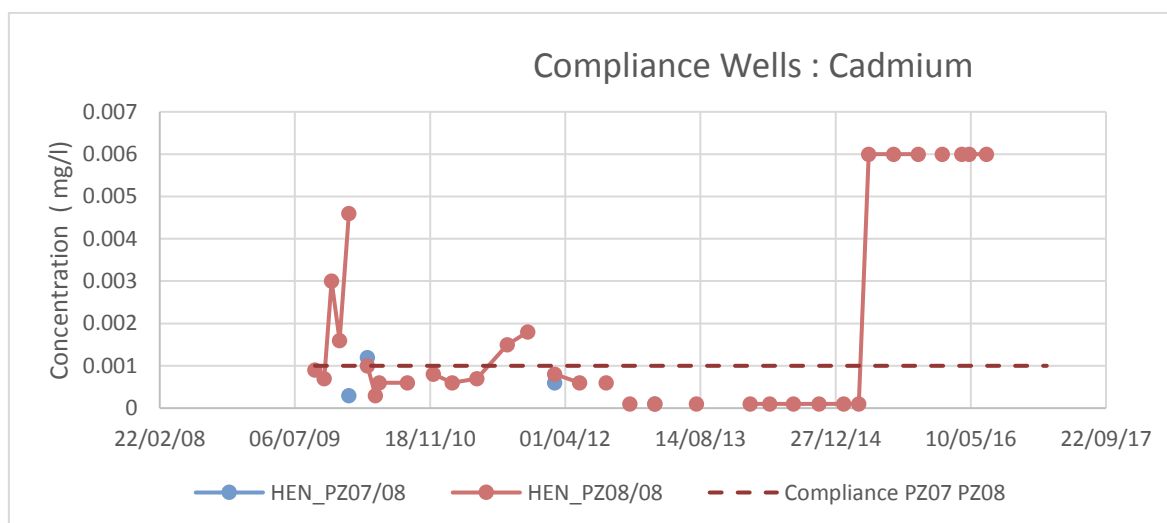
2.3.30 The cadmium concentrations for the compliance wells are presented in the graph below. This implies that the compliance criteria was exceeded in PZ08/08 from April 2016 onwards, however this is a result of the laboratory detection limit increasing to 0.006 mg/l within the database. All samples were recorded below this level and prior to April 2016 the concentrations were generally below 0.0001 mg/l. Therefore these results are not considered to represent an increase in concentrations with time but reflect the change in lab detection limits and consequently unable to demonstrate compliance. In reflection of these observations, the monitoring of cadmium since April 2017 has been reviewed and targeted for dissolved metal with a detection limit of 0.02ug/l.

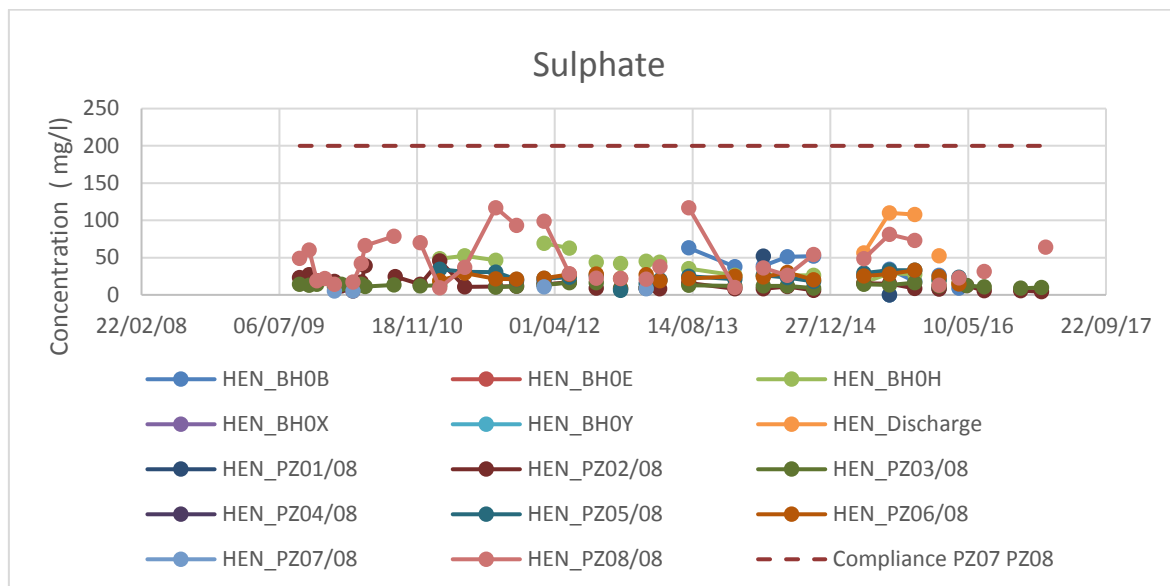
2.3.32 Sulphate concentrations remain below the compliance limit for the duration of this review period. This remains consistent with the previous HRA review in 2009.

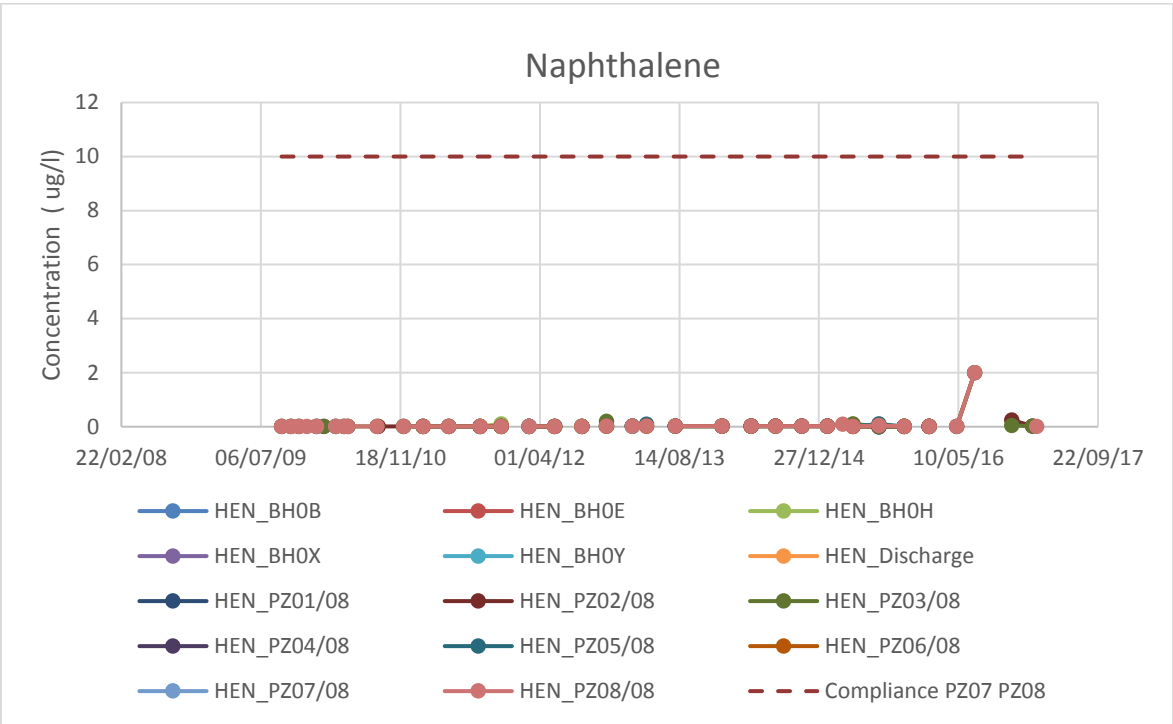
2.3.33 Naphthalene concentrations are consistently low across the site. The detection limit for all samples take on 7/7/2016 was <2 ug/l which is higher than the usual detection limit of <0.01ug/l. Therefore the graph below appear to show an increase on this occasion, however it is a reflection of the variation in detection limits. Naphthalene remains in compliance with permit criteria.

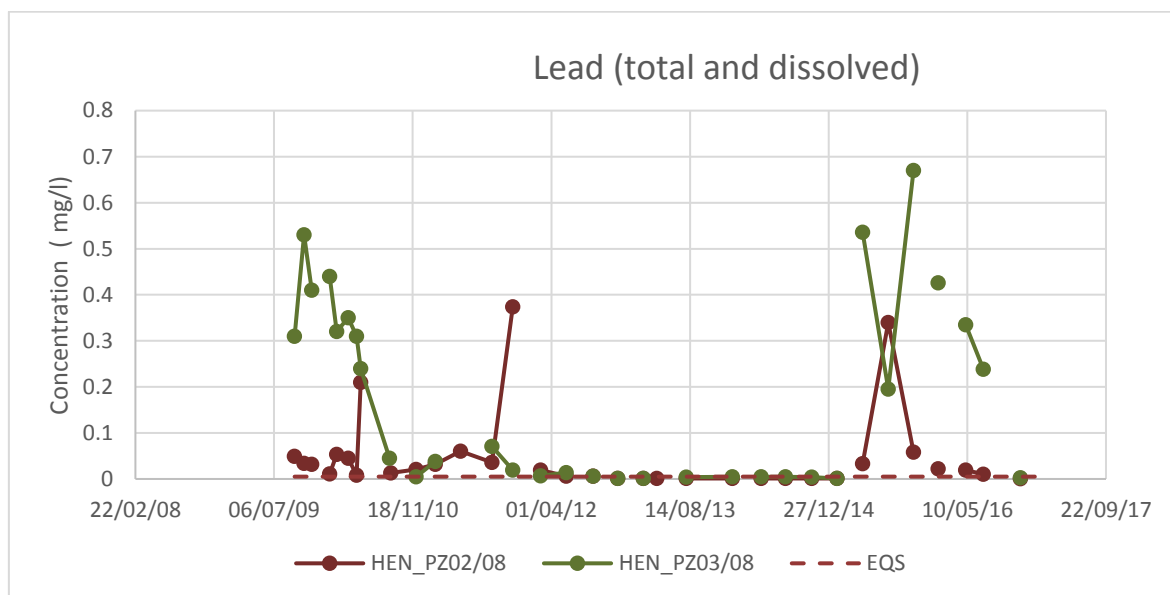
2.3.39 The up gradient groundwater quality is inferior to this as indicated in the time series chart below. It is recommended that future analysis is for dissolved lead only to avoid and spikes in concentration associated with sediments with the sample and to allow direct comparison to the relevant standard. The period of dissolved lead monitoring between 2012 and 2015 indicated consistent levels below this criteria. The high concentrations are reported for samples where total lead has been monitored.

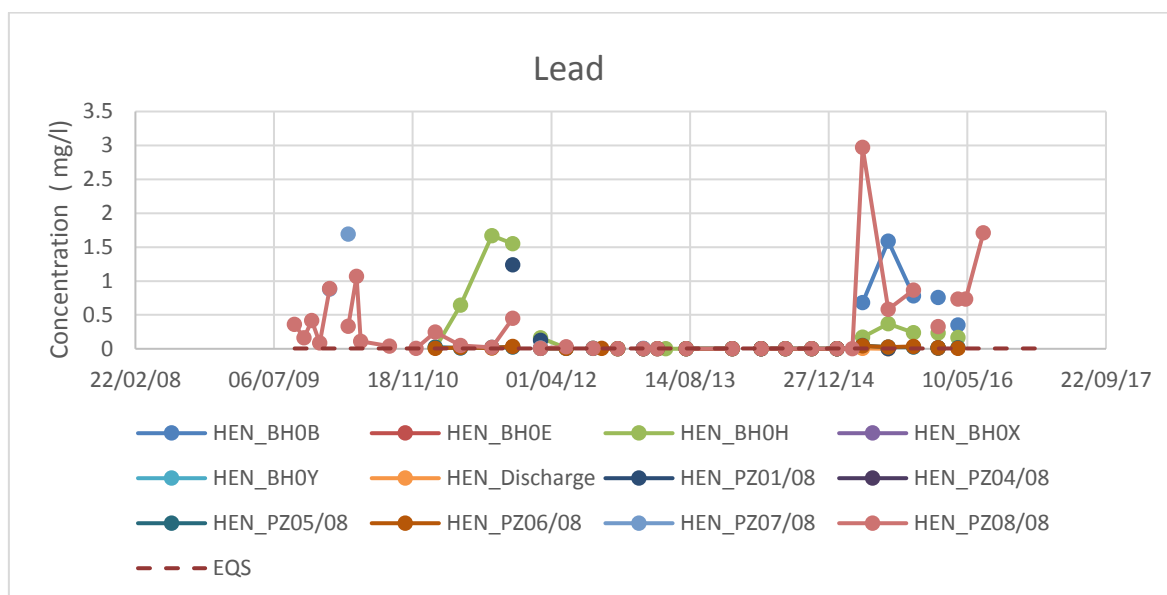
2.3.40 The down gradient monitoring wells display a similarly erratic trend with concentrations ranging from <0.001 to 3 mg/l.

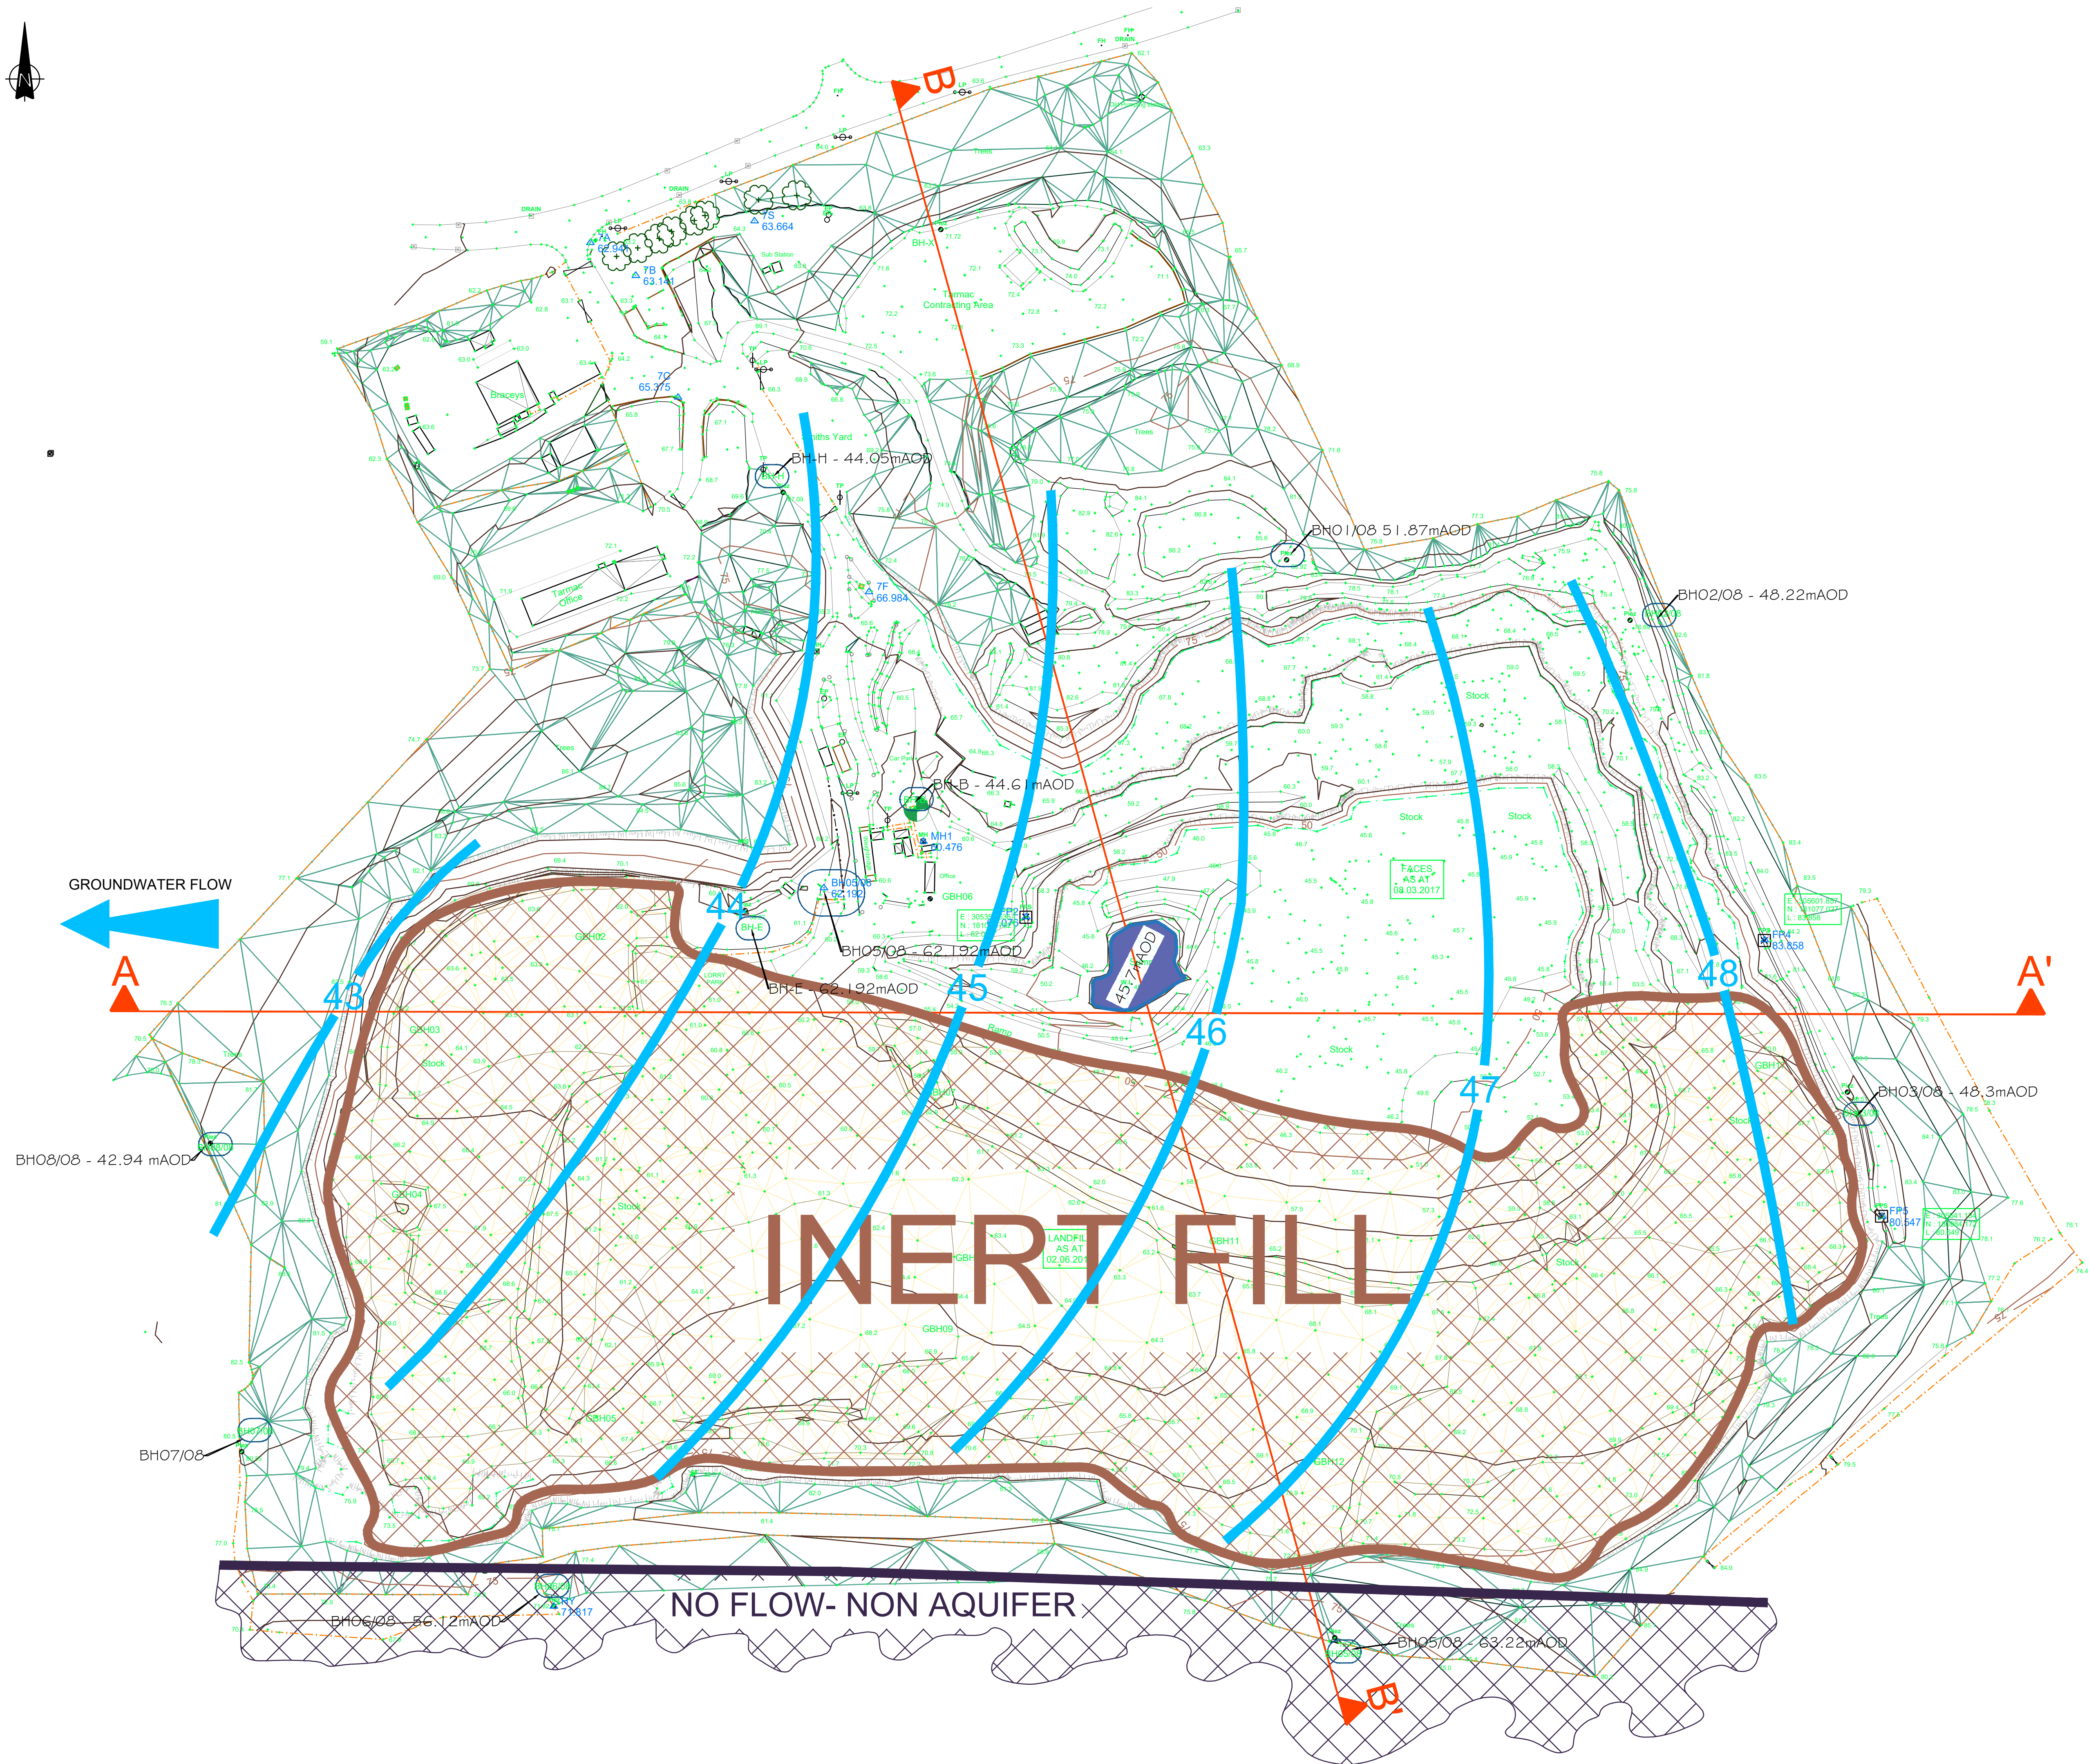
- INERT FILL
- NON FLOW, NON AQUIFER
- GROUNDWATER CONTOUR- 28.04.2015

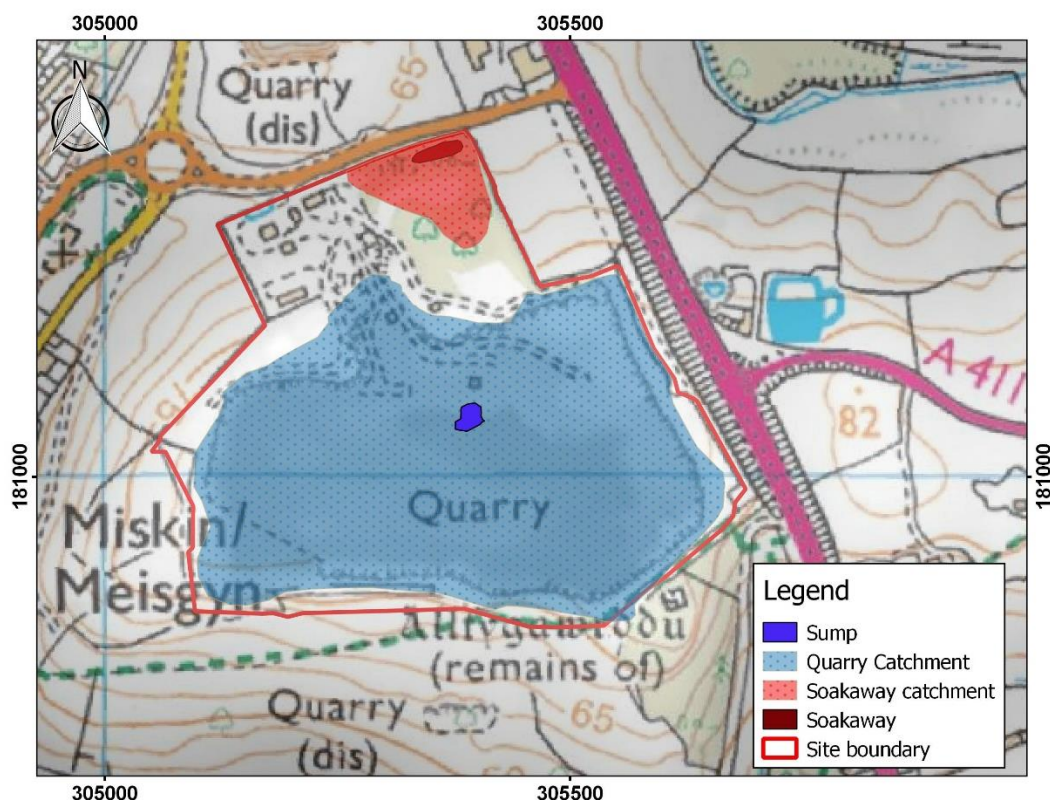
Figure 2.1 Site plan

The main quarry catchment is principally covered with bare rock with some areas of inert fill. ESI (2014) estimated the proportion of runoff from incoming rainfall (the runoff coefficient) using the established Coal Board (1982) nomogram method as being 0.67. Linear Regression of daily pumping and rainfall data yielded a coefficient of 0.71 which appeared to validate the high proportion of rainfall being diverted to runoff which may be expected in a heavily modified quarry catchment.

The sump is at an elevation of around 45 mAOD (Appendix A). Water levels are not regularly recorded in this feature although historic site topographical surveys put the sump water level at between 44.5 and 46.0 mAOD. Water level in the sump was noted to be 44.7 mAOD in June 2018. The sump level is controlled by submersible pump which is engaged manually by quarry staff.

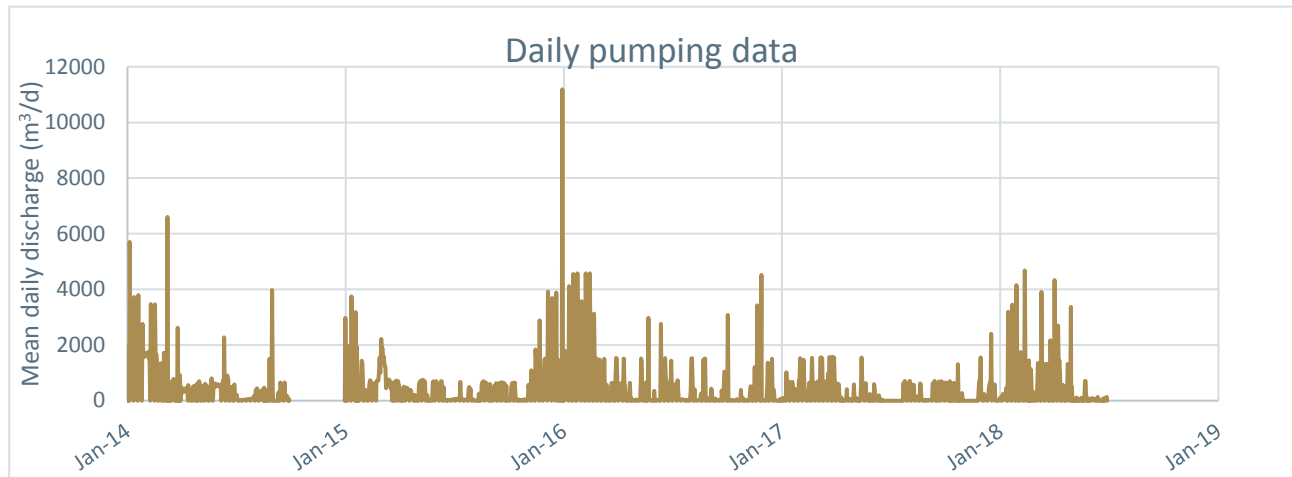
Figure 2.2 Raw daily discharge data

Over the observed period, the monthly discharge totals (expressed as a daily average) exceeded the consented volumetric limit on 8 occasions – this represents 16% of the data record.

The discharge record is highly variable. The pump capacity is currently unknown although values in excess of 6,000 m³/d (69 l/s) seem unlikely to be accurate and are probably a result of accrued totals. The maximum daily totals are considered likely to be in the order of 4,000 m³/d – 5,000 m³/d. The Site has confirmed the pump runs for 24 hrs following periods of heavy rainfall and that no flooding of the soakaway occurs during these times.

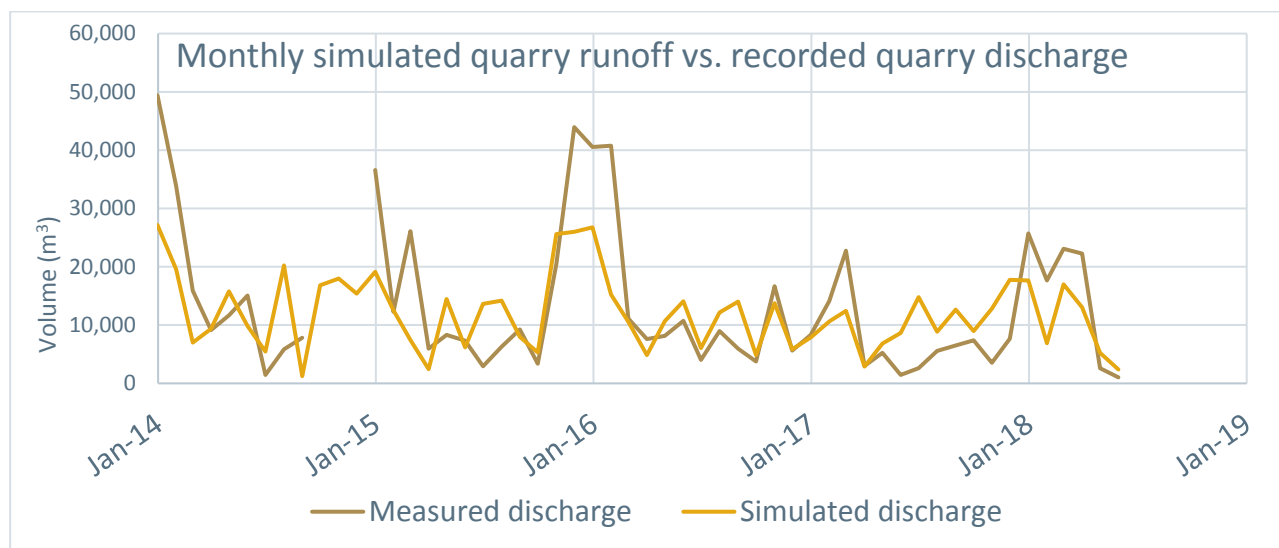
Figure 3.1 Monthly simulated runoff vs recorded site discharge

The results in Table 3.1 suggest that overall runoff is expected to represent the majority of all site discharge, with total simulated flow being 93% of the total recorded discharge (when comparing the summed values). Over the year there is a lot of variation, with recorded discharge being significantly above the simulated flows in the first quarter – this is also clear to see in Figure 3.1. This possibly indicates that the contribution of groundwater to total discharge increases at this time of year, when the water table is at its maximum elevation.

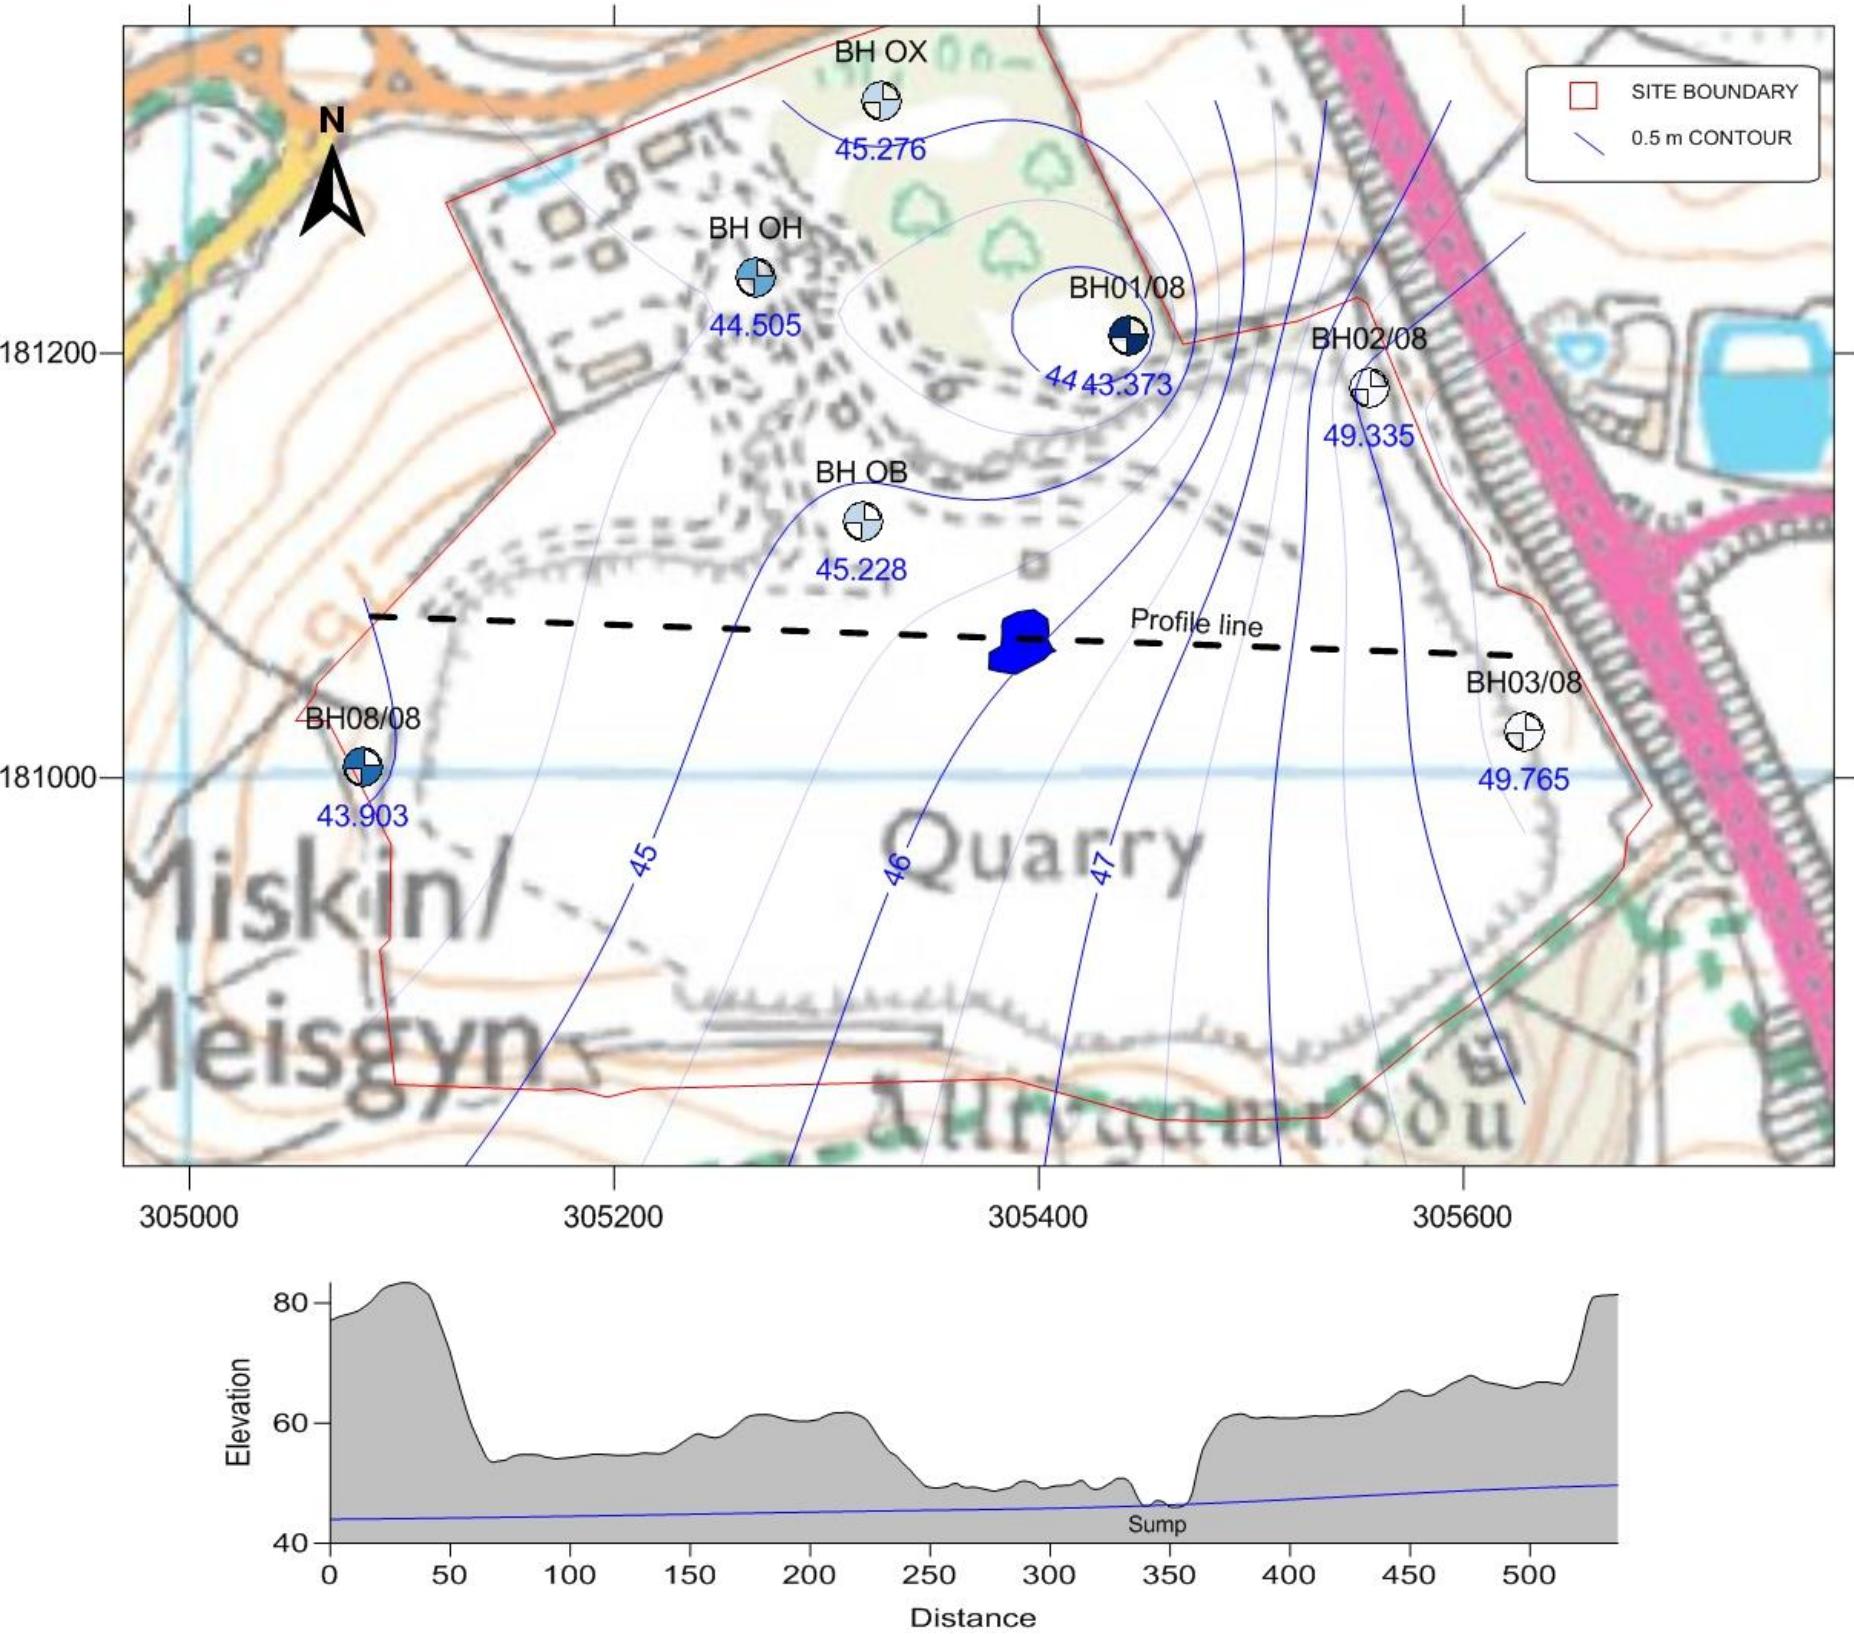
Figure 4.2 Summer groundwater contours at the Site – data recorded in July 2017

Summer and winter groundwater contours have been calculated for the Site using data collected in July 2017 and January 2018 respectively. These are presented in Figure 4.2 and Figure 4.3 along

with an east-west profile through the Site showing topography data (LiDAR) and interpolated groundwater levels.
