Hendy Quarry Landfill: Permit Variation Application (EPR/BT1088ID)

For the addition of waste types and increase in
the maximum water discharge volume

Report reference:
62487R1rev2, March 2019

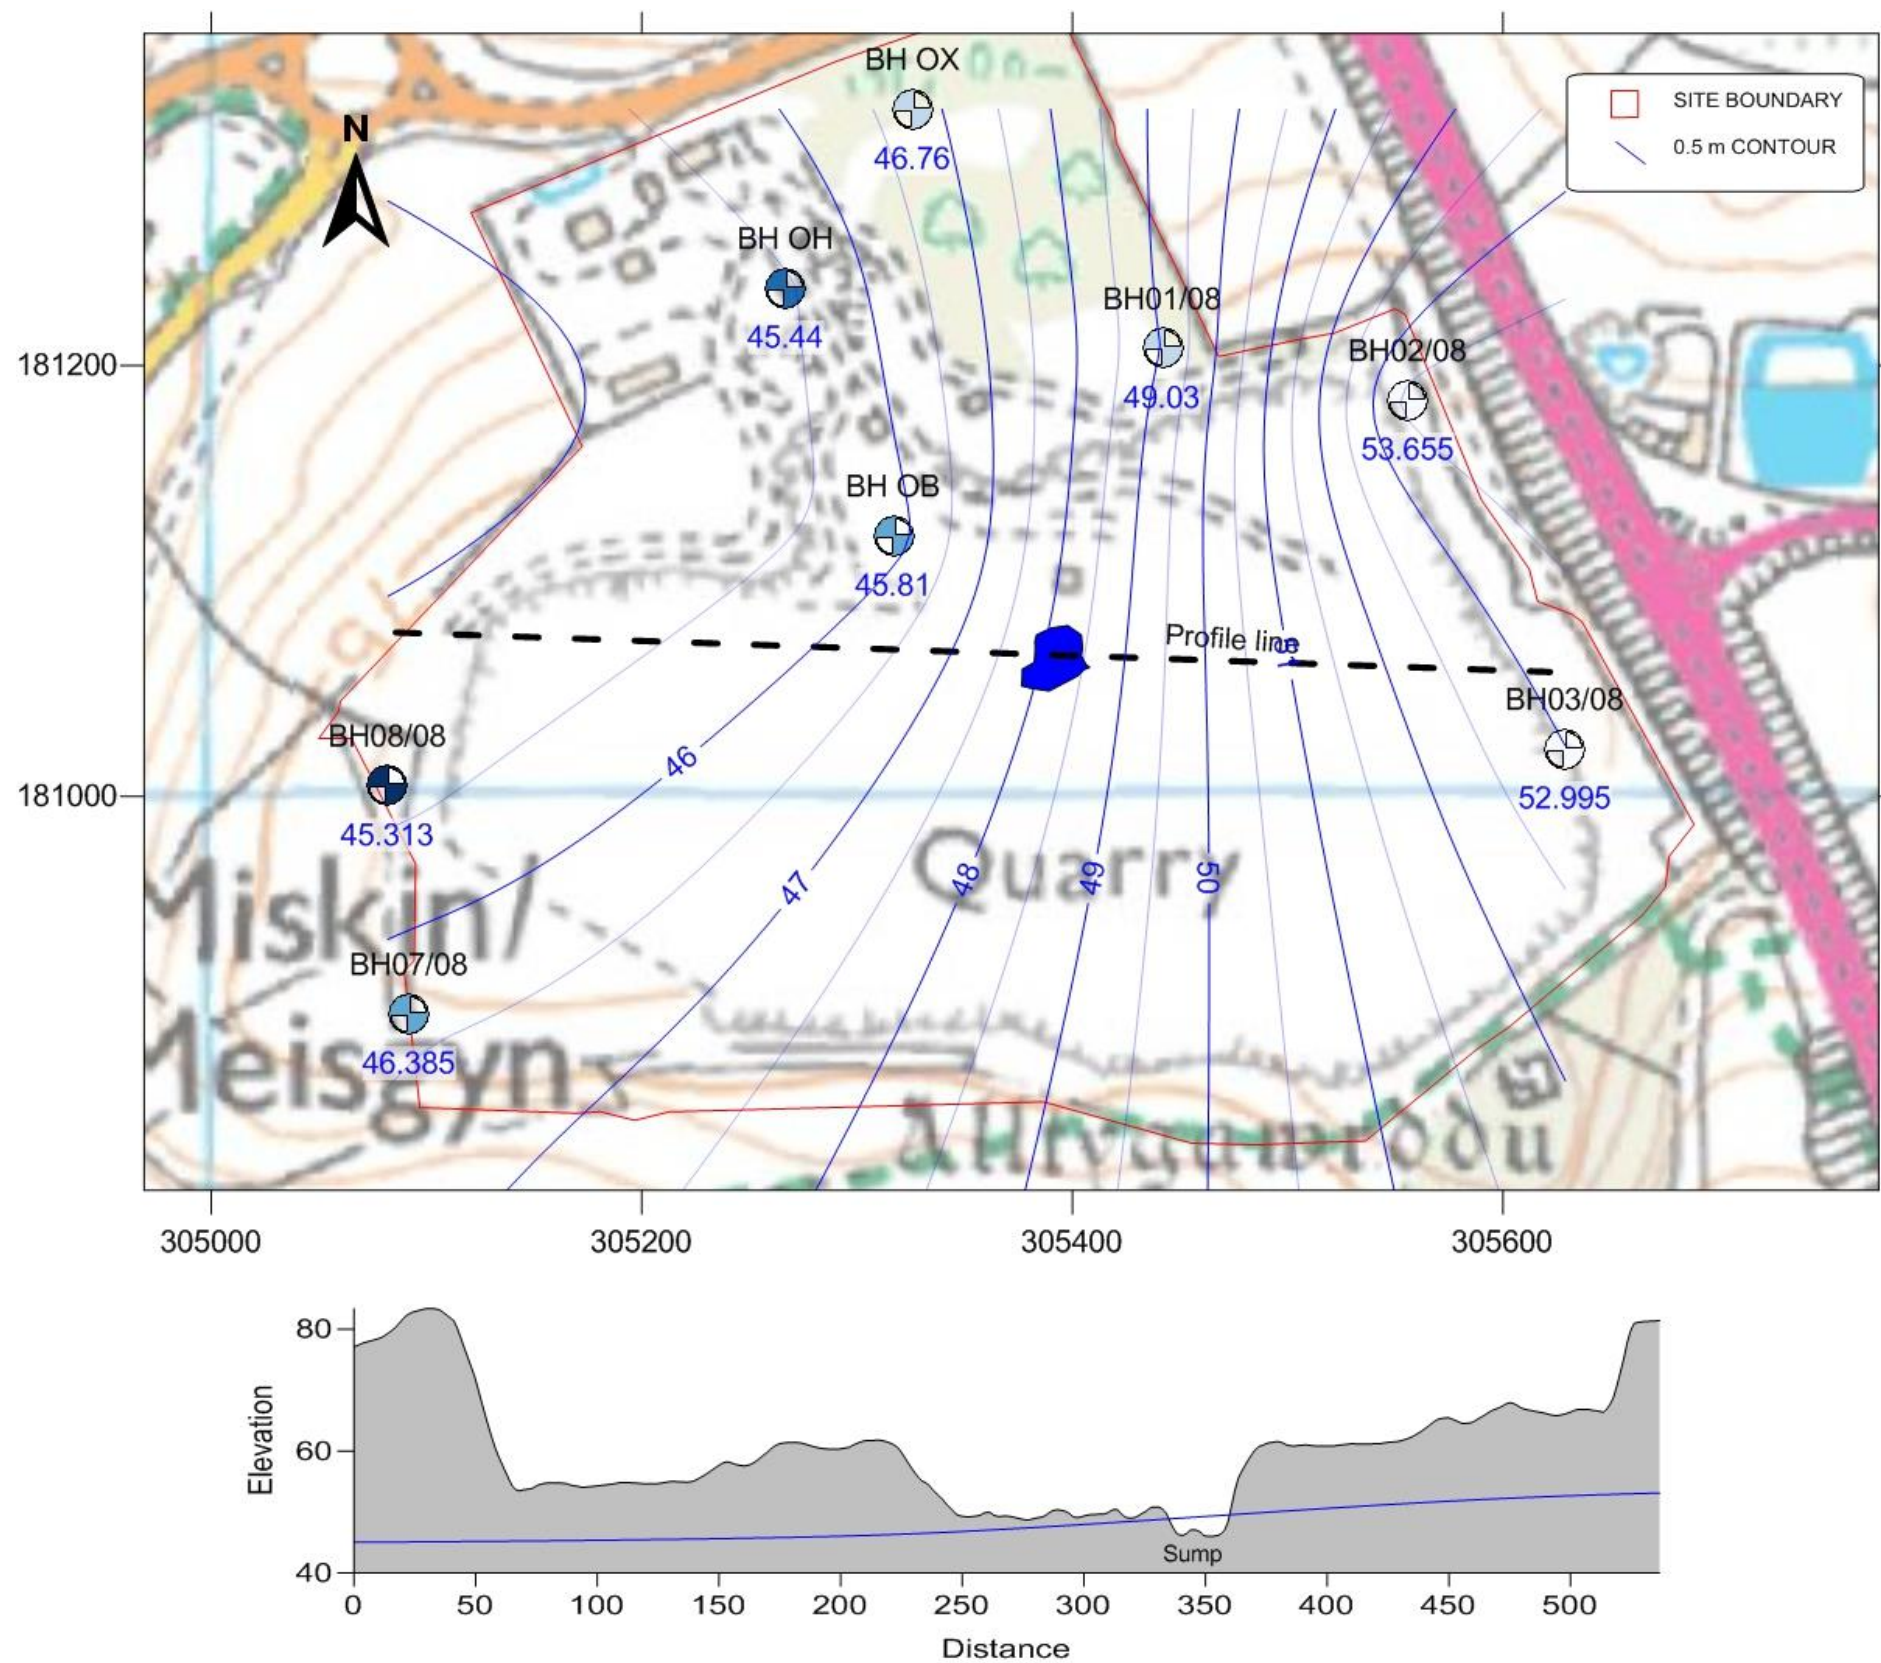
Figure 4.3 Winter groundwater contours at the Site – data recorded in January 2018

Summer and winter groundwater contours have been calculated for the Site using data collected in July 2017 and January 2018 respectively. These are presented in Figure 4.2 and Figure 4.3 along

with an east-west profile through the Site showing topography data (LiDAR) and interpolated groundwater levels.

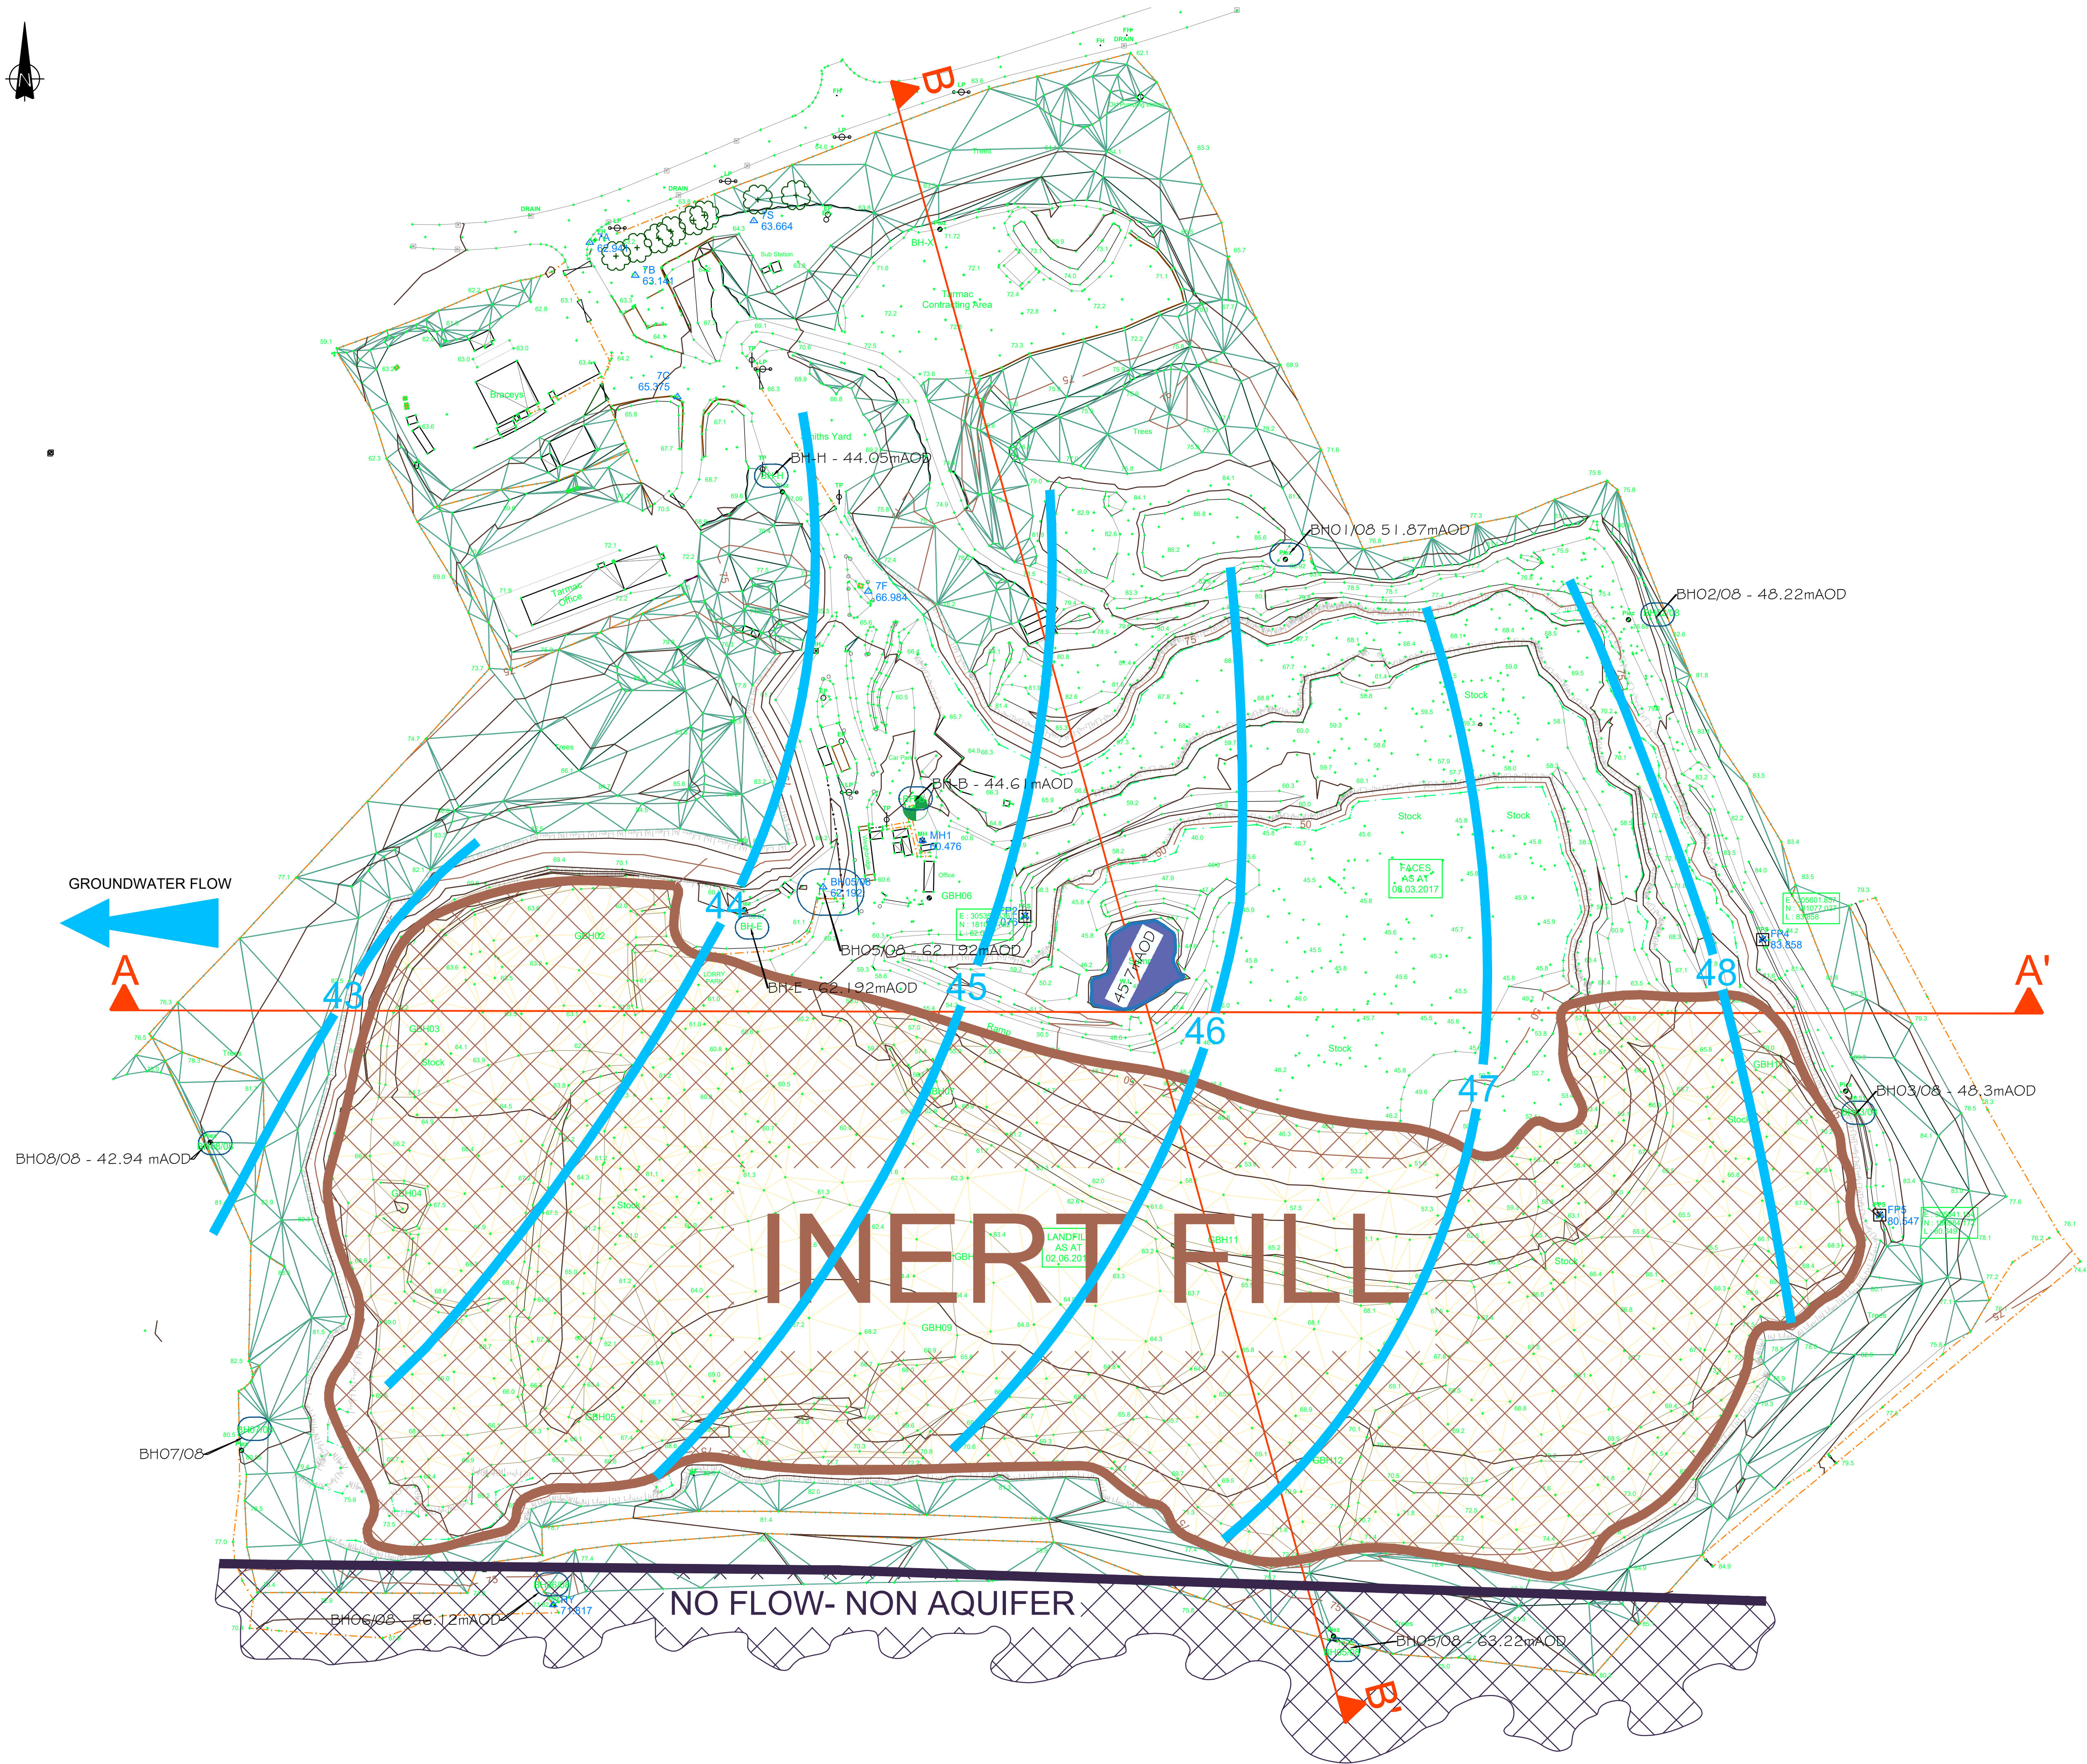
- INERT FILL
- NON FLOW, NON AQUIFER
- GROUNDWATER CONTOUR- 28.04.2015
