## Compliance Assessment Report CAR\_NRW0039481

**Permit being assessed:** AG0011001

For: PENDOYLAN STW, held by DWR CYMRU CYFYNGEDIG

**Type of assessment carried out:** Site Inspection, Reason: Routine.

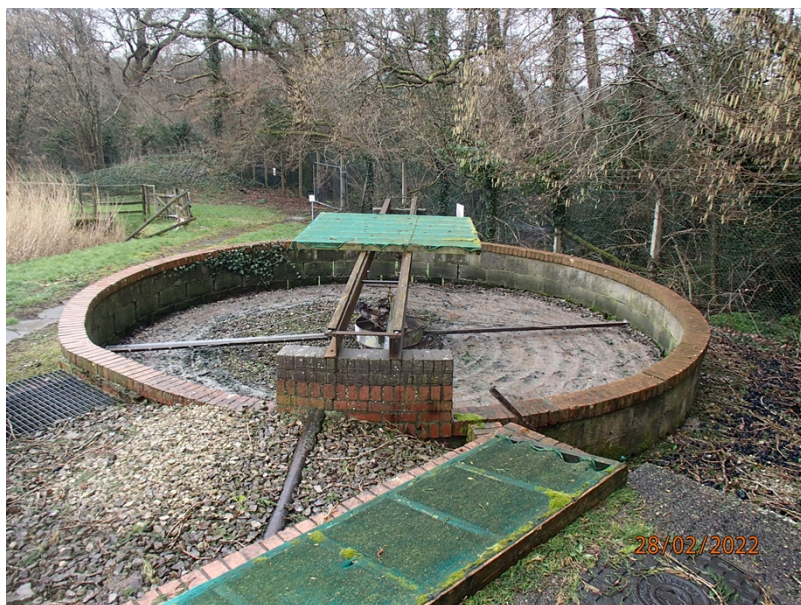
Photo 1 - filter bed

**Secondary treatment** comprised of two gravel filter beds, both showed ponding on the surface with tree litter blinding the surface of the filter bed, (see photos 1&2), treatment appeared to be compromised by this. Sewage effluent was seeping through the ventilation gaps between bricks of the filter bed structure to ground around the tanks instead of filtering through the process as intended. Overall, the filter beds were not functioning well and lacking maintenance.

| Criteria | Action needed | Complete by |
|---|---|---|
| WQ-B1 | Investigate the poor performance of the works and provide the results of your findings, any explanation and include a time frame for the resolution of issues identified. | 16/03/2022 |

It was agreed by all on site that maintenance was urgently needed, and Matthew Roberts committed to conducting a two-stage investigation as in the case of sample failures, whilst still awaiting the lab results of today's sample. Before we left for the day, Lee Banks confirmed that a contractor had been engaged to quote for work required at Pendoylan.

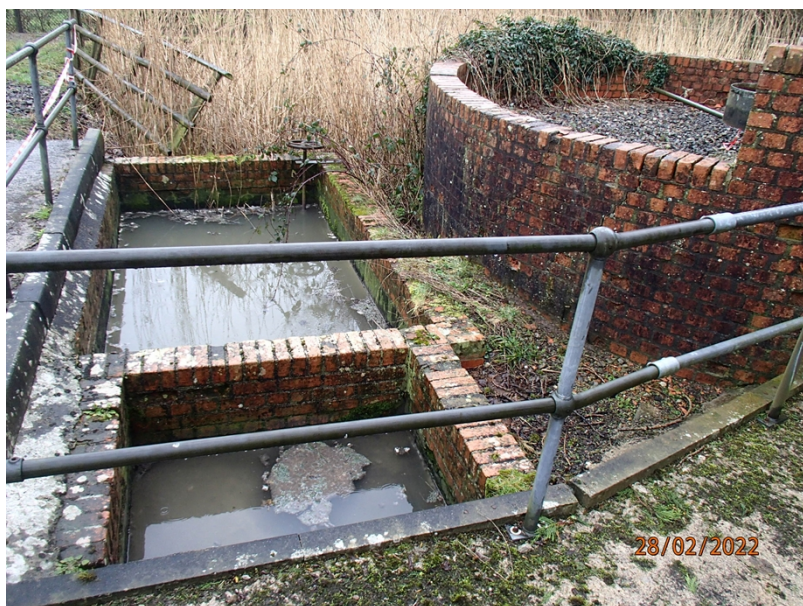
Photo 3 - Humus tank

The filtered flow settled in humus tanks before entering tertiary treatment stage in the form of a reed bed. Tankers reportedly empty the primary and humus tanks usually on a weekly or biweekly basis. Lots of fats and surface solids was present in the humus tanks and the effluent appeared to be poorly treated.

Upon review of the site logbook, it was noted that the reed bed weir is brushed regularly as part of maintenance. 20th January '22 the humus tank was flushed out, then fully emptied on 31st Jan however no record was found for cleaning of the tank in February.

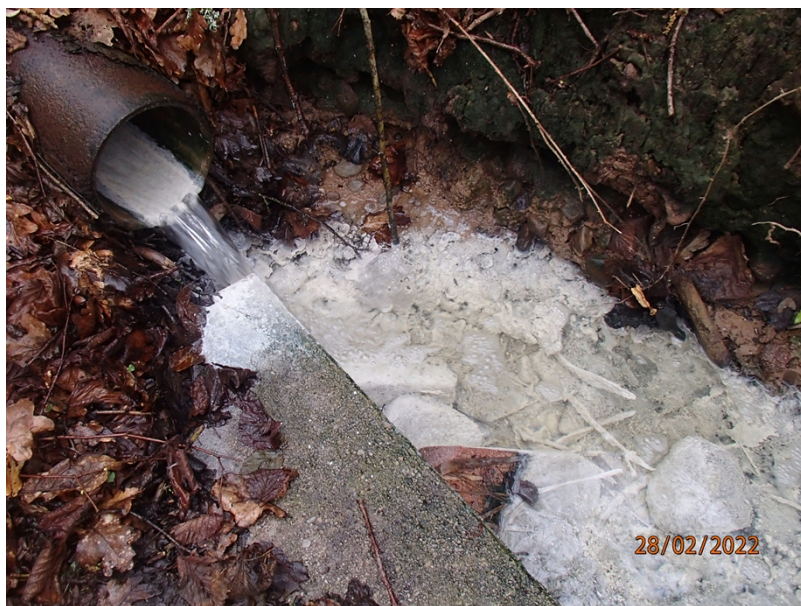
Photo 4 - discharge

**Reed beds:** There was a strong odour noticeable with a white colour visible through the reeds. The outfall area from the reedbed had a white deposit on the bed and weir resembling 'sewage fungus' type substance, the effluent itself was clear.

**Outfall:** The white substance was also visible at the final effluent sampling point and the outfall (see photo 4), deposited on the bed and continuing along the edge of the watercourse for 4-6 metres. On inspection, it appeared to be a 'sewage fungus' type deposit, Chris Edwards took a sample away for analysis. It was noted that the odour of the

final effluent was not what would normally be expected.

Paul Stallard took a sample of final effluent for analysis, on-site analysis revealed the following results:

- Ammonia(cal Nitrogen) = 19.8mg/l
- Turbidity = <5
- pH = 7.26
- Temperature = 8.9 degrees C

| Criteria | Action needed | Complete by |
|---|---|---|
| WQ-C1 | The last OSM samples on NRW's WISKI system is 29/11/21, please provide any available OSM or operational monitoring data since 29/11/21 to date. Please also provide the results of the biological analysis of the white 'sewage fungus' type deposit on the discharge. | 16/03/2022 |
