| | <b>EPR Compliance Assessment Report</b> | Report ID: 37211/0239807 | | | |
| Site | A S H Wrexham Recycling Centre | | Permit Ref | 37211 | |
| Operator/ Permit holder | Alan's Skip Hire ( Wales) Ltd | | | | |
| Date | 20/05/2015 | | Time in | 14:05 | Out 16:20 |

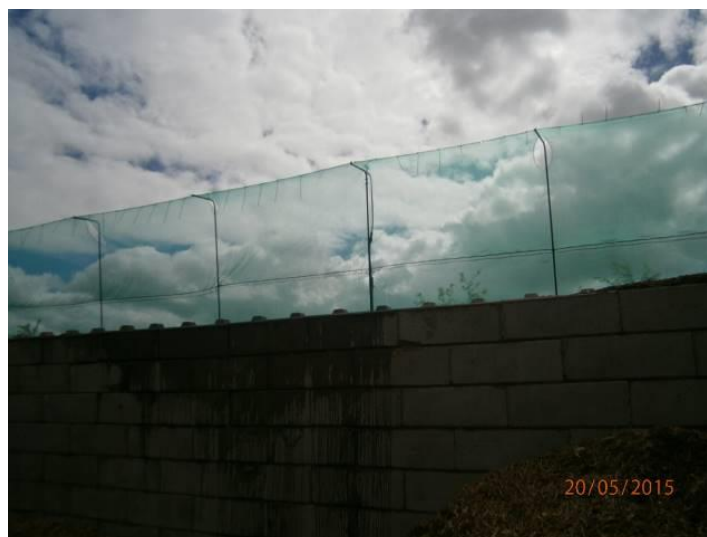
Photograph 1

Within the external storage areas improvements had also been made. Netting has now been placed along the full length of the far side boundary behind the wood chip storage bays (photograph 1) This is still being extended to the section of wall which juts out near to the wheeled bin storage area – this bay wall has also been increased in height to assist in trying to prevent any emissions from site operations impacting on neighbouring units.

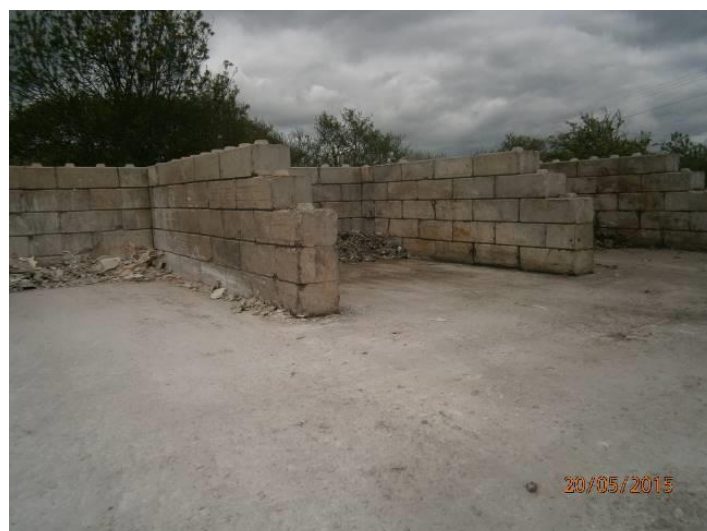
Photograph 2

At the far end of the main waste transfer building all the external bays used for the storage of plasterboard etc were not giving rise to any concern – hardly any waste was located within these bays (Photograph 2).

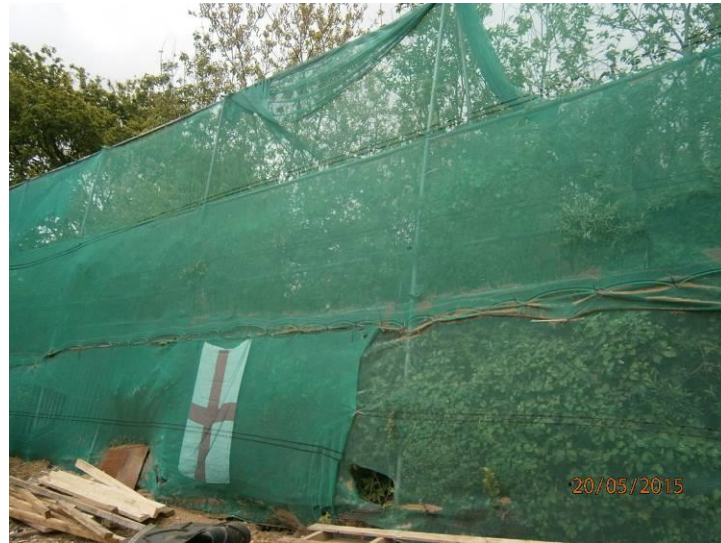
Photograph 3

The PAL waste processing plant was operational with material being processed through the plant. Observations are noted within the breaches section below but it should be noted that additional netting has been placed along the permit boundary to try and reduce any emissions off site (photograph 3).

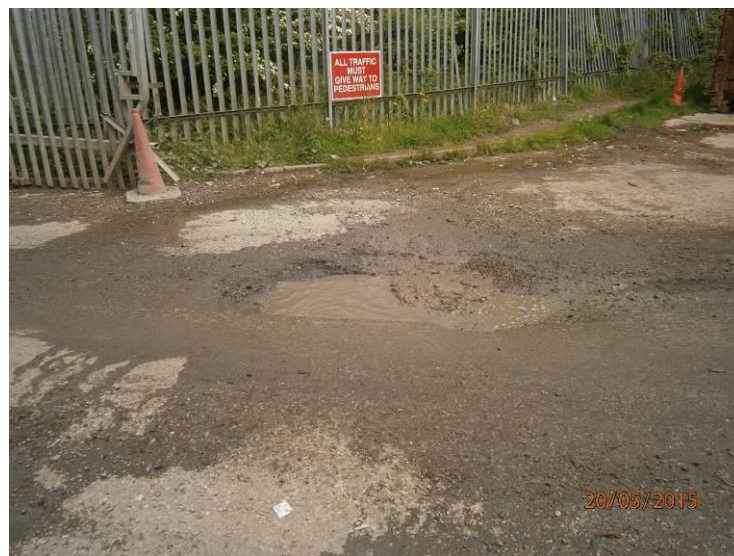
Photograph 4

As highlighted previously, site drainage continues to be an ongoing issue. Contaminated run off (from areas of the site being used to store waste material) is escaping from the concreted areas onto unmade ground (near to the boundary with MPS) In addition there is also the potential for contaminated run off to enter the Redwither Brook (Surface watercourse) via the gully drain next to the bridge over the brook - this is a direct point source discharge to surface water. Regulating officers are aware that large scale proposals are due to take place. In the interim measures should be put in place to prevent any potential discharge. Officers were also concerned in relation to a large pothole within the entrance way to the permitted site (photograph 4) and a pool of standing water at the front right hand side of the main waste transfer building which contained contaminated water (photograph 5) .

| <b>Section 4- Action(s)</b> | | | |
|---|---|---|---|
| B3 | C3 | Ensure that drainage system is compliant with permit condition. Whilst full drainage system overhaul is planned and developed ensure that interim measures are taken to prevent pollution (repair of potholes and large areas of standing water) | N/A |

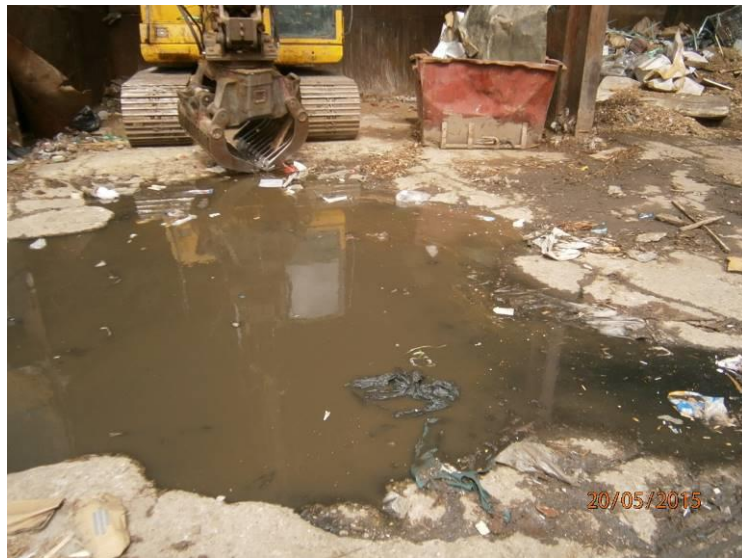
Photograph 5

**B3 - Infrastructure (Site Drainage Engineering (Clean & Foul)), Permit condition 2.1.1 (Table S1.1), Compliance Classification Scheme Category 3 Breach.**

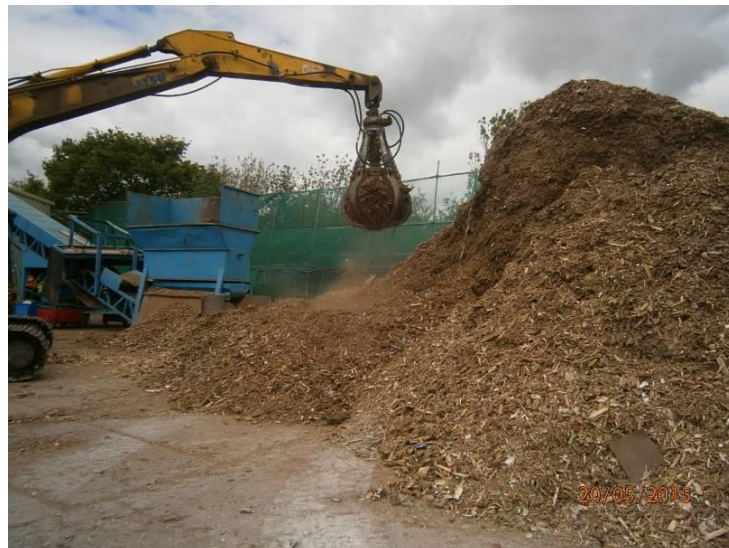
Photograph 6

Sections 4.8.10 and 4.8.11 of the dust management plan refer to the height of external stockpiles on site. The specified limit is 3m. As also stated the bay walls have been constructed to ensure that the height of the stockpile is lower than the wall for both dust and fire implications. As observed on site, the heights of the stockpiles were clearly in excess of this limit. Of particular concern was the height of the shredded woodchip located between the shredder and screener and also the PAL waste material stockpiled prior to treatment. The height should not exceed 3 m. Not only does the height give the potential for airborne emissions whilst untouched (wind-blown) but when the stockpiles are being moved by machinery at a height in excess of 3m the risk of dust emissions is greater due to bay walls being exceeded. Operatives on site should be aware of this limit, you may wish to consider a marker on the bays walls to indicate the 3m height limit. This limit is also stated in your planning permission.

| <b>Section 4- Action(s)</b> | | | |
|---|---|---|---|
| C4 | C3 | Reduce height of stockpiles on site and consider method for ensuring that operatives remain below this height when moving/adding to stockpiles | N/A |
