## Compliance Assessment Report

**Report ID:**  
**CAR\_NRW0035694**

| Site | Treherbert Community Recycling Centre | Permit Ref | AB3091HR | | |

### **Compliance Assessment Report – Treherbert HWRC, RCT (EPR/AB3091HR)**

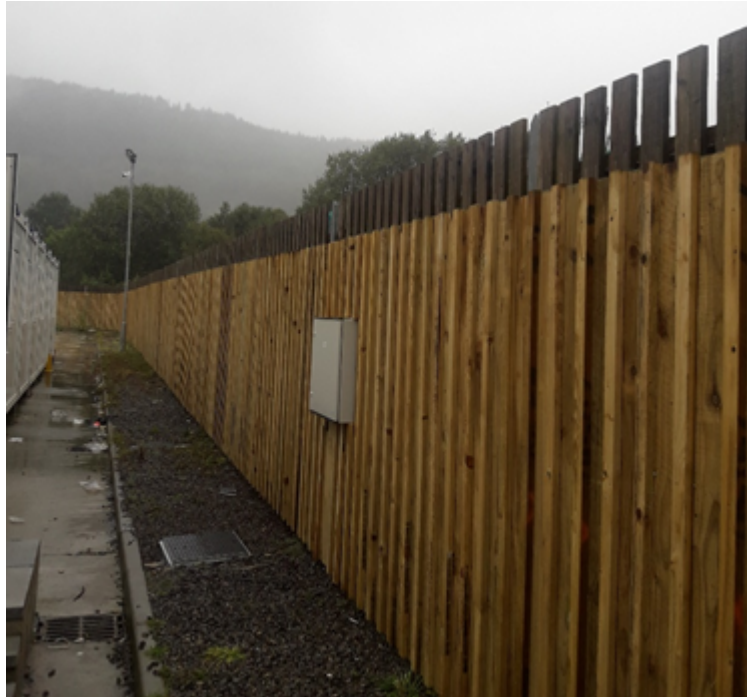
**Figure 1** – additional layer of timber applied to acoustic barrier

The most recent update to the site consisted of the additional layer of timber applied to the acoustic barrier on the North/North East boundaries of the perimeter as shown below.

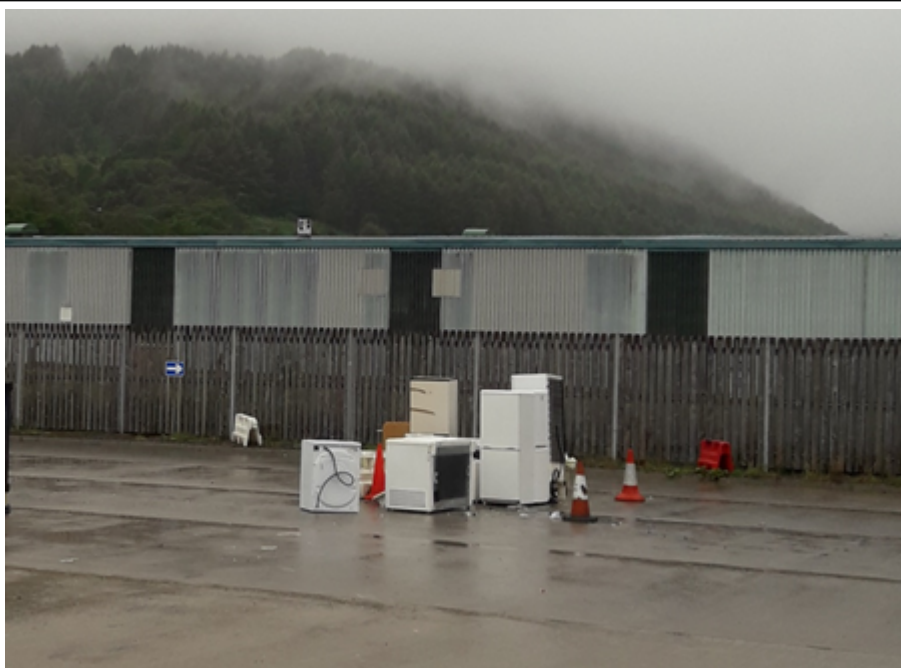
**Figure 2** – storage of WEEE on site during the inspection

During the inspection it was noted that Waste Electrical & Electronic Equipment (WEEE) was being stored out in the open, and the Site Operators were informed during the inspection that the permit will be checked on return to the office to determine whether the storage of this waste is compliant with the permitted conditions.

Permit condition 2.4.1 states that *'the storage (including temporary storage) and treatment of WEEE shall be carried out in accordance with the technical requirements of Annex VIII of the WEEE Directive'*. The part of Annex VIII of the WEEE Directive that condition 2.4.1 refers to states that *'weatherproof covering for appropriate areas'* are required for the storage of WEEE (including temporary storage) prior to its treatment. Regarding the wording of 'appropriate areas', the DEFRA Guidance for the Best Available Treatment Recovery and Recycling Techniques (BATRRRT) and treatment of Waste Electrical and Electronic Equipment (WEEE), states that weatherproof covering is intended for those appliances destined for reuse. Since this is the case, we can confirm that there is no requirement for storing the WEEE identified during our inspection under waterproof covering.
