## Compliance Assessment Report CAR\_NRW0039708

For: Bryn Pica Landfill EPR/DP3732SQ, held by Cynon Valley Waste Disposal Company Ltd

At: Bryn Pica Landfill Site , Llwydcoed, Aberdare, Rhondda-Cynon-Taff, CF44 0BX.

**Type of assessment carried out:** Site Inspection, Reason: Routine.

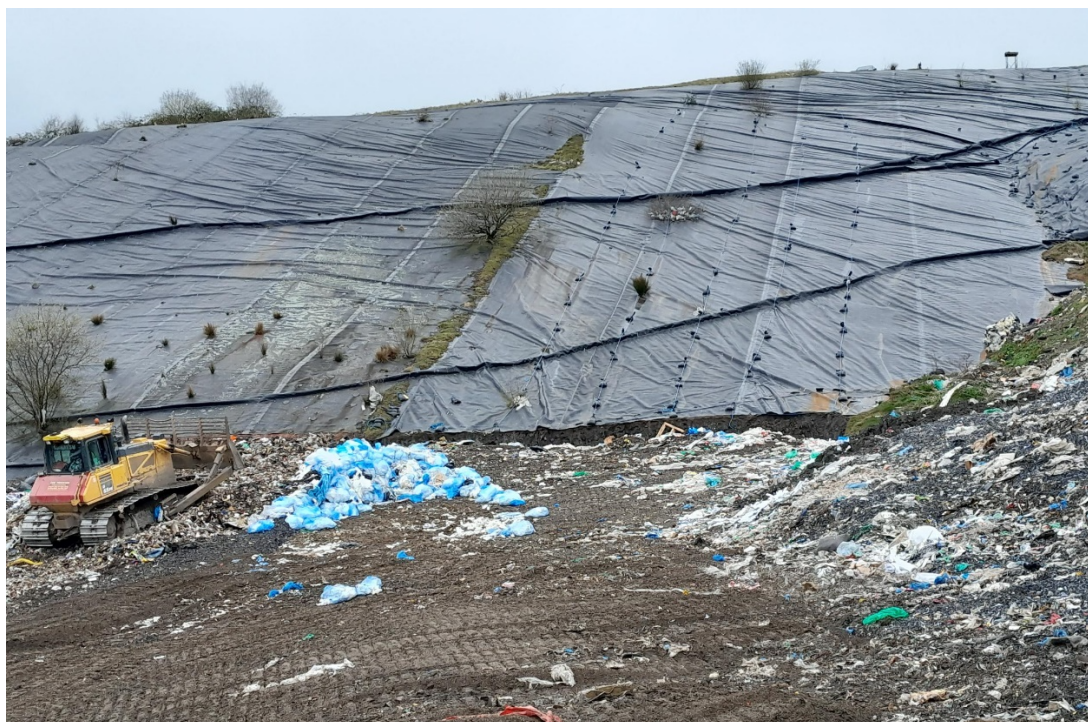
Site received extra waste from Viridor over a short period of plant shutdown in Cardiff since the new year. NRW inspected the current tipping operation and found this to be satisfactory. The tipping face was seen to be small, with plenty of daily cover present. The current tipping cell 5a(ii) was being filled at the time, at the last visit the cell 4b was being completed and Cell 5 was being constructed. 2 operators were moving the waste into position using a shovel and a compactor. A third operator was employed picking stray litter. A hawk was observed to be flying which resulted in no seagull presence at all. No excessive odour was witnessed. No wind-blown waste of noticeable quantities was observed, no dust was seen from the operation. However, vegetation was seen growing through the temporary liner of the adjacent cell which

needs to be addressed to ensure the integrity of the liner remains intact.

Pic 1 – The current tipping face Cell 5a(ii) with Cell 4b in the background filled and with temporary cap. Taken 4<sup>th</sup> Apr 2022.

**Action** – Site to review the vegetation growing through the temporary cap and remove where necessary.

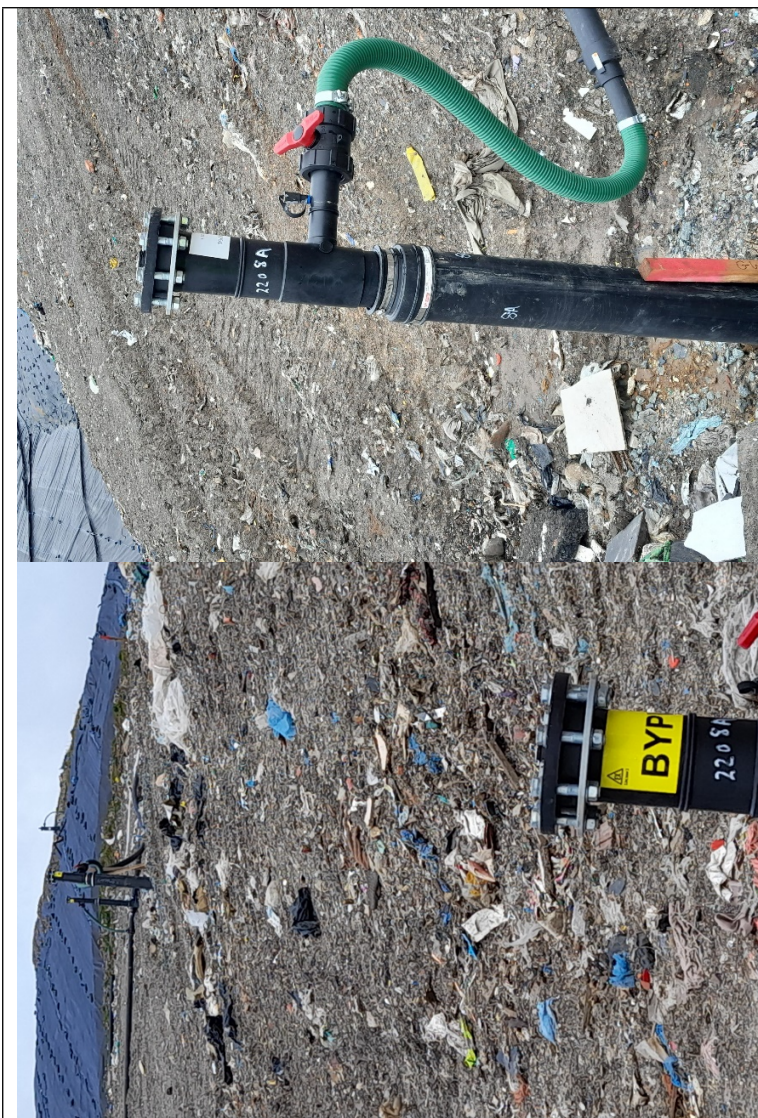
DSEAR markings are a legal requirement to delineate potentially explosive areas such as gas wells. At the time of the inspection these were missing from the newly installed wells on site. Site immediately responded and confirmed these were in place the following day. The following pictures show the missing DSEAR markings on 4<sup>th</sup> Apr on the left with the added markings shown on the right from a picture taken by site representatives on 5<sup>th</sup> Apr 2022.

**Action** – Completed
