## Compliance Assessment Report

**Report ID:**  
**CAR\_NRW0032897**

| Site | Port Talbot Steel Works | Permit Ref | BL7108IM | | |

This intervention confirms our EPR compliance assessment in relation to a spillage of heavy fuel oil (HFO) from a pipeline near Phoenix Wharf Tank Farm in August 2016. The spillage resulted in a Compliance Classification Scheme (CCS) Category 2 incident. Associated enforcement action in relation to this case has now concluded.

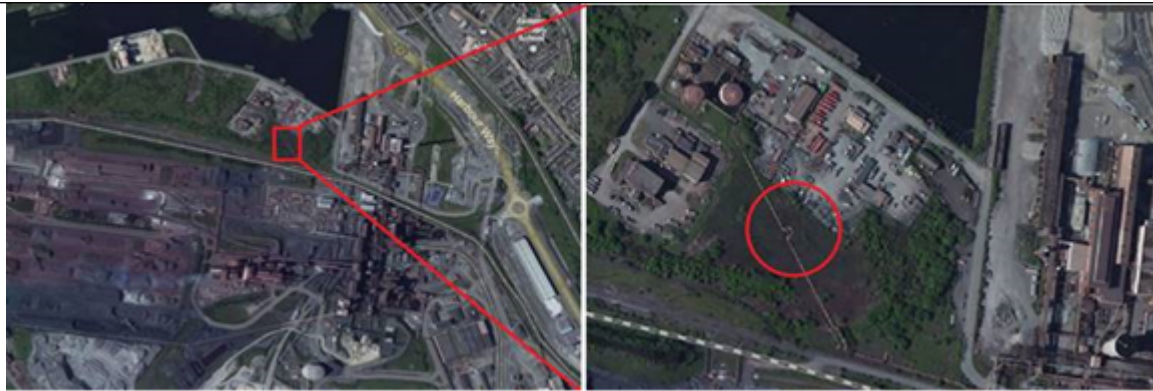
Further investigation revealed a leak of approximately 142 tonnes of HFO from a pipeline between the tank farm and the steelworks power plant.

The leak occurred within an area of reed bed with difficult access located south-east of the tank farm. Although the leak occurred outside the EPR/BL7108IM permitted installation boundary, Tata Steel UK Ltd owns both the tank farm and the pipeline infrastructure in question.

Tata Steel is procuring replacement sections of pipework to allow necessary repairs to be made. As a precautionary measure, the entire stretch of pipeline across the reed bed will be replaced and pressure tested before HFO transfer resumes.
