**SOUTH SIDE  
QUEENSWAY WASTE  
MANAGEMENT SITE,  
LLANWERN STEELWORKS**

**2016 Annual Review of  
Environmental  
Monitoring**

*Report Number 1555r2v1d0117*

**January 2017**

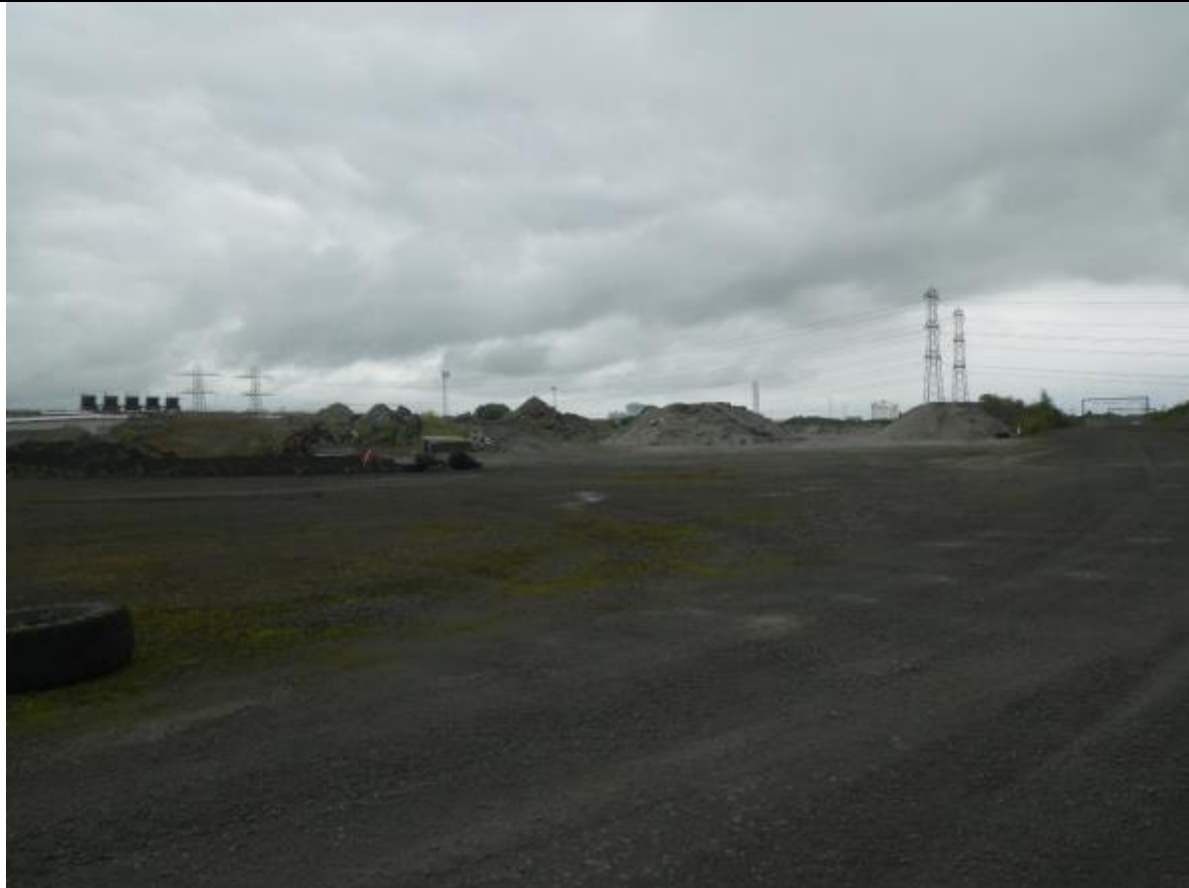
Photo 126 – Blast furnace slag (BFS) area

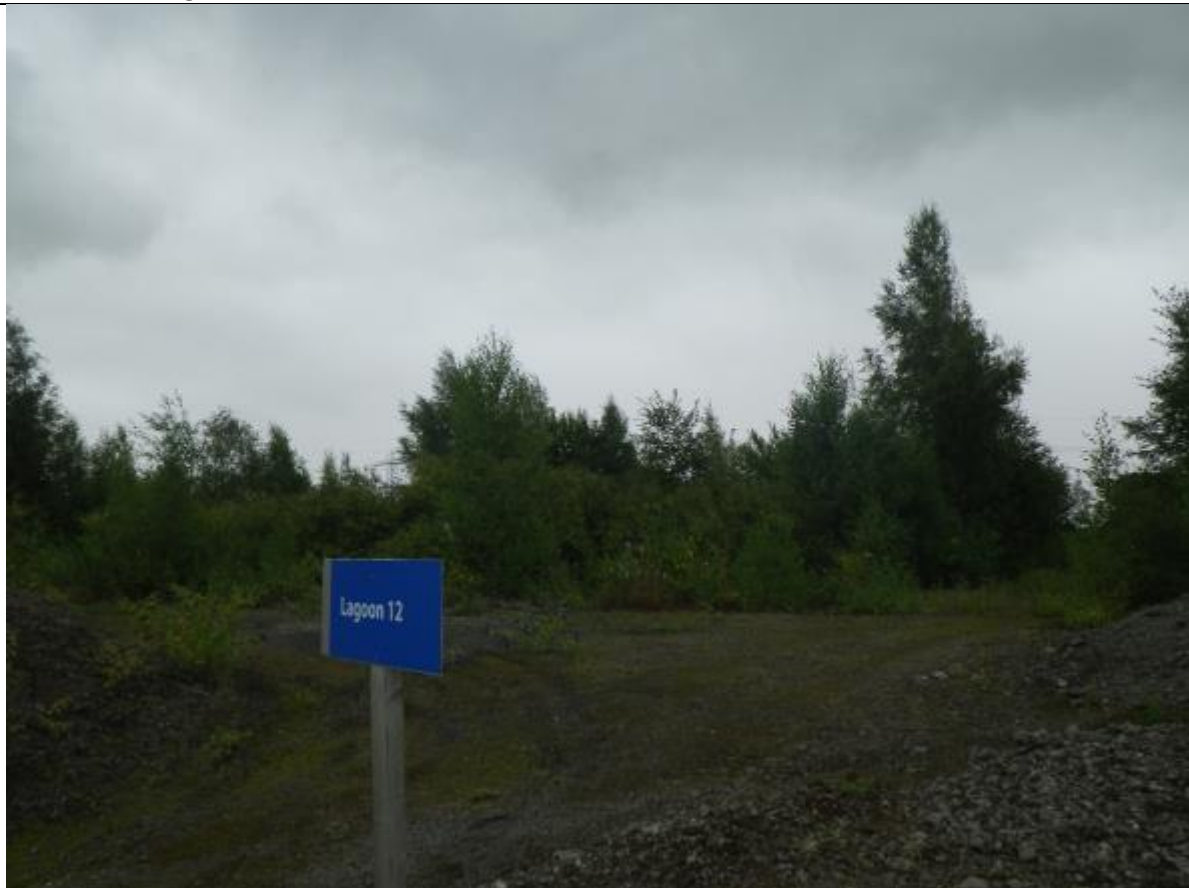
Photo 127 – Lagoon 12

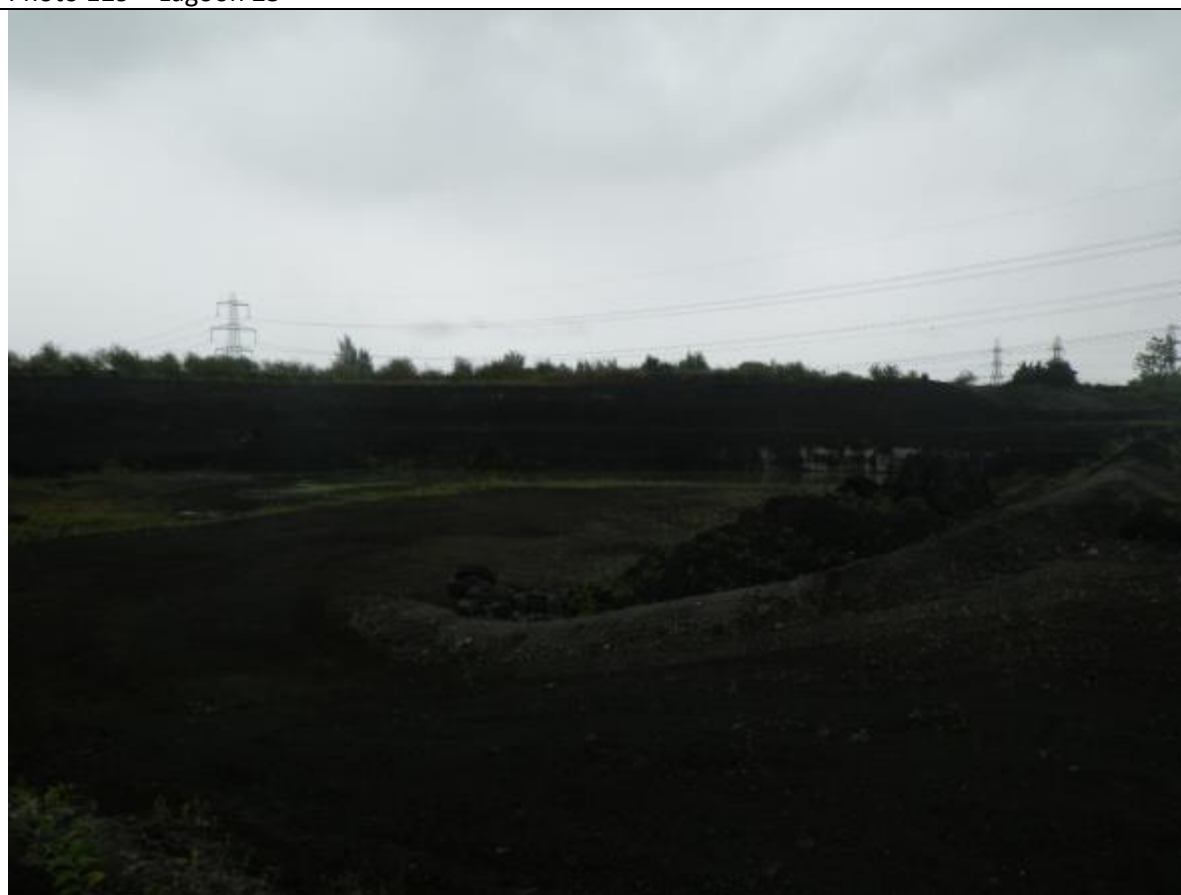
Photo 129 – Lagoon 25

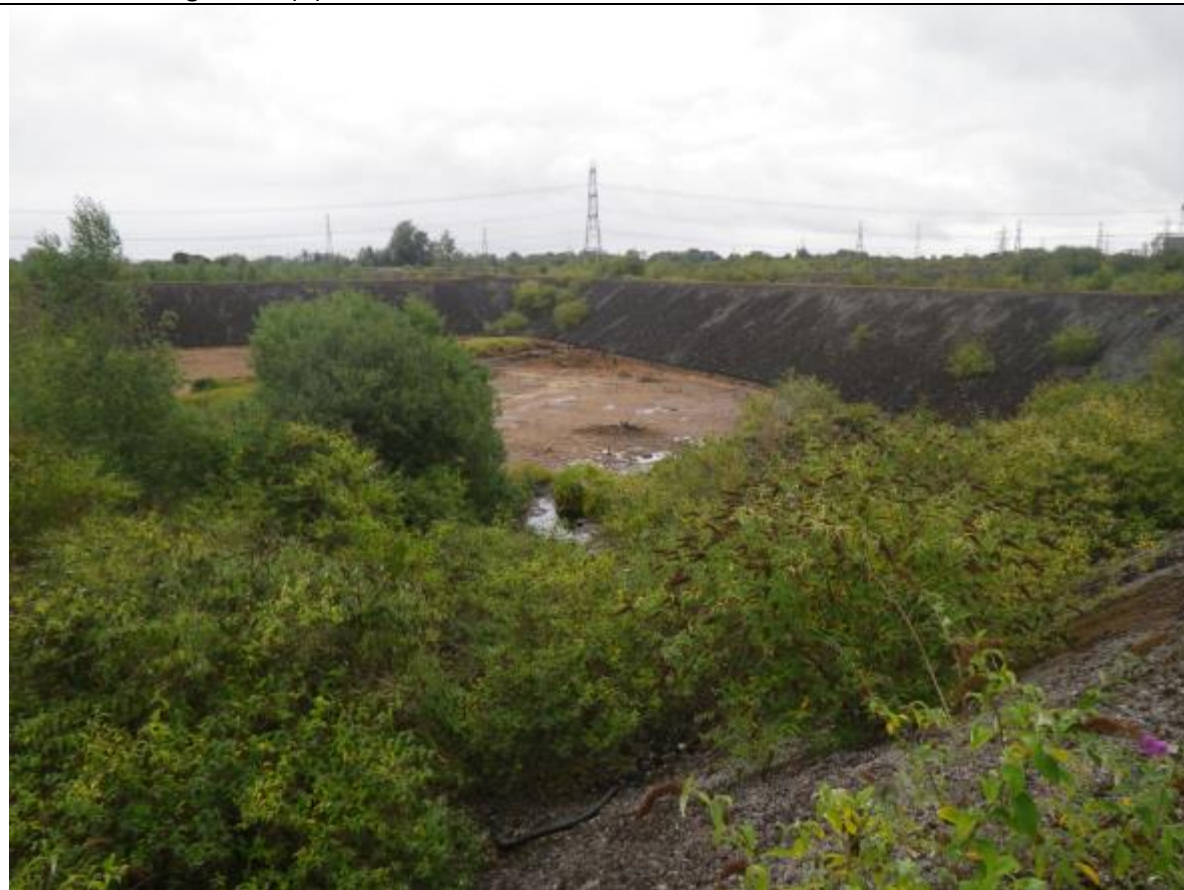
Photo 130 – Lagoon 27 (A)

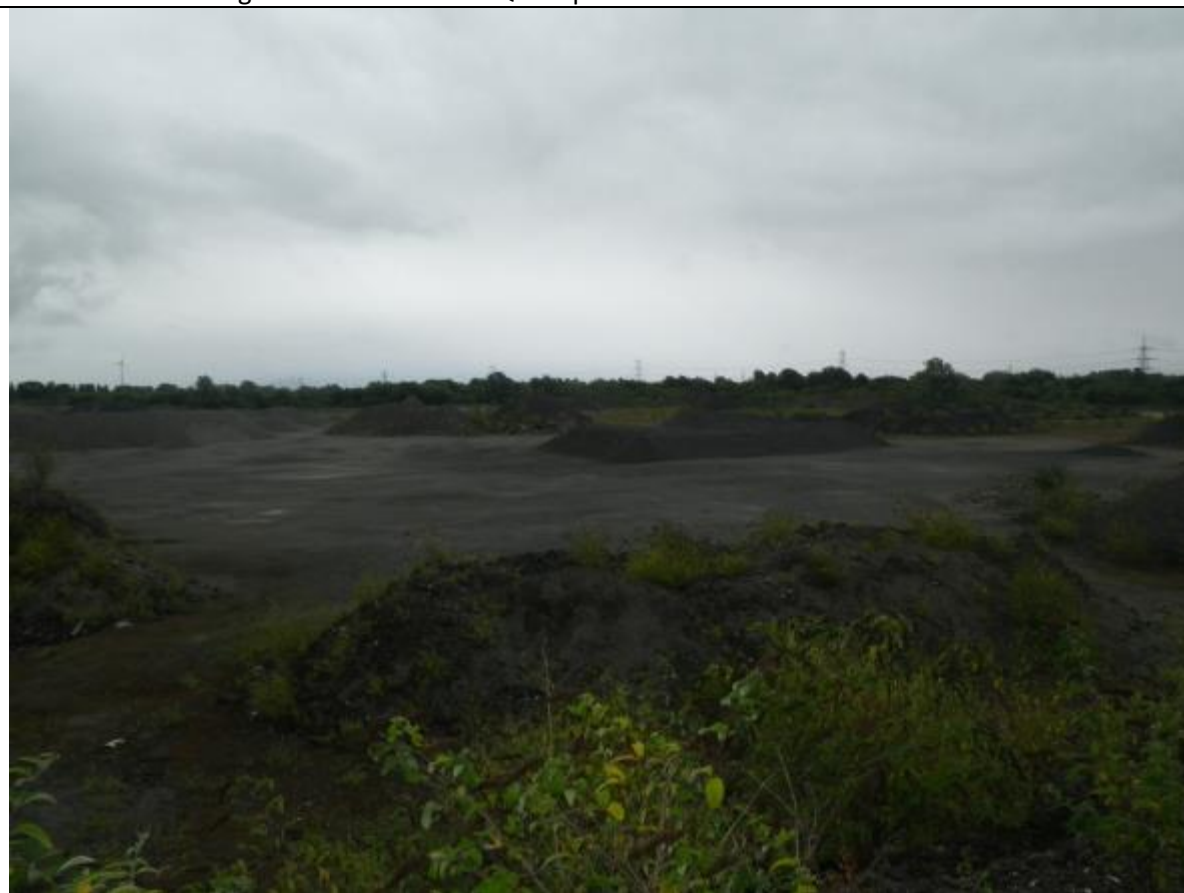
Photo 131 – Looking east out towards SSQ PPC permitted area

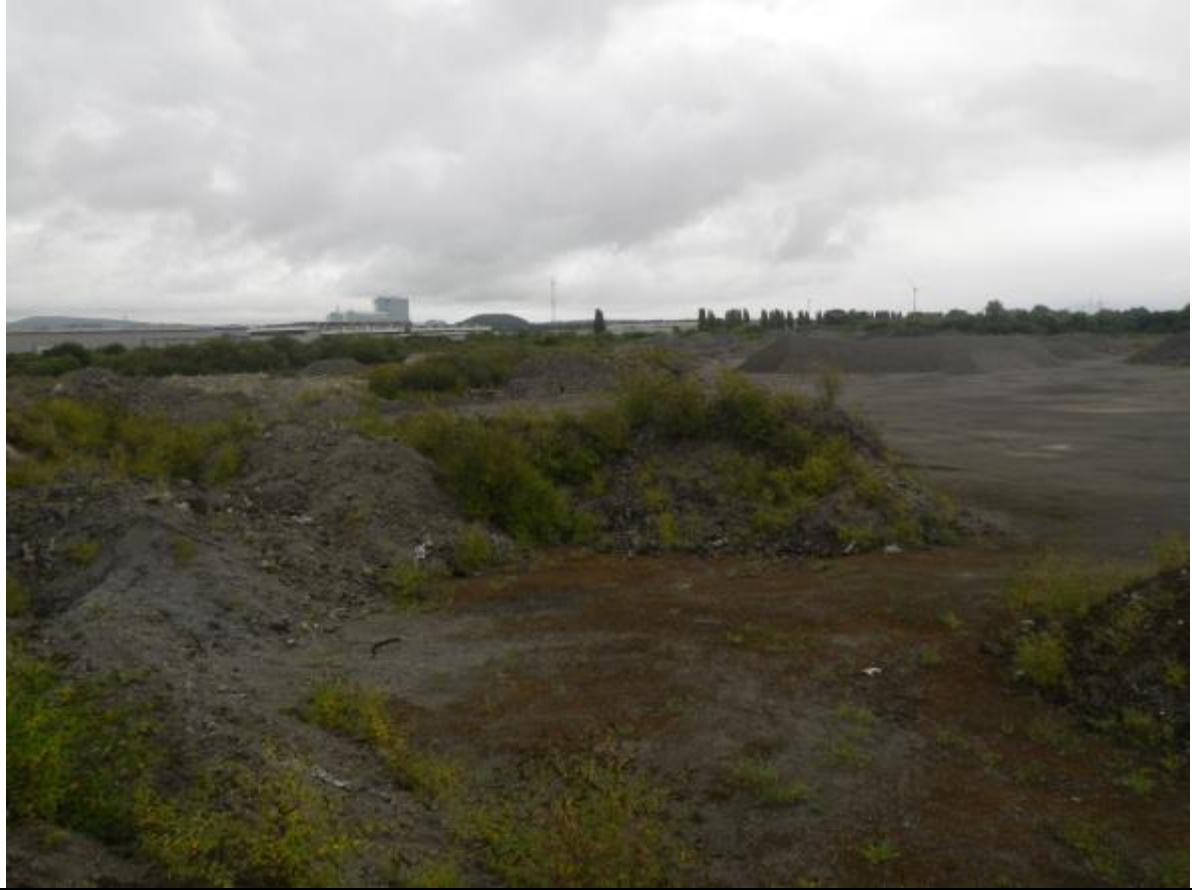
Photo 132 - Looking North out over SSQ PPC permitted area

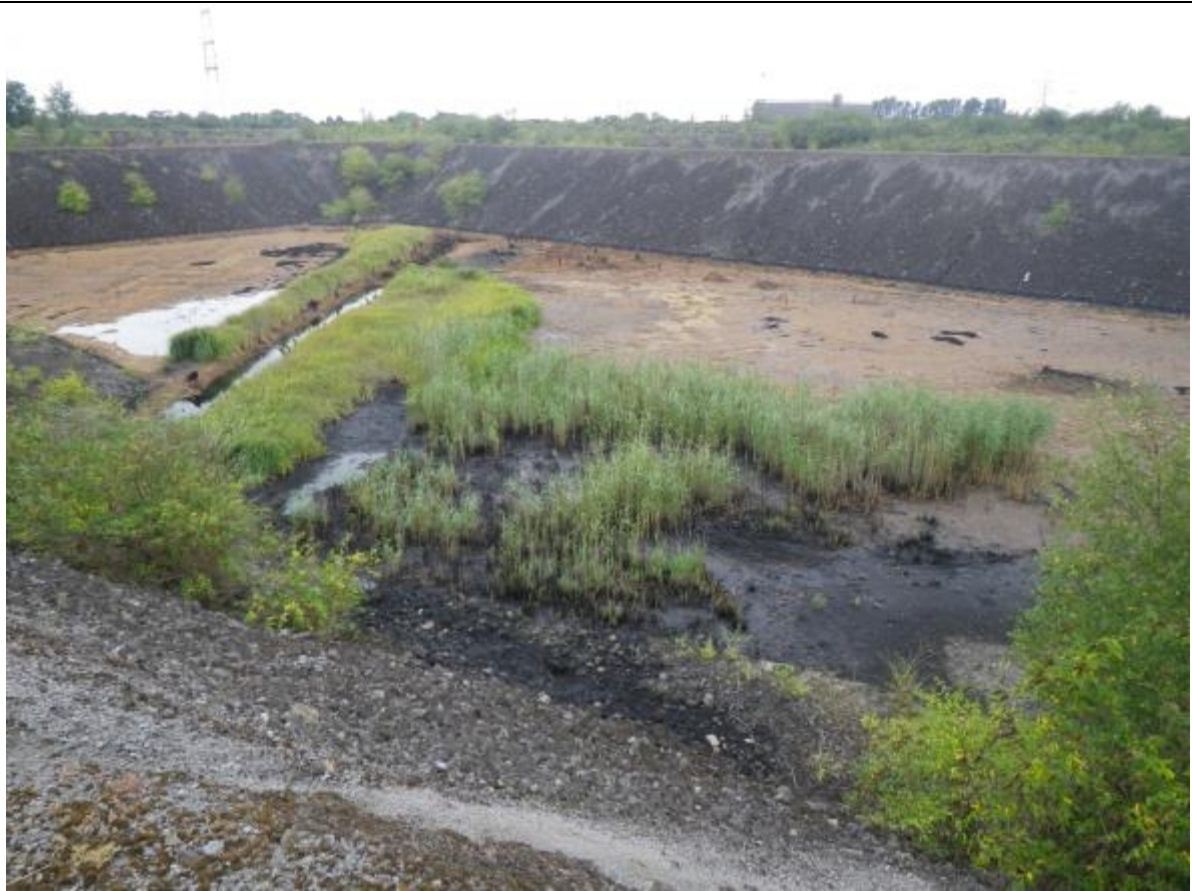
Photo 133 – Lagoon 27 (A)

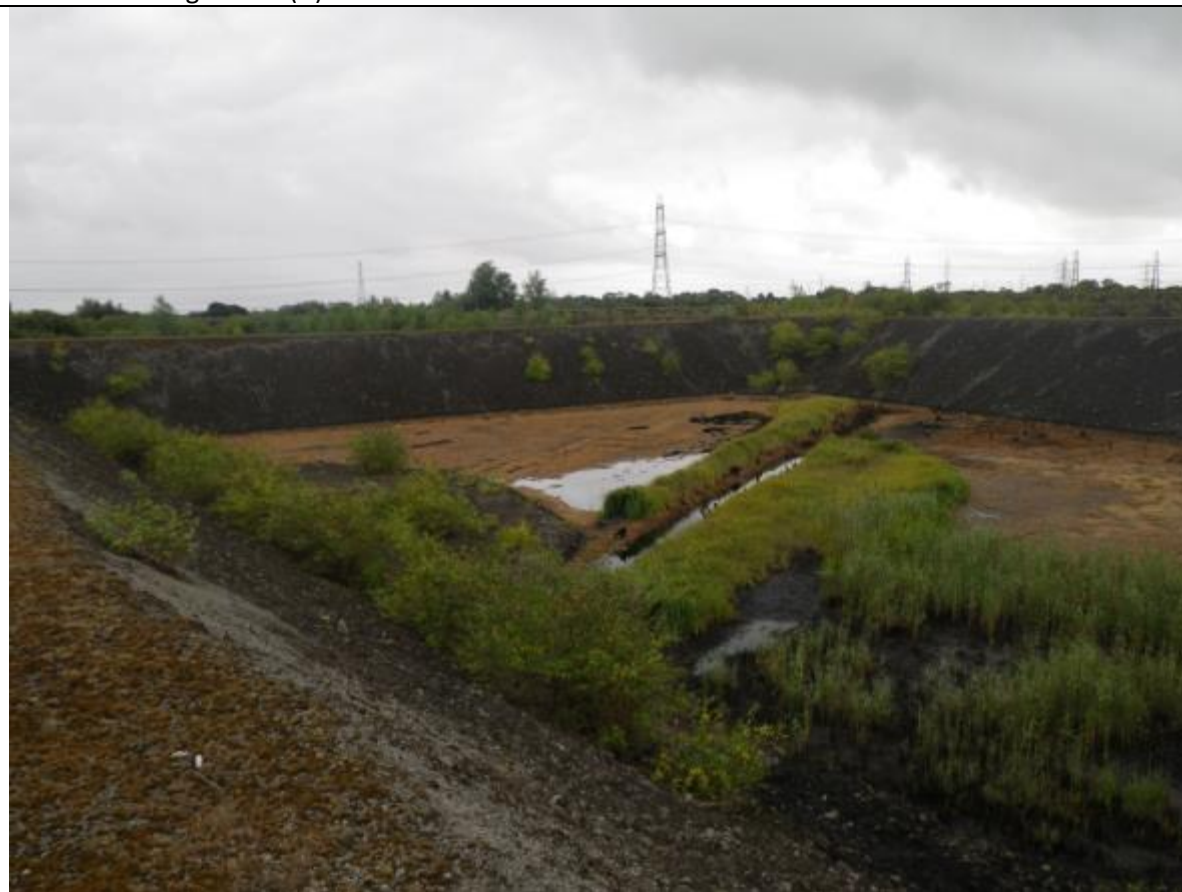
Photo 134 – Lagoon 27 (A)

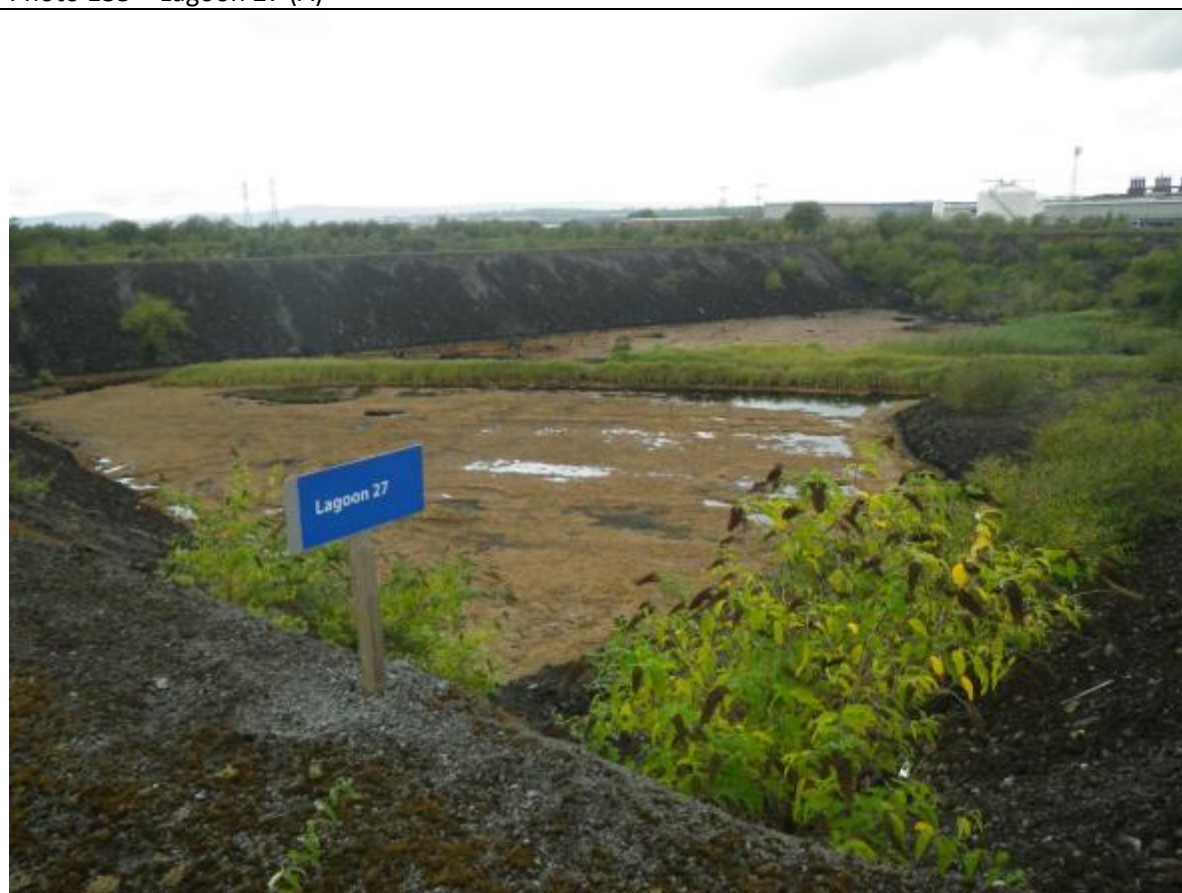
Photo 135 – Lagoon 27 (A)

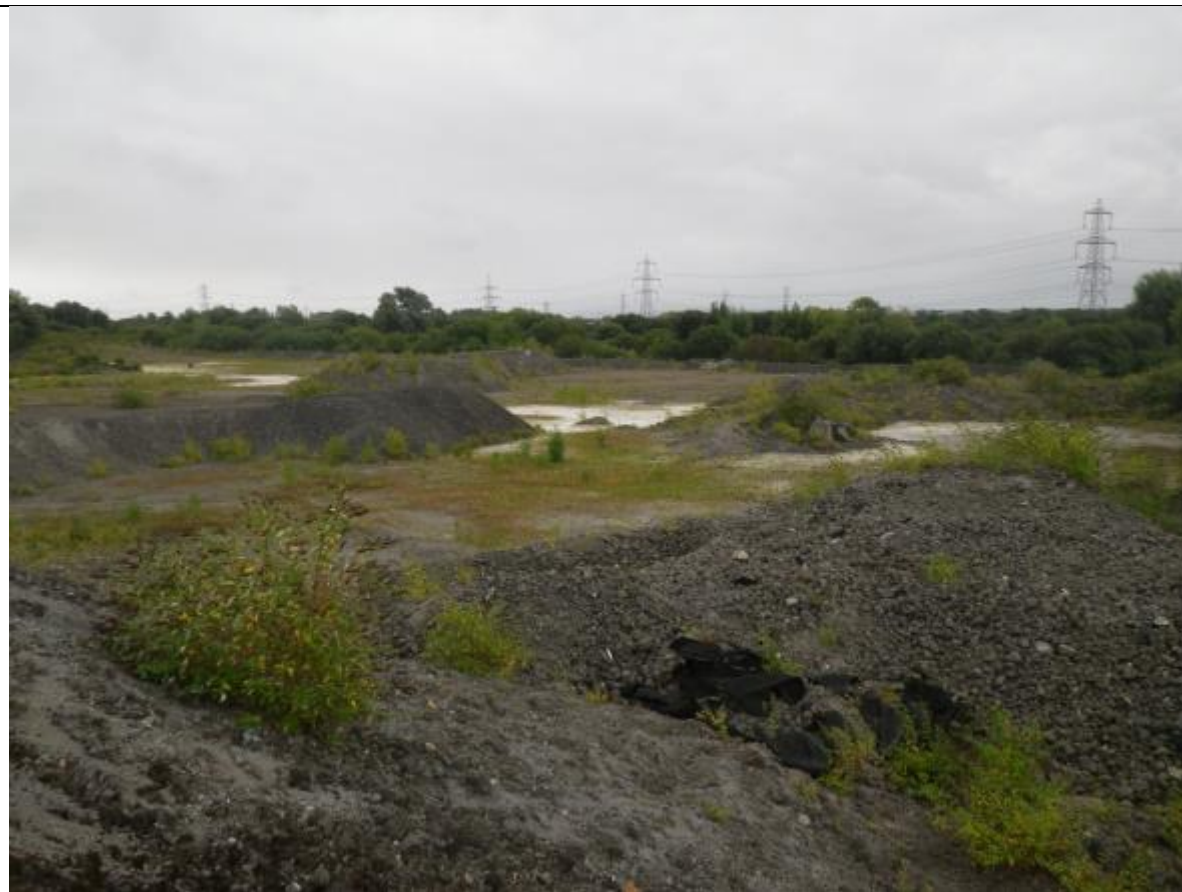
Photo 136 – Looking south towards SSQ PPC from Lagoon 27. Trees form boundary to site. Lagoon 27B not enclosed.

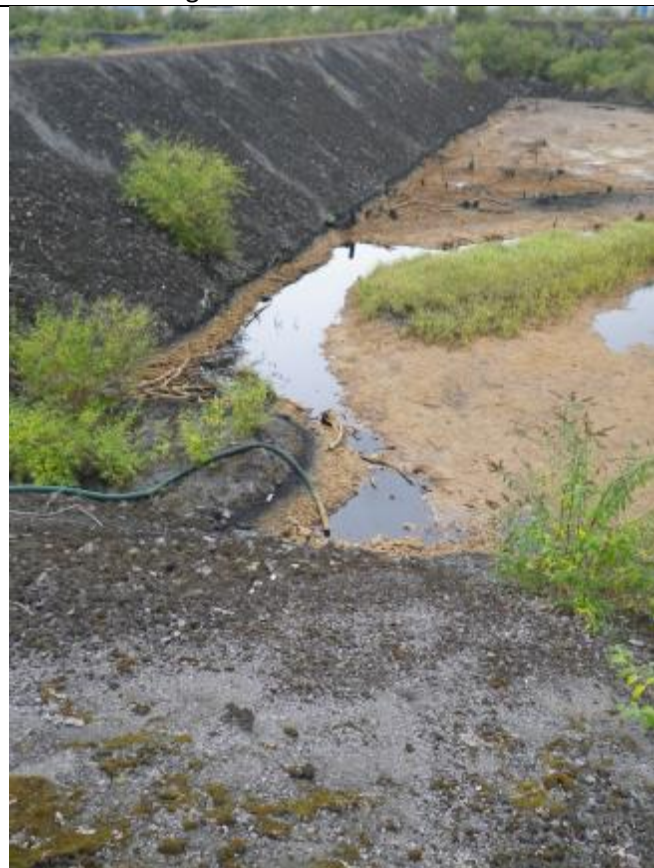
Photo 137 – Lagoon 27A

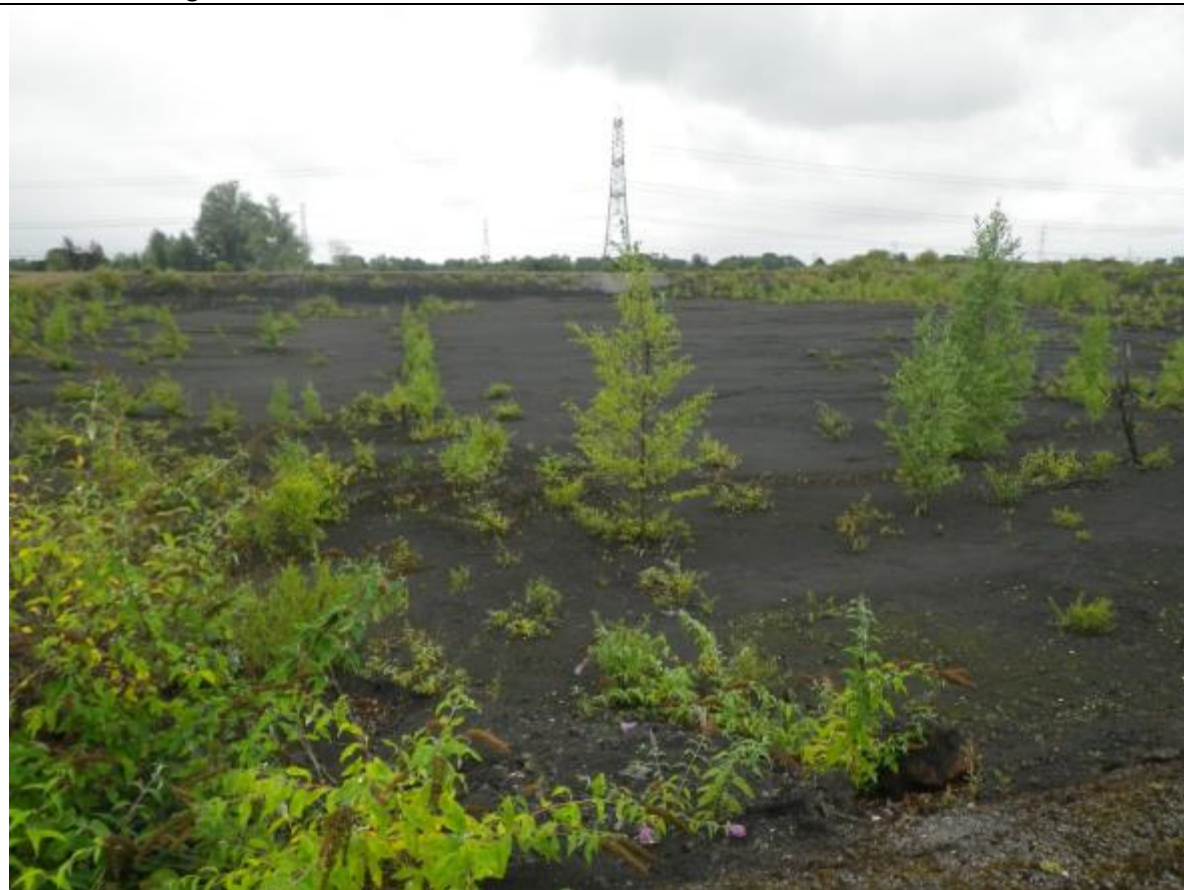
Photo 138 – Lagoon 27C

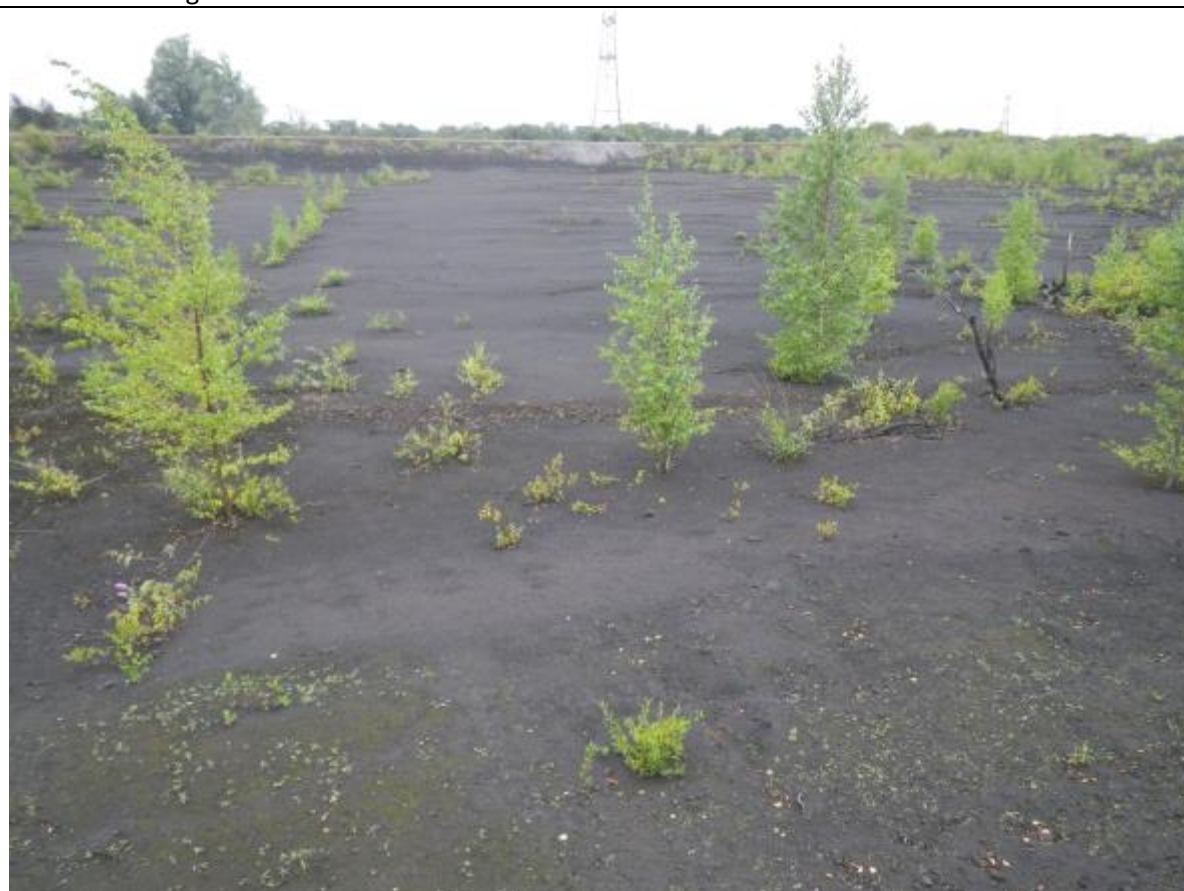
Photo 139 – Lagoon 27C

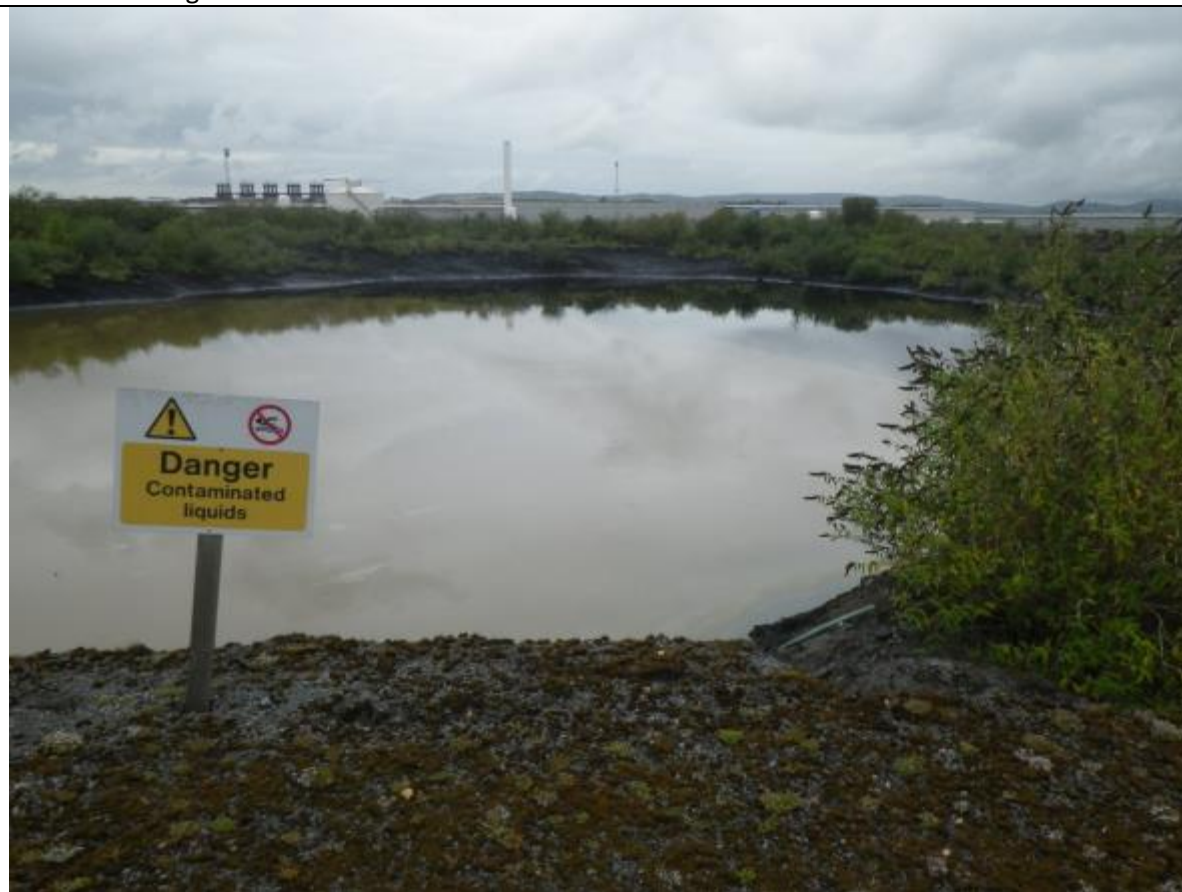
Photo 140 – Lagoon 27D

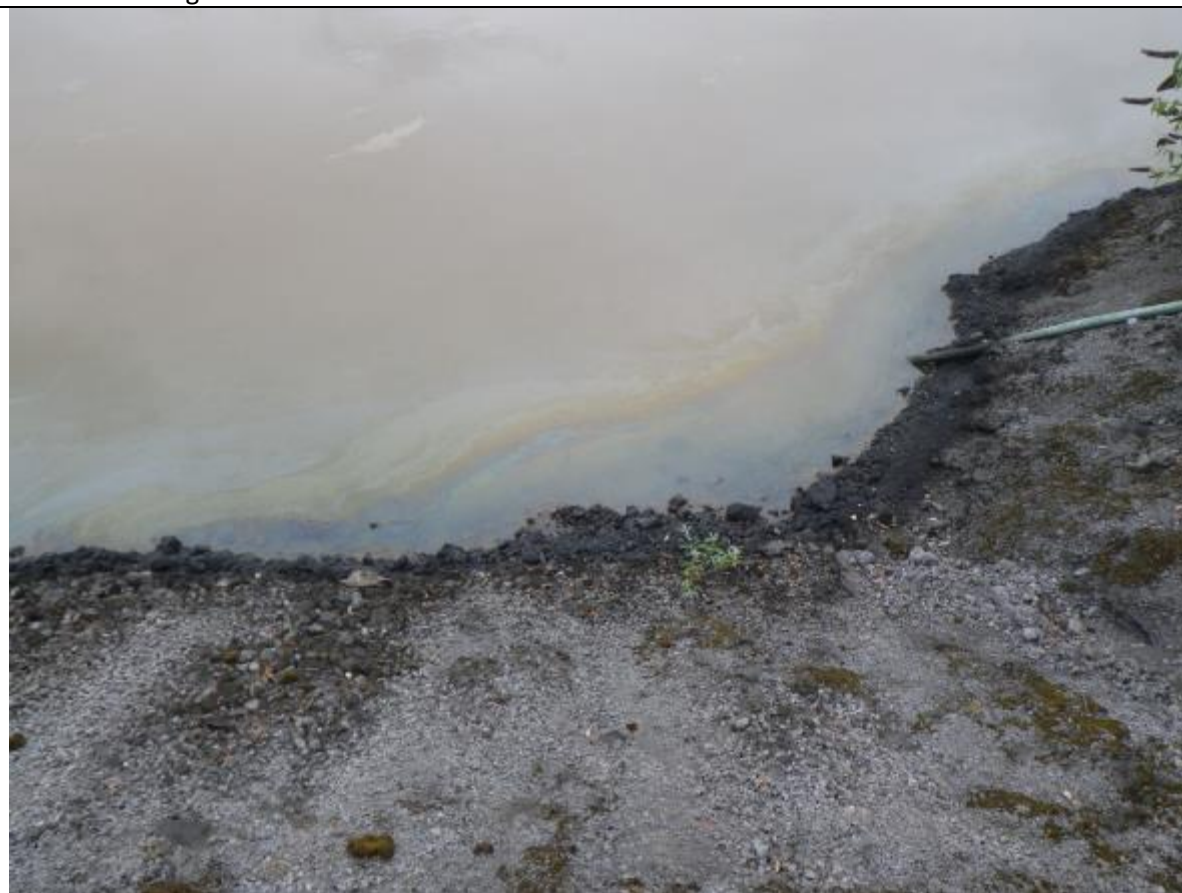
Photo 141 – Lagoon 27D

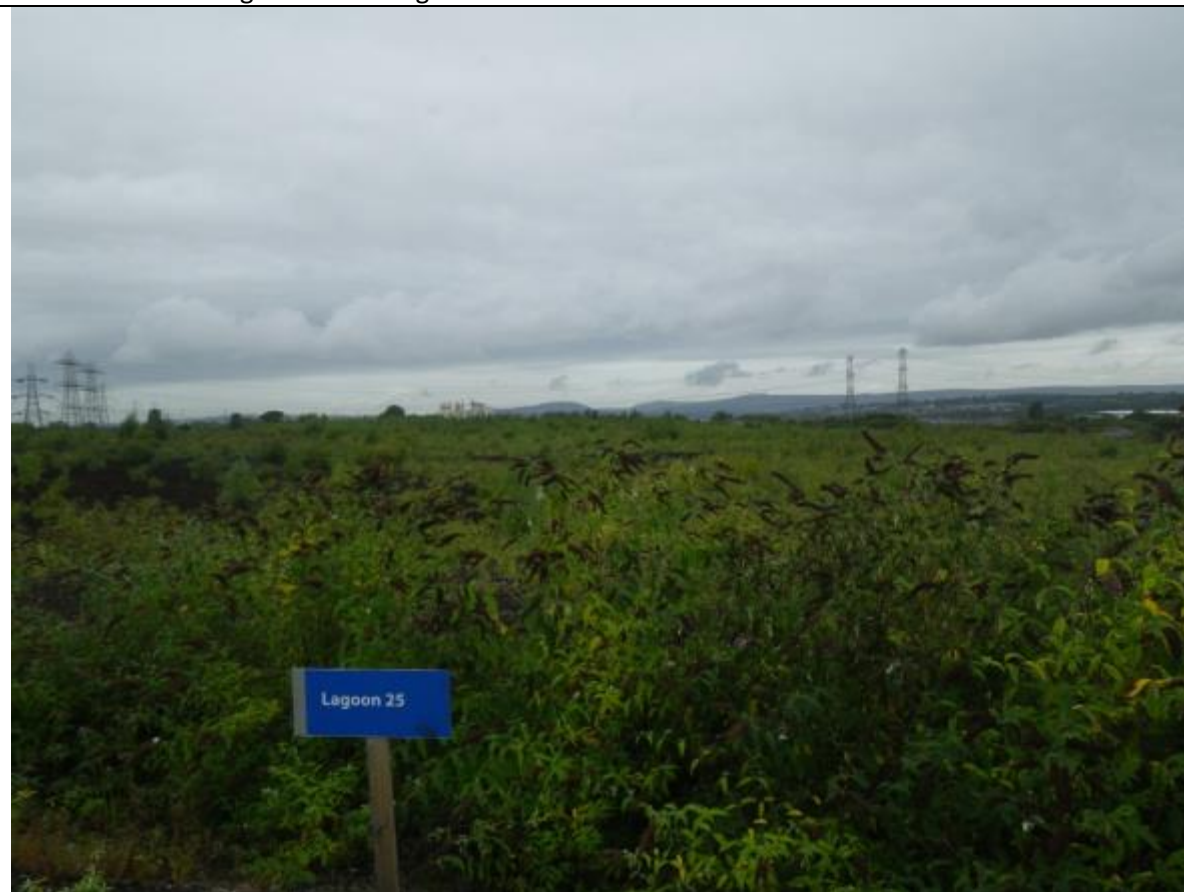
Photo 142 – Looking West over Lagoon 25
