## 1. General information

| Location Plan: | | St. Ishmael Sea Wall | |
| | | Assessment Date: 29/07/2020 | |
| | | CARRS Exam ID: | 2960028 |

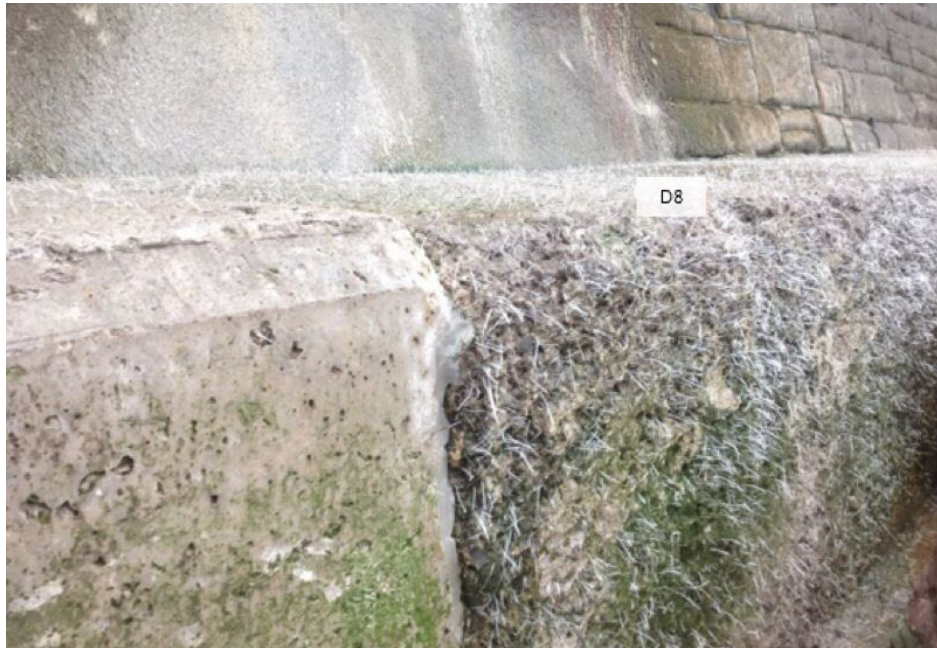
**Photo number: 32**

**Description:** Loss of cement from concrete apron face, exposed fibre reinforcement. Between 2014 and 2020, the fibre has become more visible (minor).

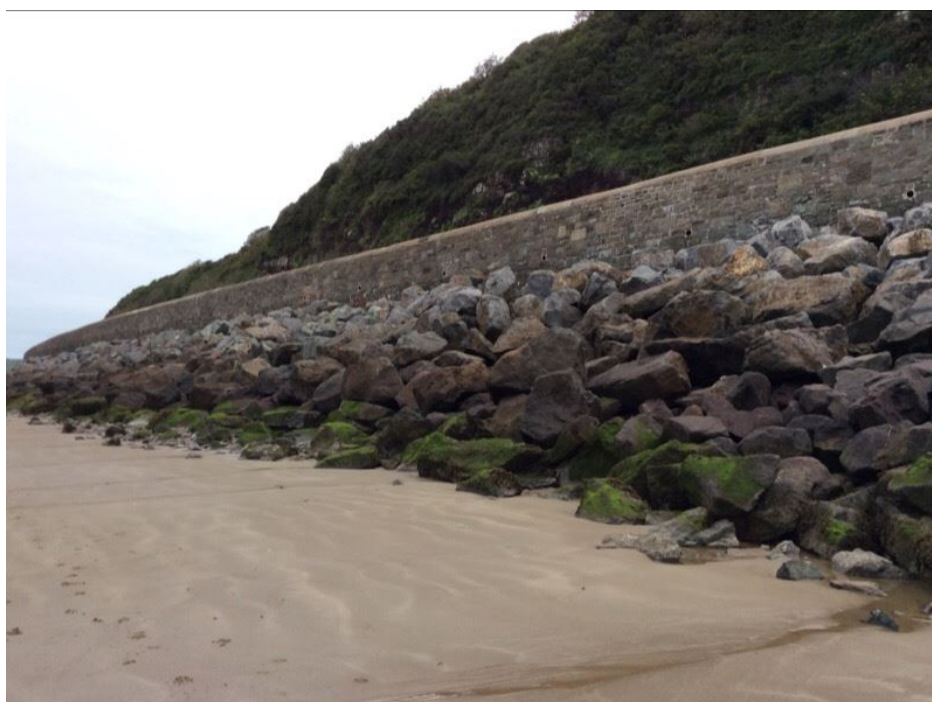
**Description:** New defect from 2020 inspection. Poor interlock between rock units.

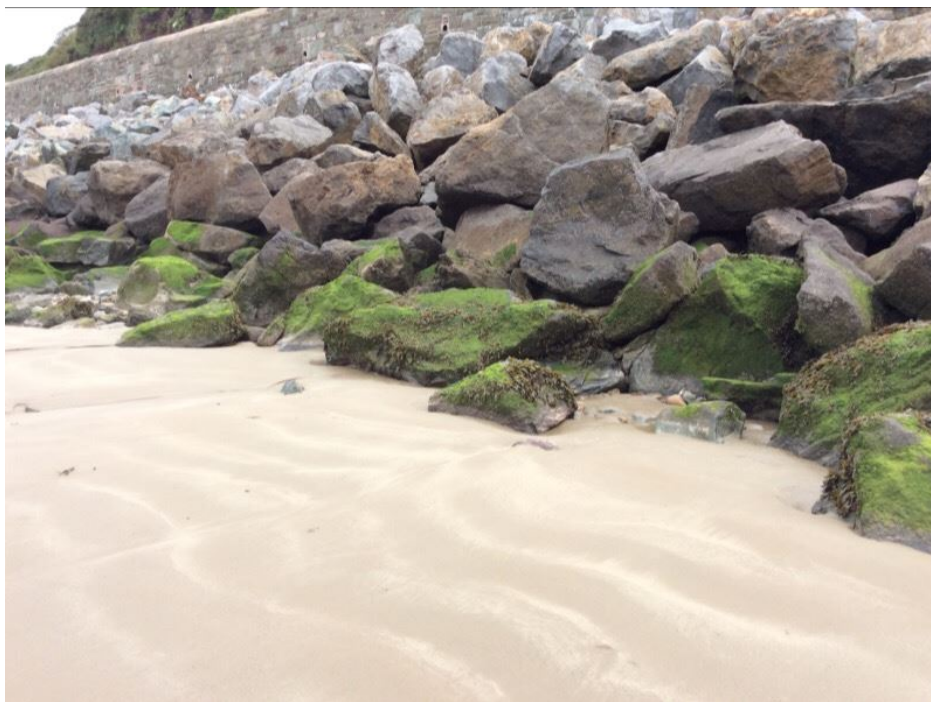
#### Defect Ref: D24

**Description:** New defect from 2020 inspection. Small rock units present in armour toe.
