**WYNNSTAY GROUP PLC  
LLYSONNEN MILL, TRAVELLERS REST,  
CARMARTHEN**

**DISCHARGE OPTIONS APPRAISAL AND  
DRAINAGE IMPROVEMENT SPECIFICATIONS**

**FEBRUARY 2011**

| <b>REPORT No.:</b> | <b>129-01-02.R1</b> |

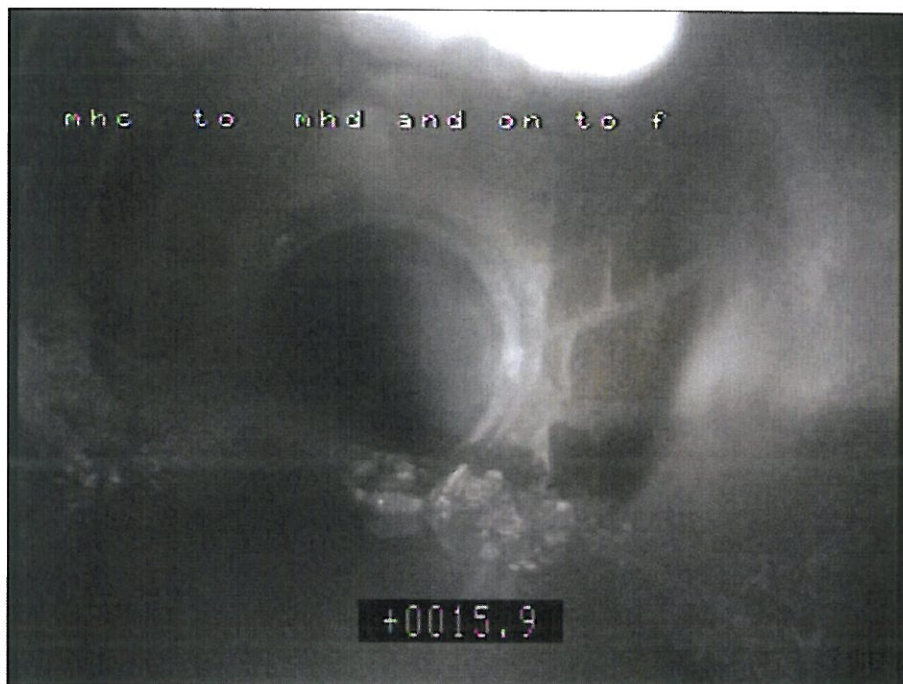
Photo: 37\_5a, Tape No.: 01, 00:03:20  
15.9m, General Observation, Remark: MH D

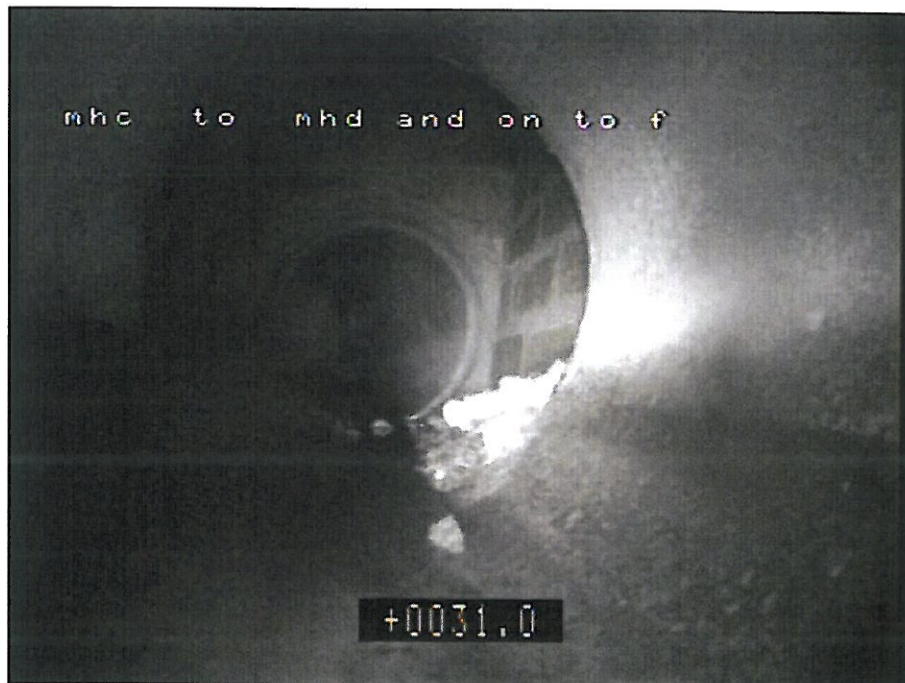
Photo: 39\_7a, Tape No.: 01, 00:05:31  
31m, Manhole Remark: MH F
