## / Main sections

| Project name :<br><b>Protherics UK Ltd, Wales, Drainage</b> | Project number :<br><b>J48577</b> | Contact : | Date :<br><b>26/09/2017</b> |

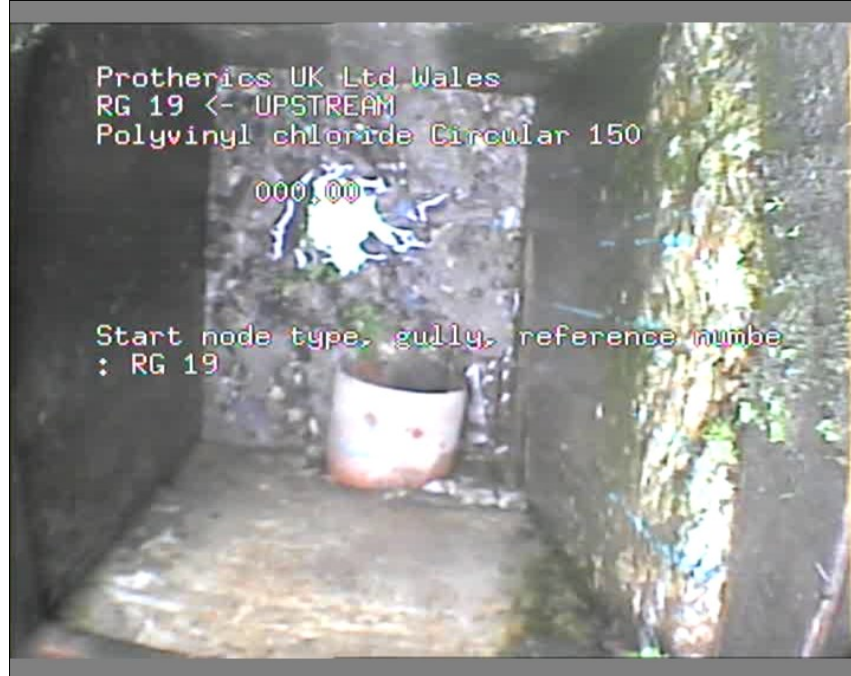
Photo: 49\_49\_307\_A.JPG  
 0m, Start node type, gully, reference number : RG 19
