# NETWORK RAIL

## Bridge Detailed Examination Report

| Structure Name: BONT FURNACE STREAM | | Type: BU | | Exam ID: 14462980 | |
| Route: Betws-y-Coed Branch | | | | Complete Exam: No | |

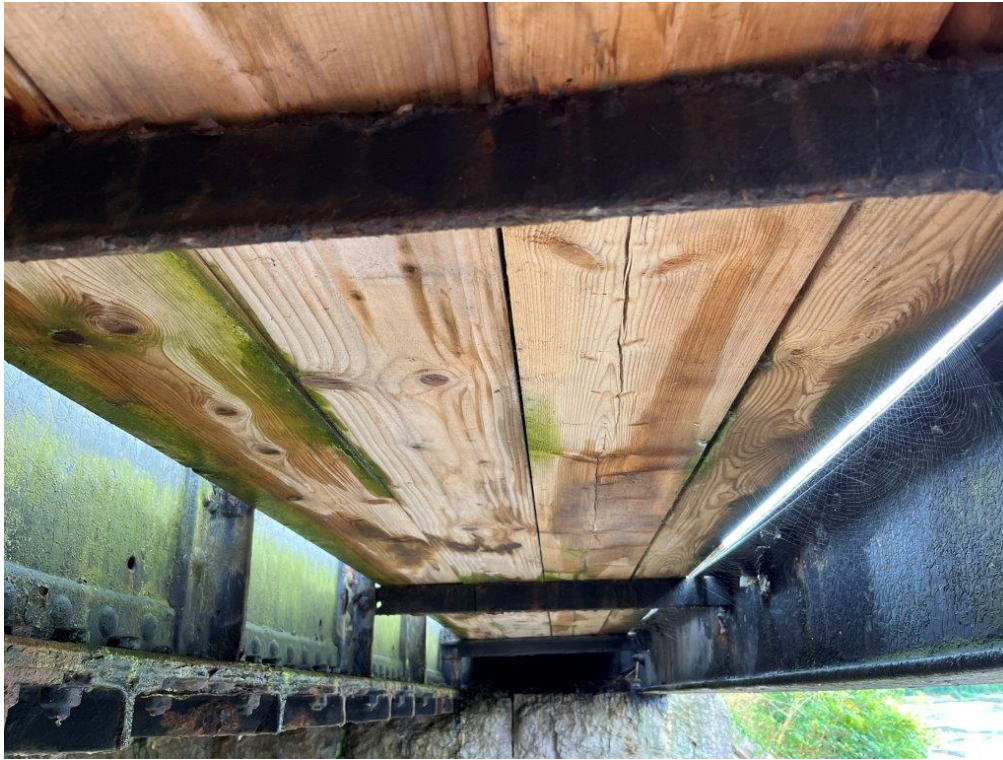
Photo 29: US Walkway / DCK (02/08/22)
