**Rhondda Cynon Taf County Borough Council**

**A8066 Tynybryn River Channel Survey**

July 2020

Inspection team	Nicholas Tucker	Ifan Thomas
	Andrew Duncan	Mike Bond
Report by:	Nicholas Tucker	
Inspection date	29 <sup>th</sup> June 2020 & 1 <sup>st</sup> July 2020	
Report No.	A8066

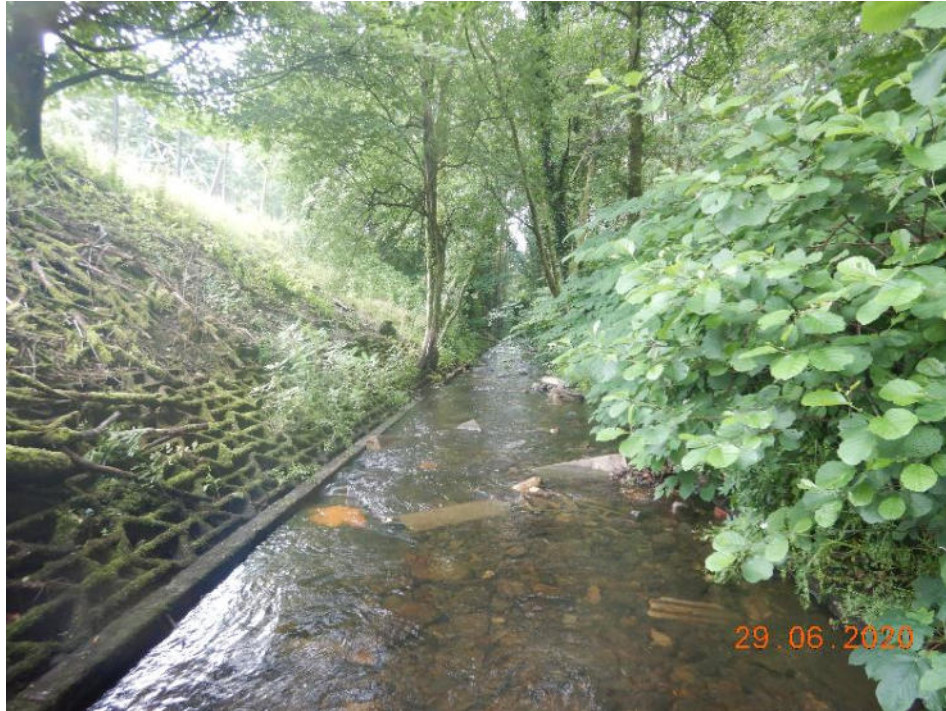
*Figure 1: General view of Tynybryn River Channel, viewed from the inspection start point*

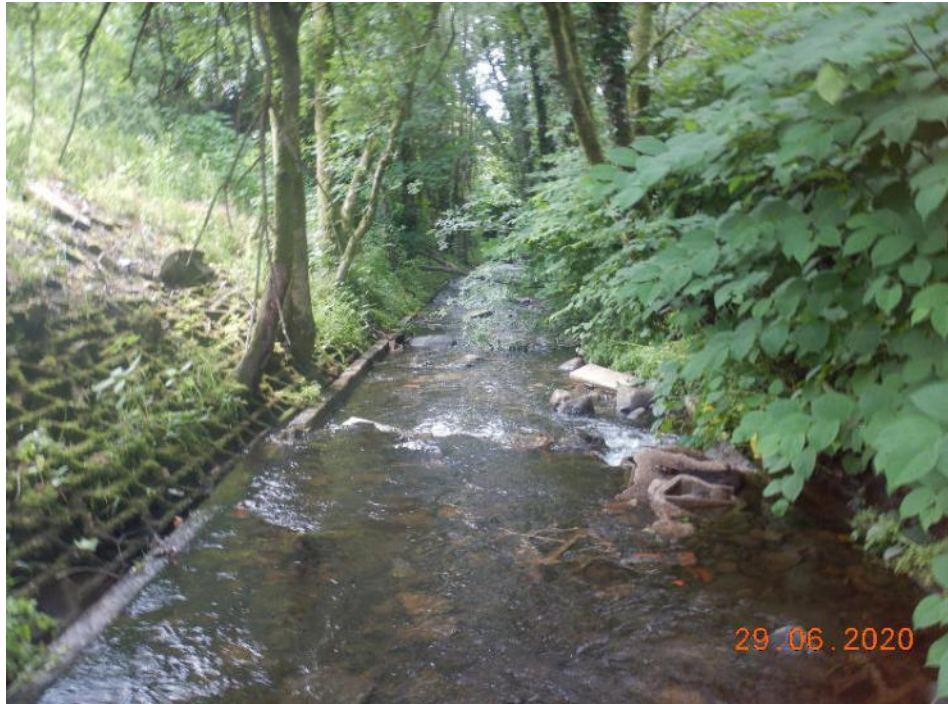
*Photo 1 – General view of the river channel, viewed from the inspection start point*

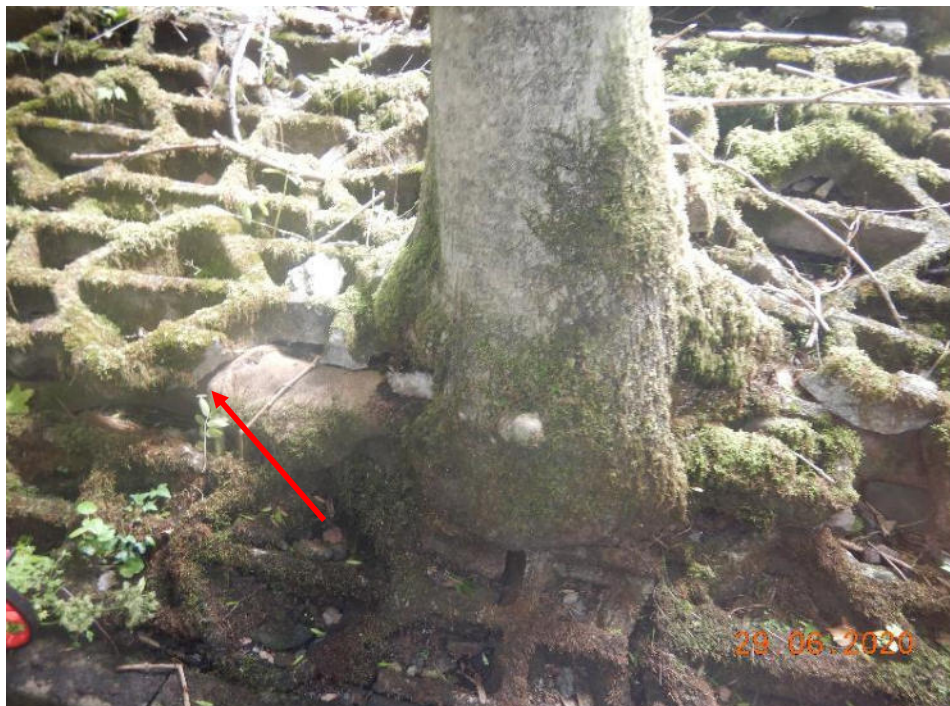
17.2m & 19.3m	There are two trees growing to the revetment measuring 180mm and 400mm in diameter, respectively. There are sections of loose and displaced concrete surrounding the trees both measuring 300mm high and 700mm long.	8, 9	2	E	RM	ii.

*Photo 8 – Tree growth causing displacement of concrete (17.2m)*

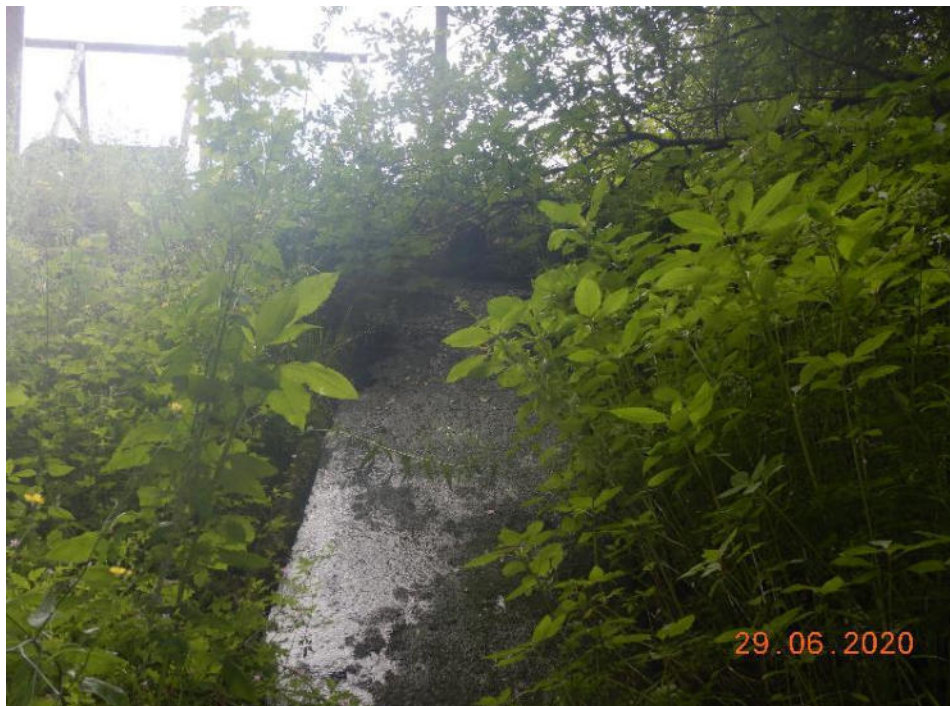
*Photo 10 – Drainage pipe (27.4m)*

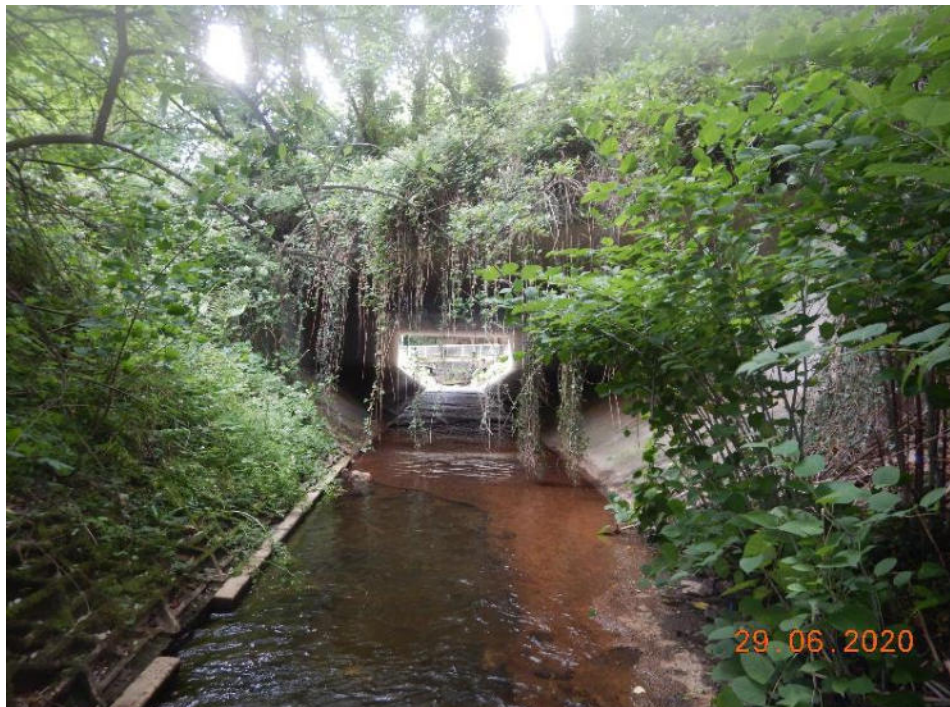
Chainage	Description	P	S	Ex	W	Ref.
-	The culvert was found to be in a good condition overall, with only minor defects identified.	24, 26	-	-	-	-
101.2m – 139.7m	There are 75mm diameter weep holes spaced 2m apart on both sides of the structure. There is white and green coloured infiltration coming from several of the weep holes.	25	2	C	N	-
110.3m	There is offensive graffiti present to the left side of the structure.	27	-	-	RM	vi.
129.4m	The jointing has come loose on the left side of the invert over a 1.2m length.	28	2	B	N	-

*Photo 24 – Upstream elevation of Tynybryn Culvert (101.2m)*

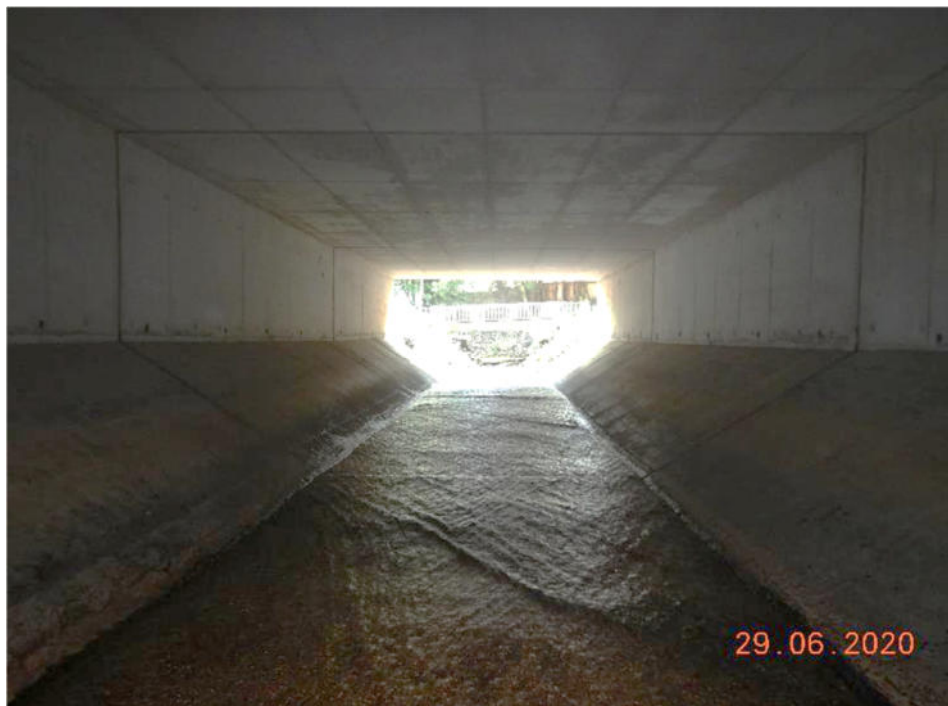
*Photo 26 – General view through the culvert, viewed looking downstream*

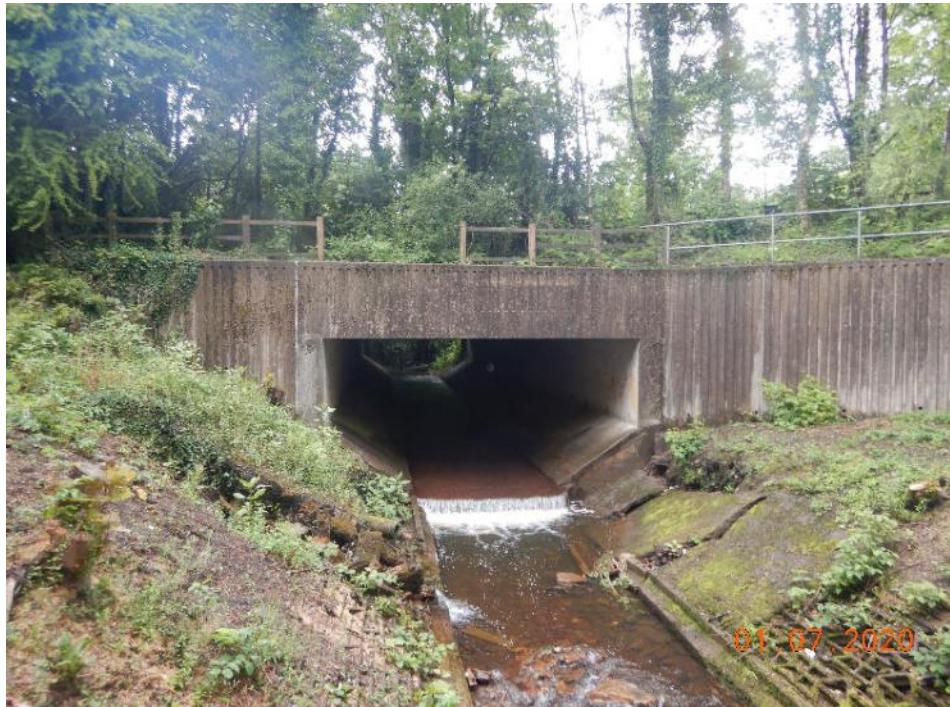
*Photo 29 – Downstream elevation of Tynybryn Culvert*

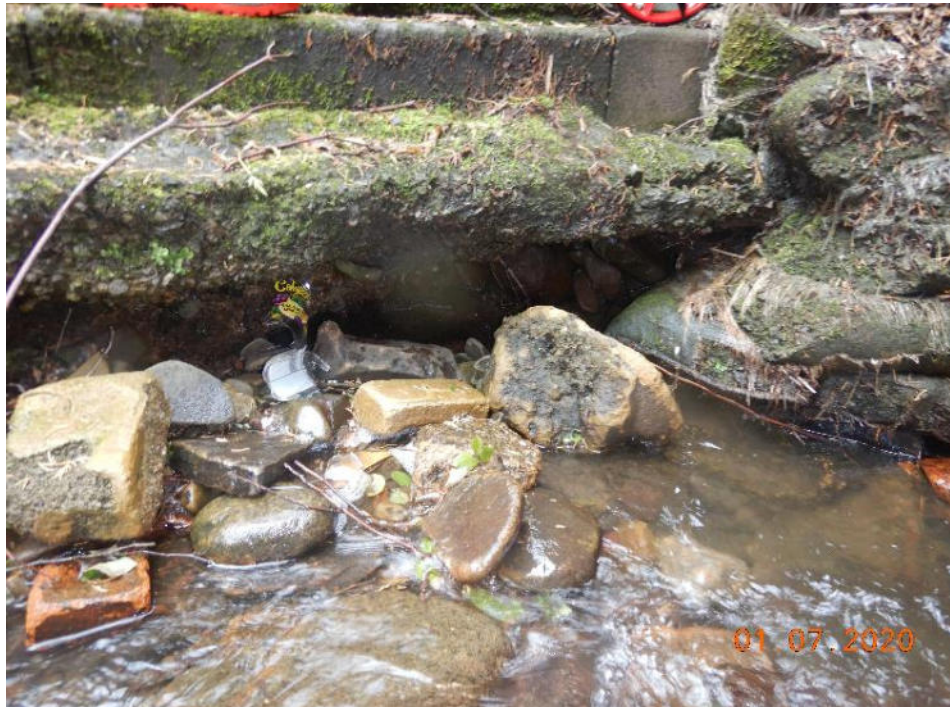
*Photo 33 – Undercutting to the concrete toe (145.4m – 156m)*

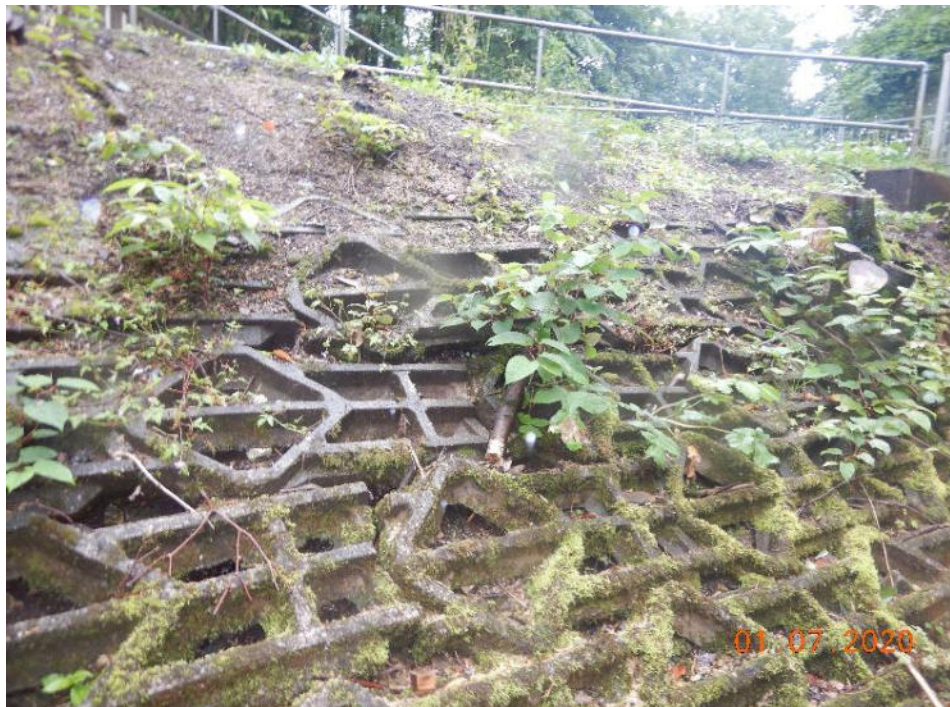
*Photo 34 – Displaced concrete (149.9m – 156.6m)*

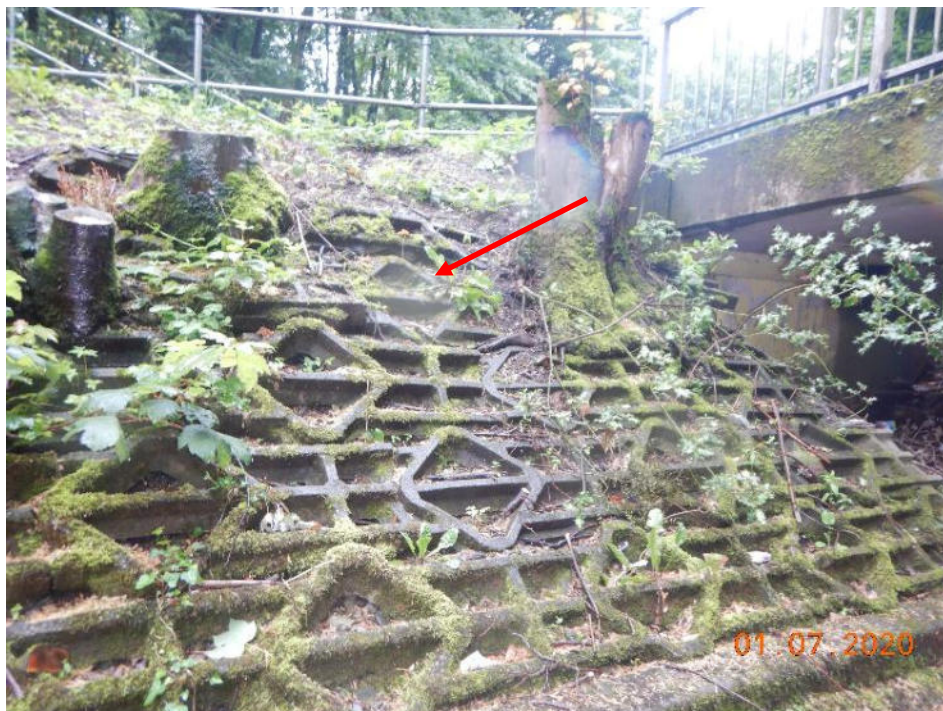
*Photo 35 – Displaced concrete and tree stumps (149.9m – 156m)*

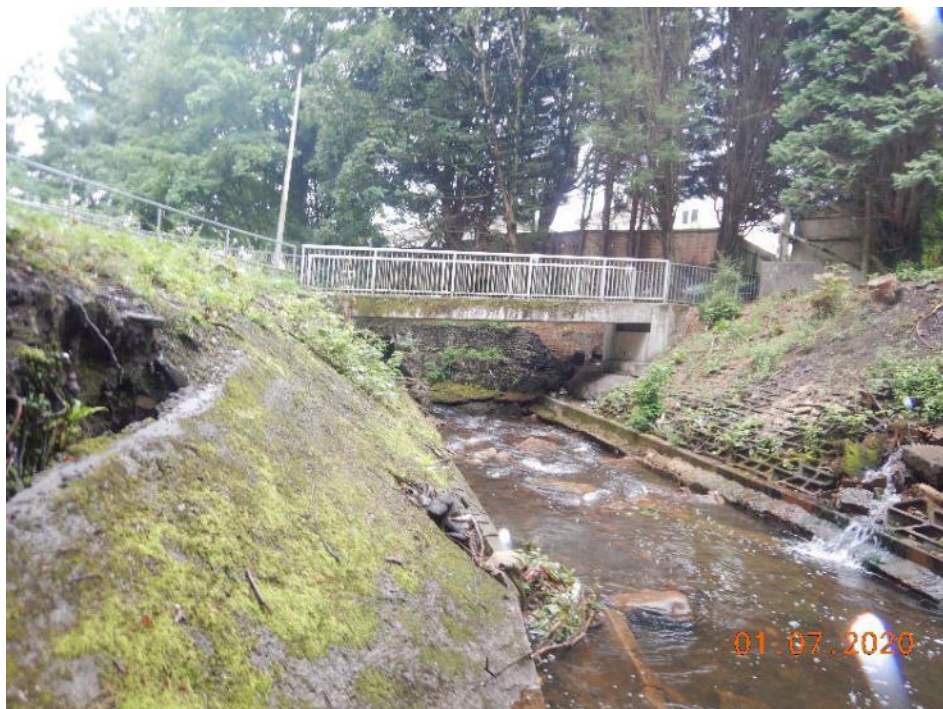
*Photo 36 – Upstream elevation of Tynybryn Footbridge*

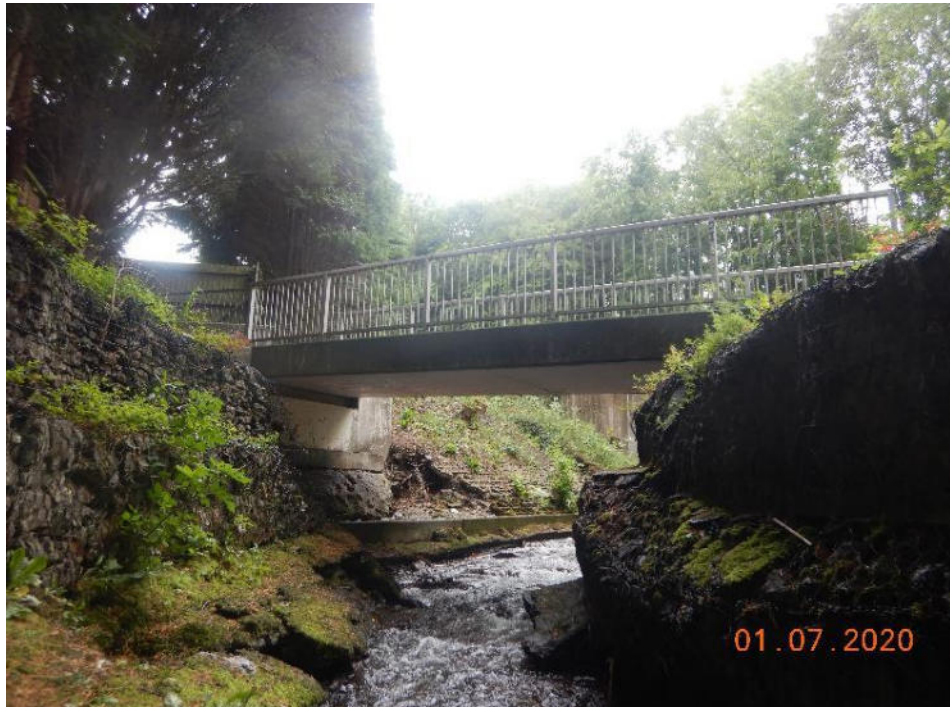
*Photo 37 – Downstream elevation of Tynybryn Footbridge*

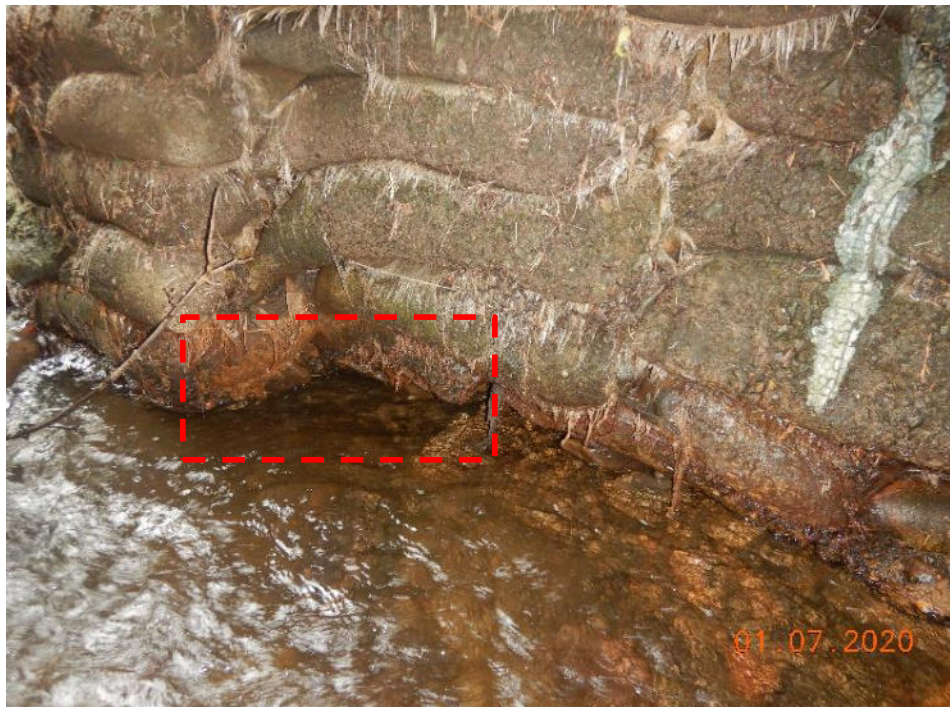
*Photo 38 – Scour to concrete bagwork (157m)*

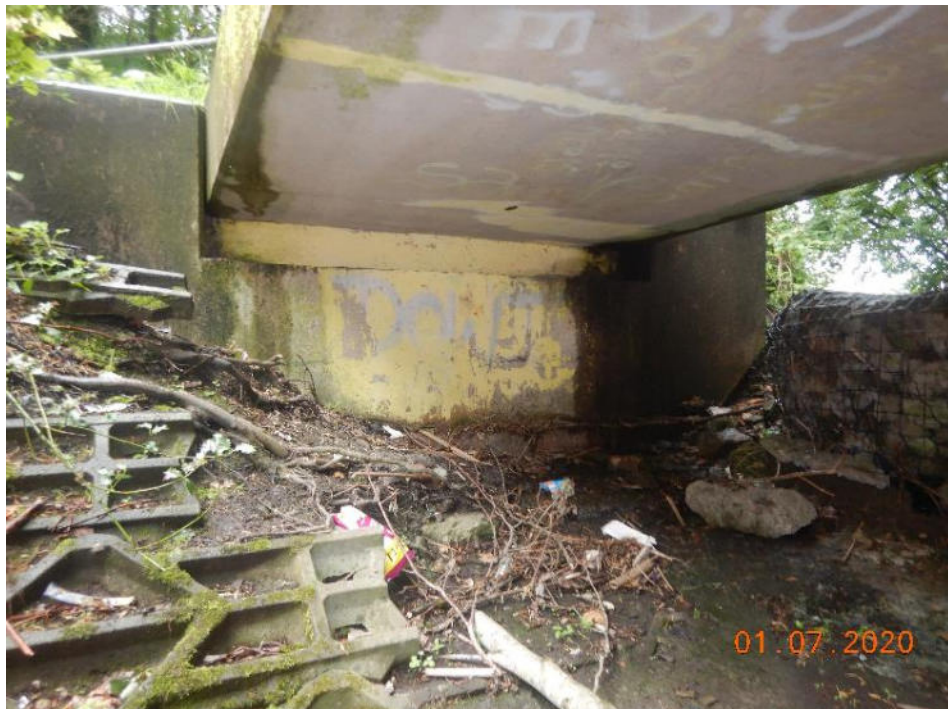
*Photo 39 – General view of the east abutment of Tynybryn Footbridge*

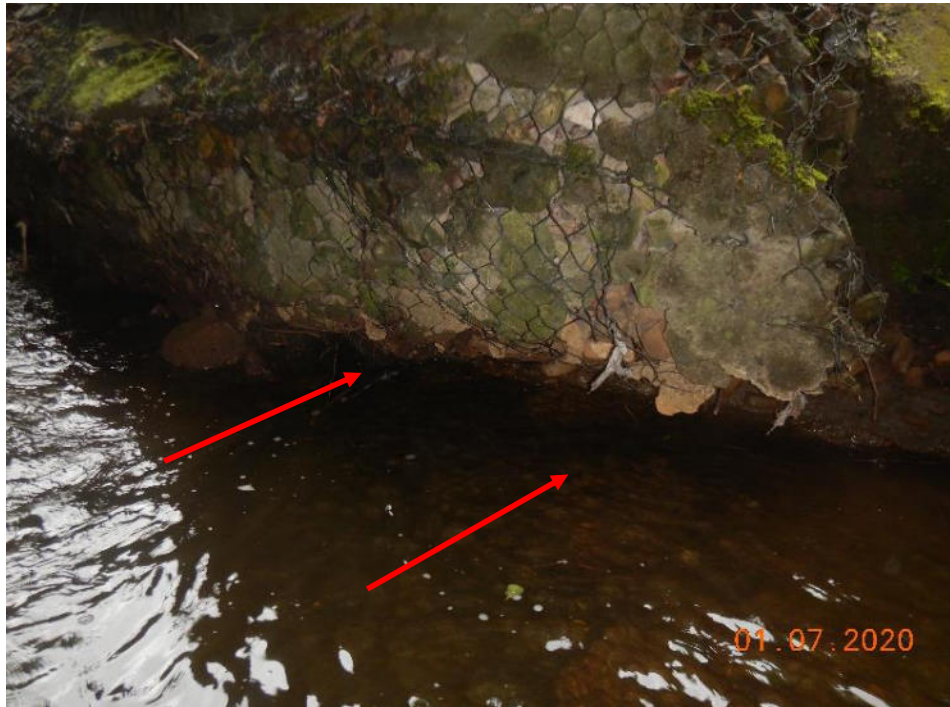
*Photo 41 – Undercutting to the gabion basket training wall (163.4m)*

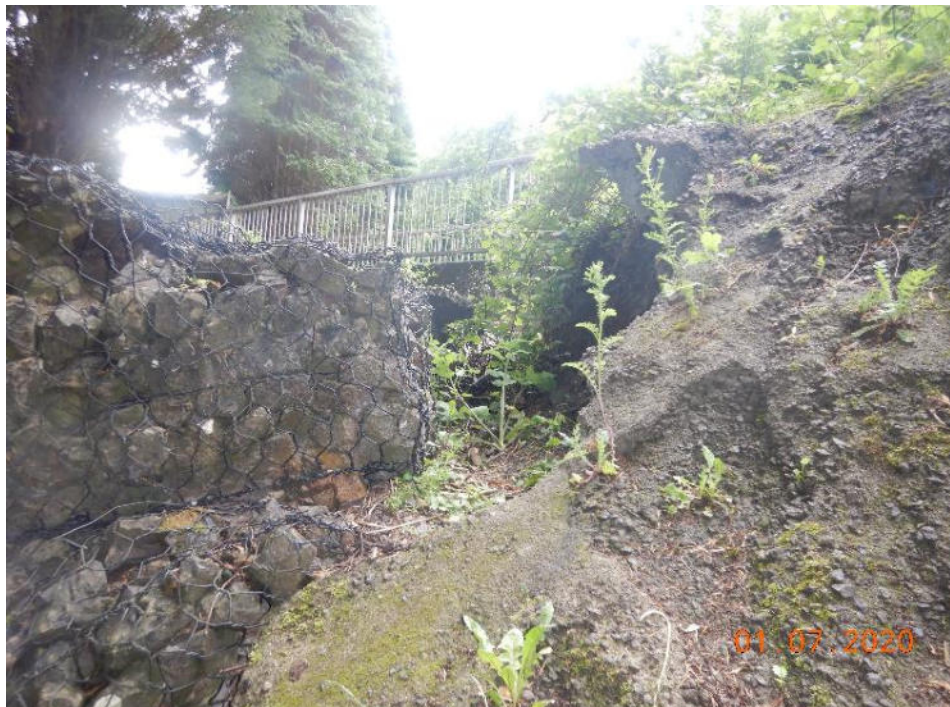
*Photo 42 – Void behind the gabion basket training wall (165.4m)*

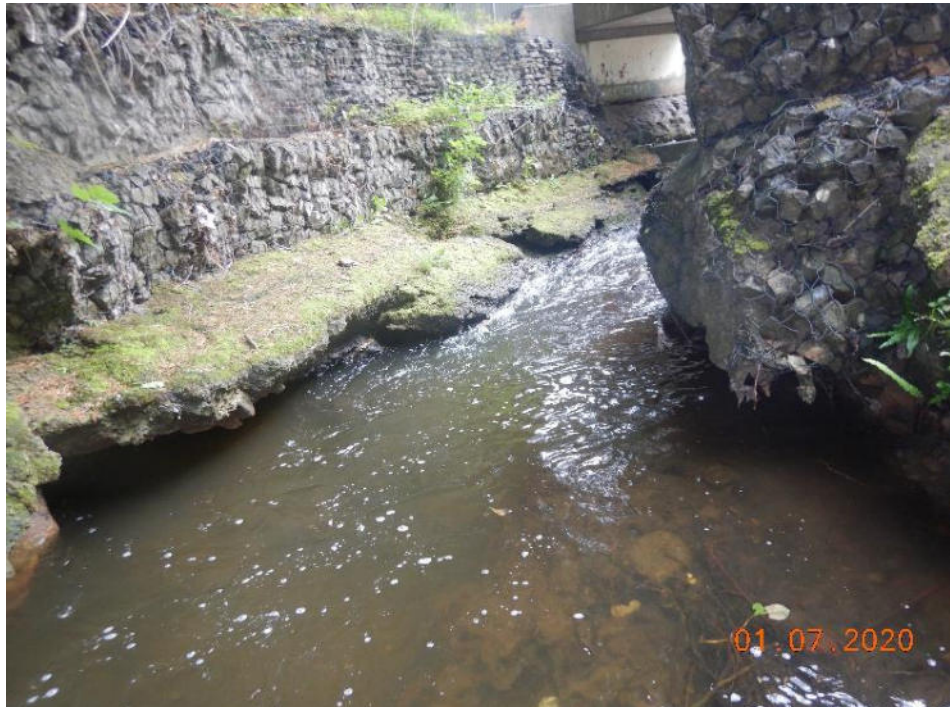
*Photo 43 – Remnants of a concrete invert downstream of the footbridge*

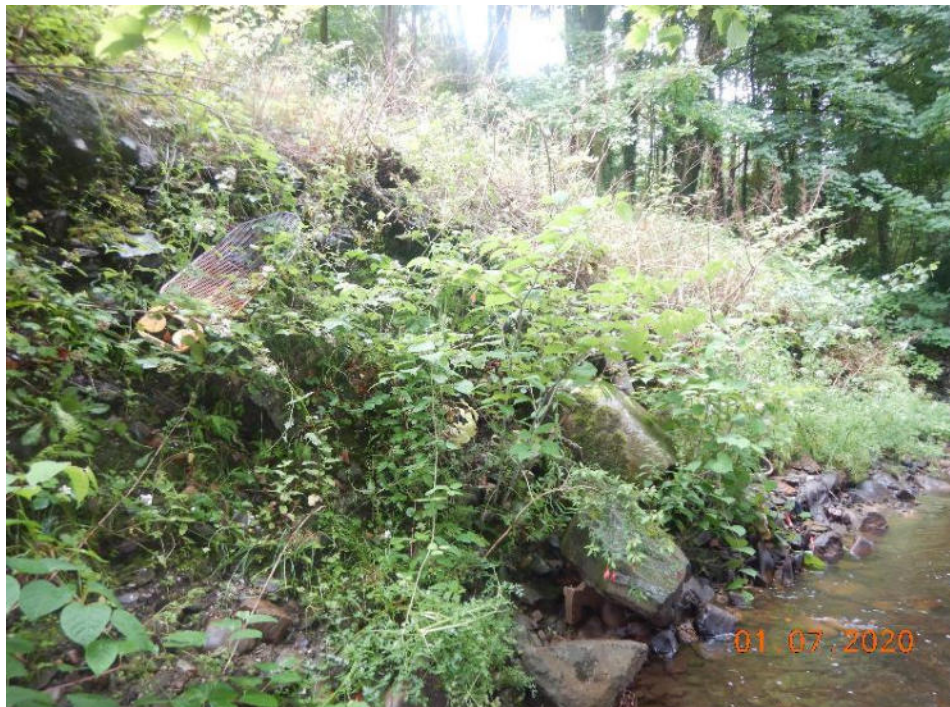
*Photo 44 – Earth embankment (165.4m – 185.7m)*

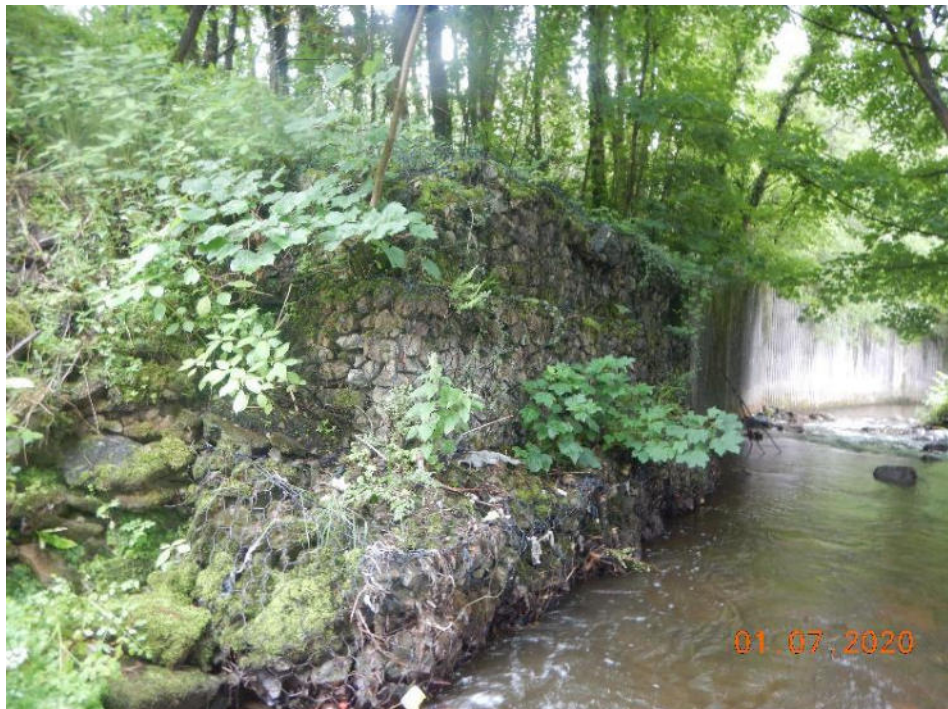
*Photo 45 – General view of the gabion basket retaining wall (185.7m – 192.7m)*

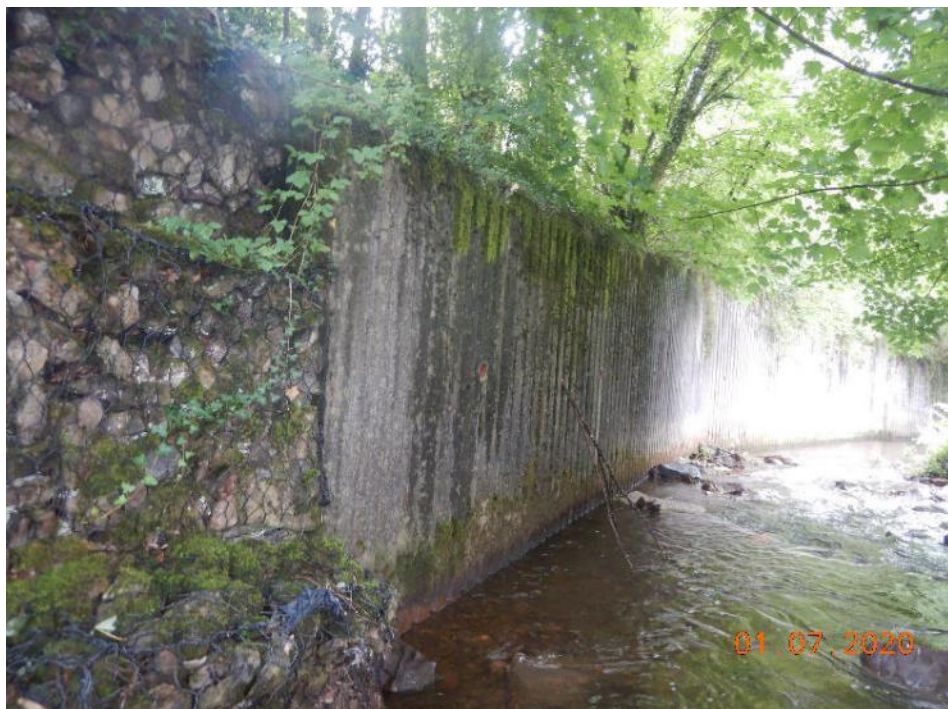
*Photo 48 – General view of the concrete retaining wall (192.7m – 246.6m)*

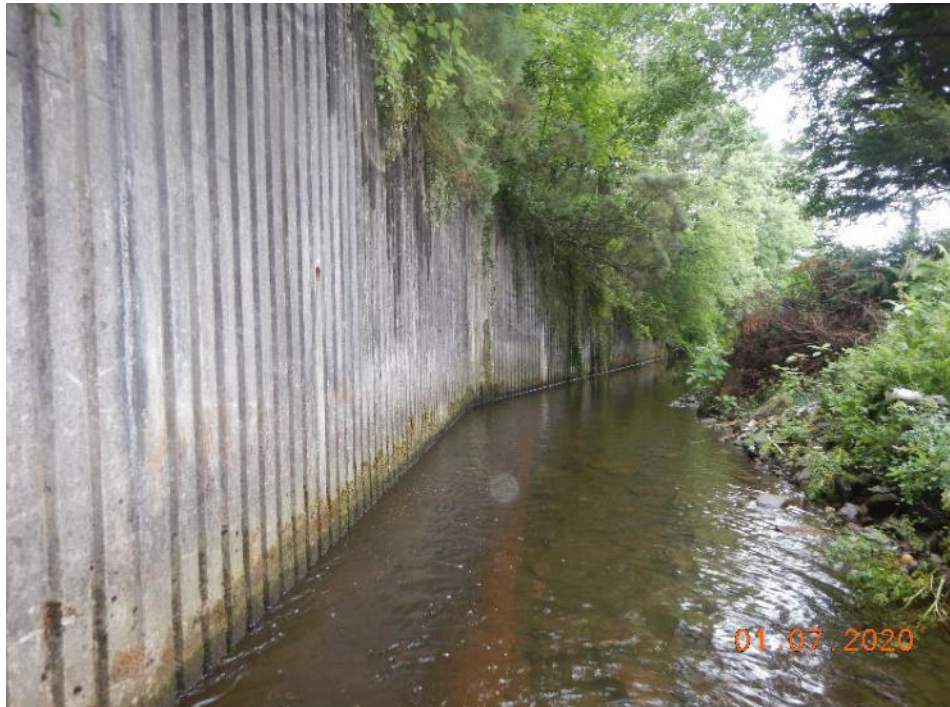
*Photo 49 – General view of the concrete retaining wall (192.7m – 246.6m)*

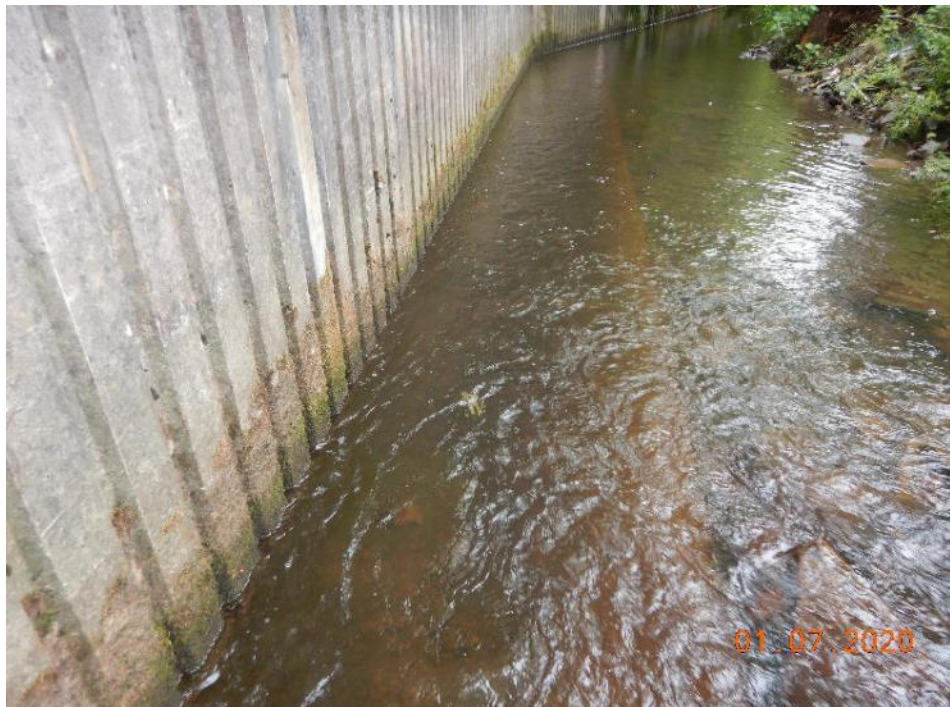
*Photo 50 – Concrete apron to the base of the retaining wall (208.8m)*

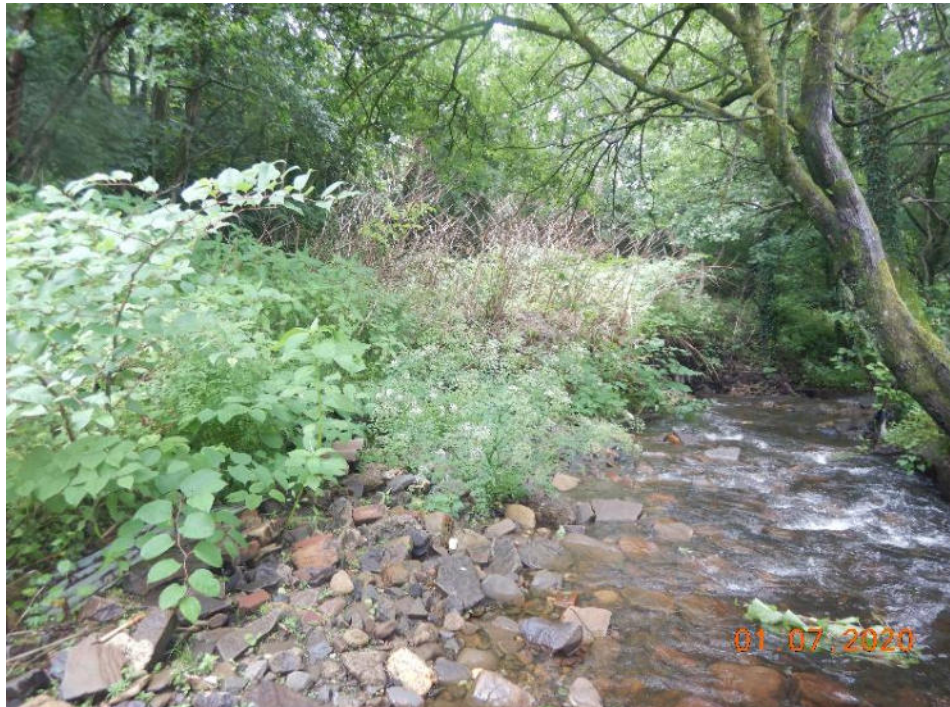
*Photo 51 – Vegetation growth to embankment (246.6m – 294m)*

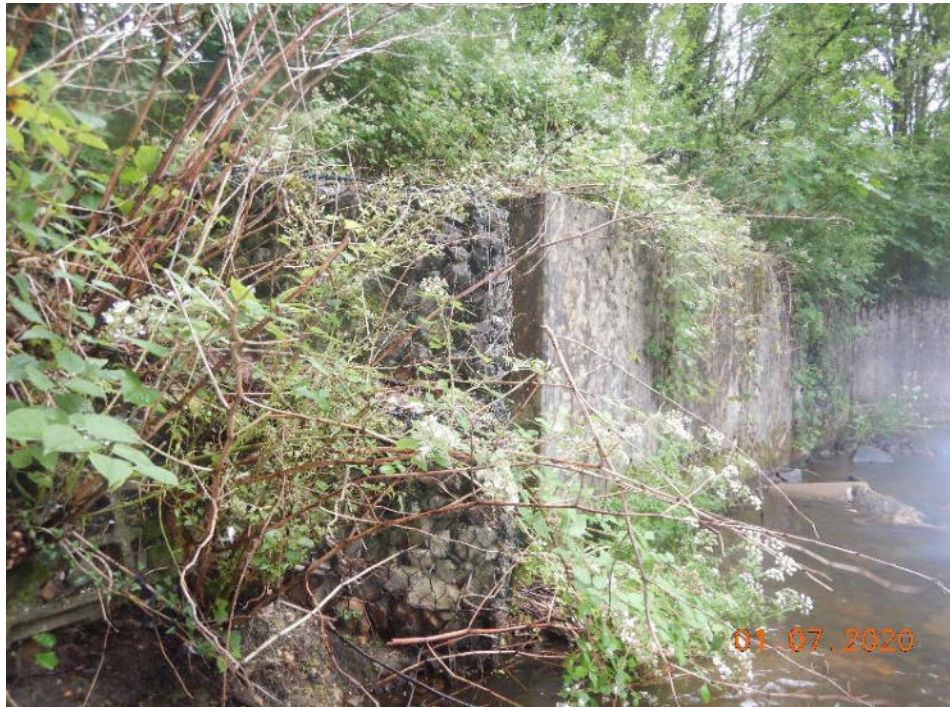
*Photo 57 – Dense vegetation growth to gabion baskets (320.5m)*

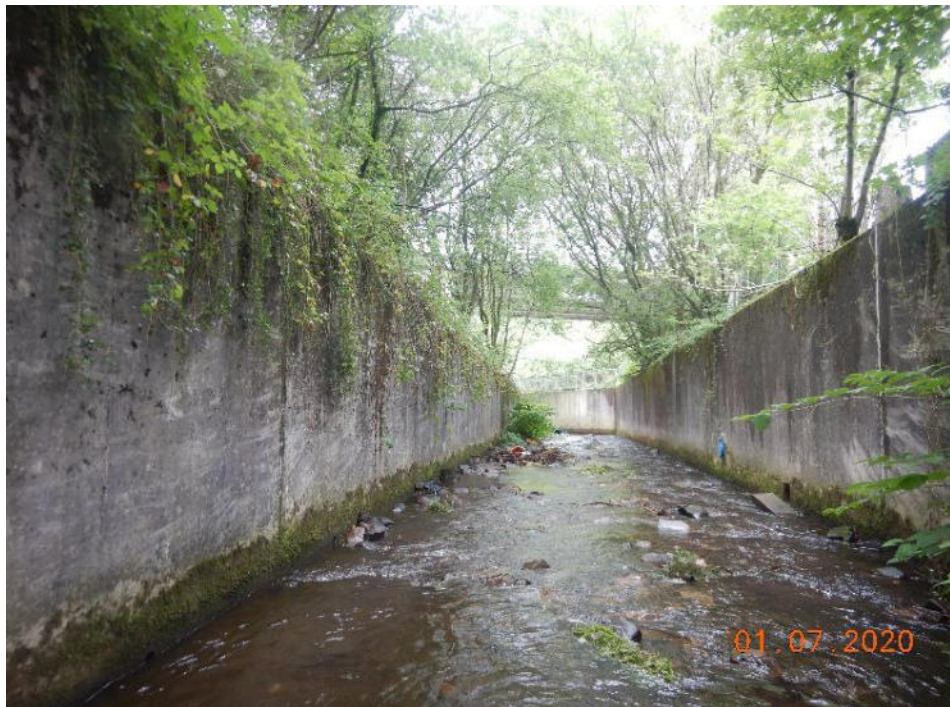
*Photo 58 – General view of the concrete retaining wall (321.5m – 413m)*

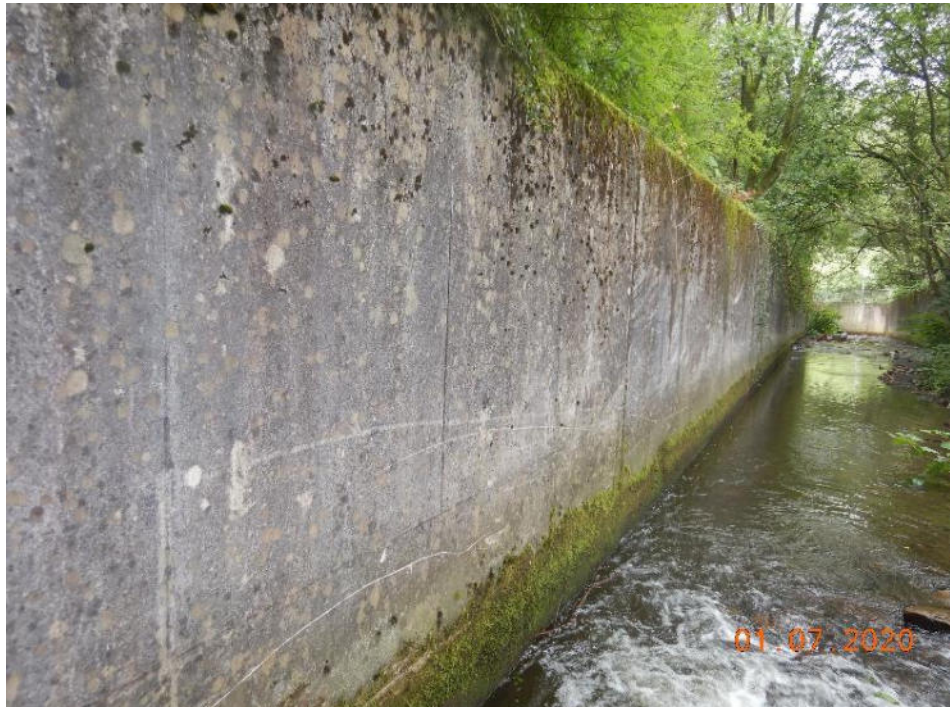
*Photo 59 – General view of the concrete retaining wall (321.5m – 413m)*

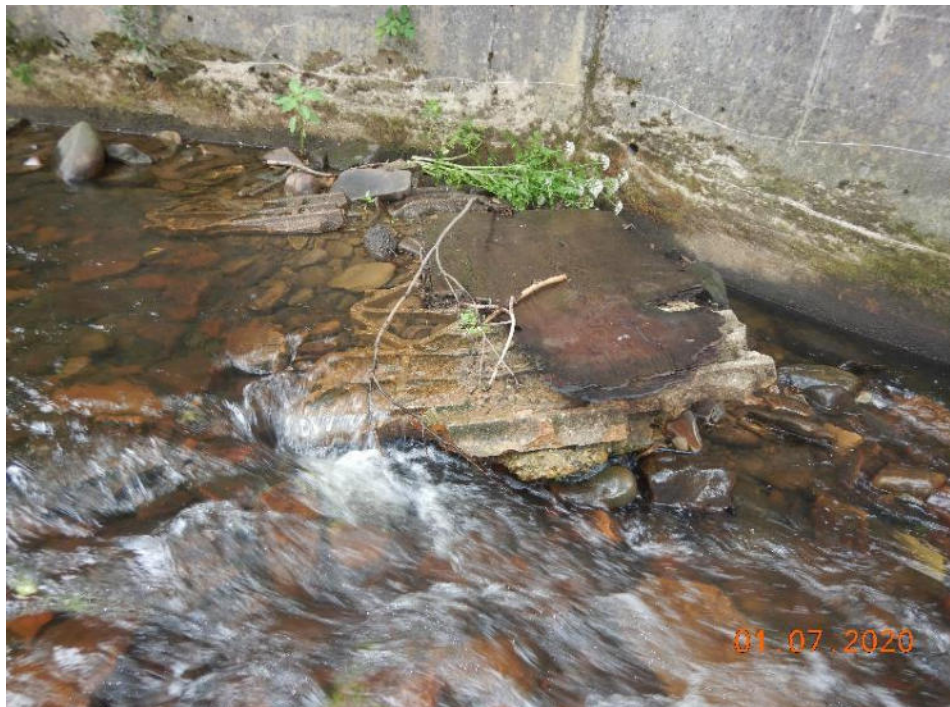
*Photo 60 – Section of concrete revetment in the watercourse (331.5m)*

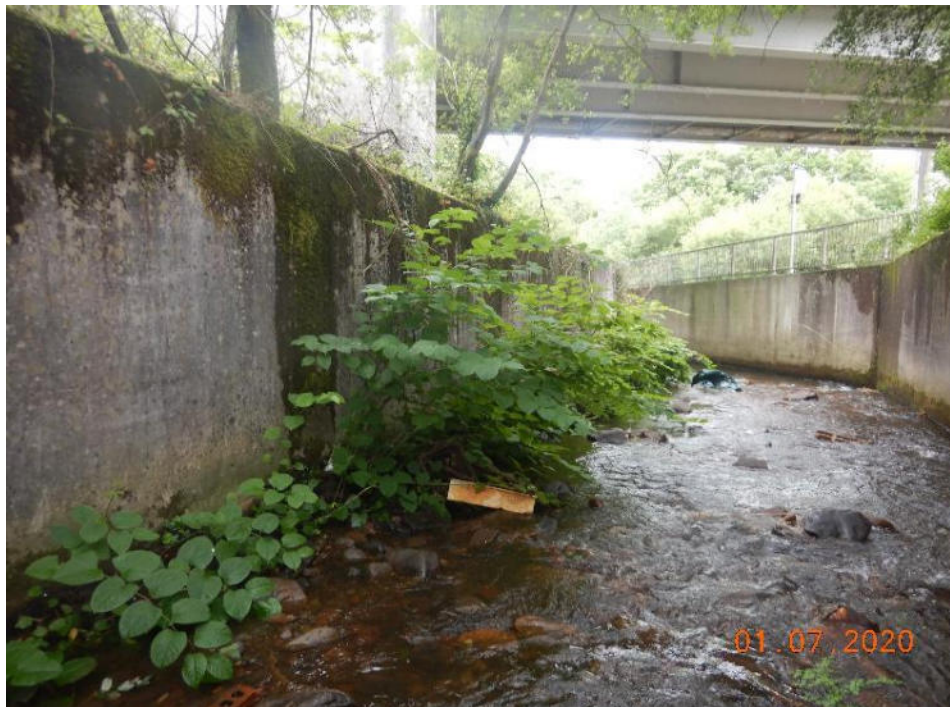
*Photo 62 – Japanese Knotweed growth (379.9m – 413m)*

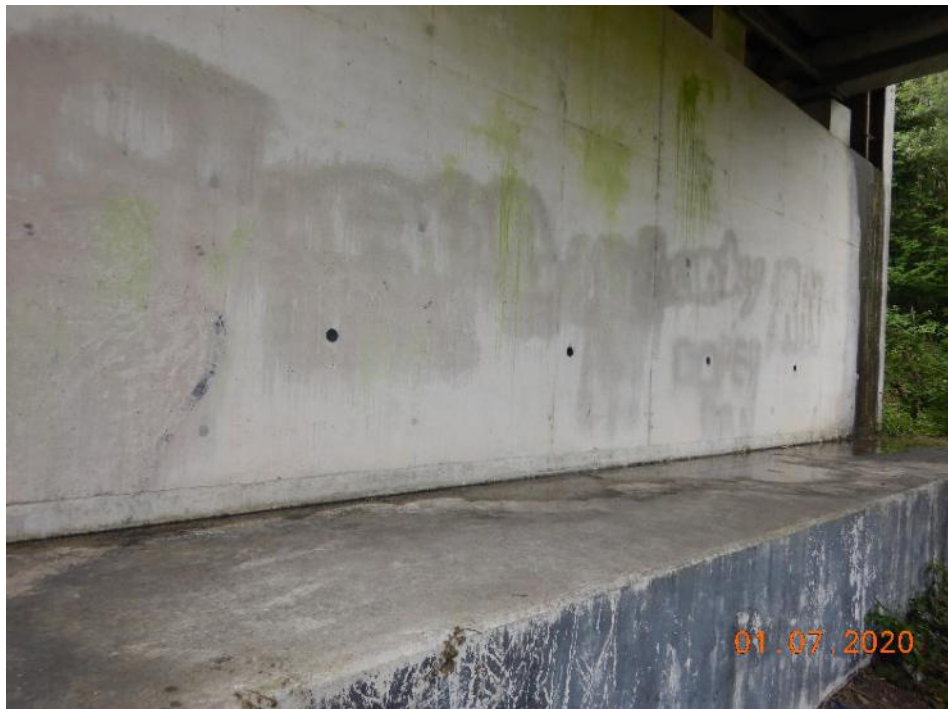
*Photo 63 – General view of the east abutment (394.3m – 406.4m)*

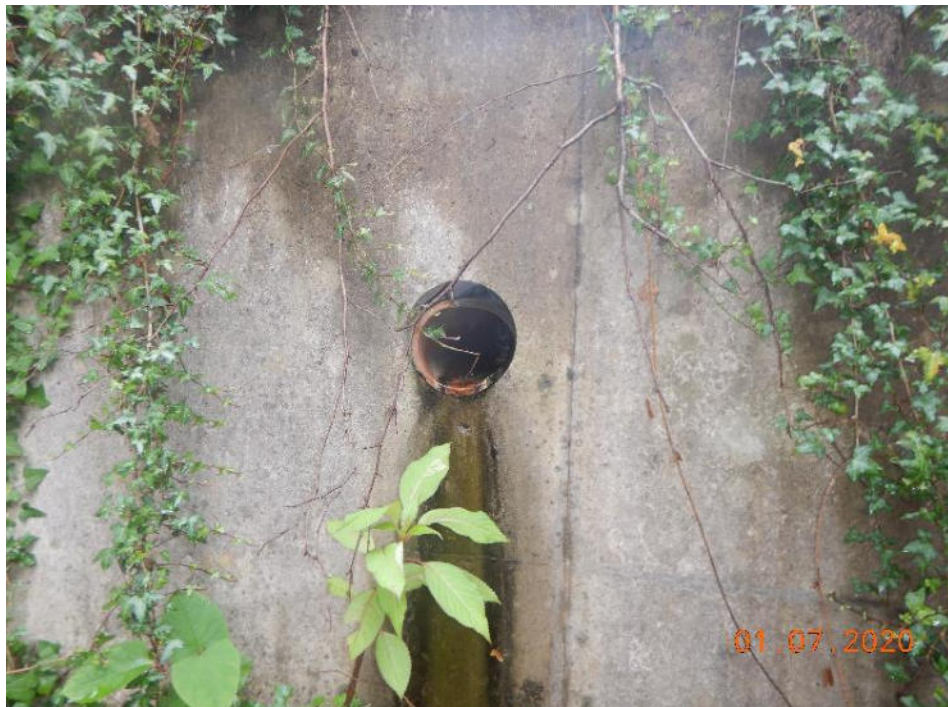
*Photo 64 – Clay drainage pipe (409m)*

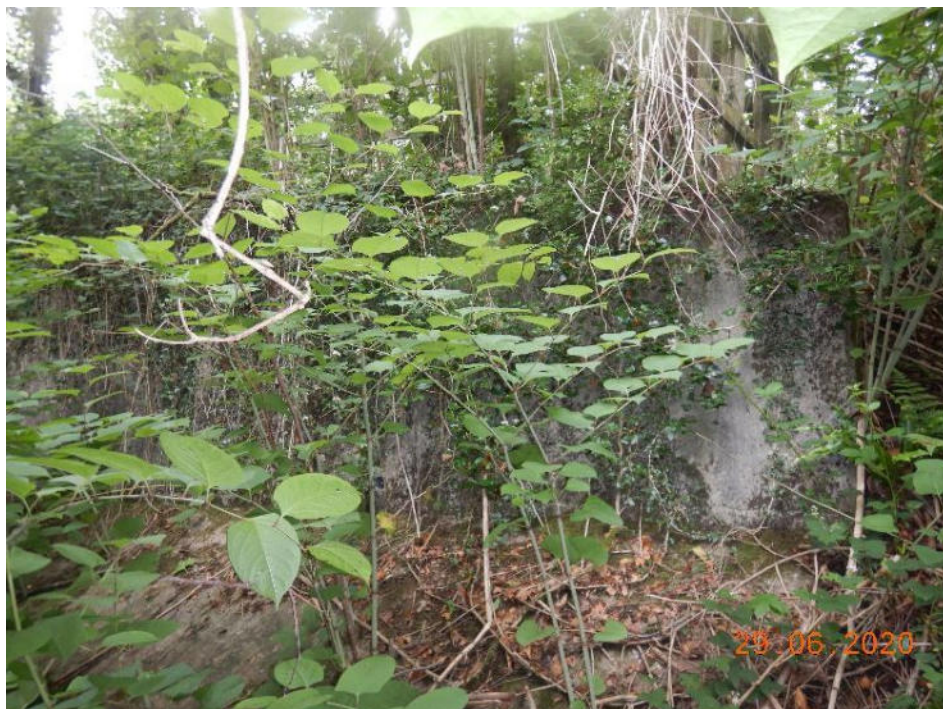
*Photo 70 – General view of the concrete retaining wall (84.3m – 101.2m)*

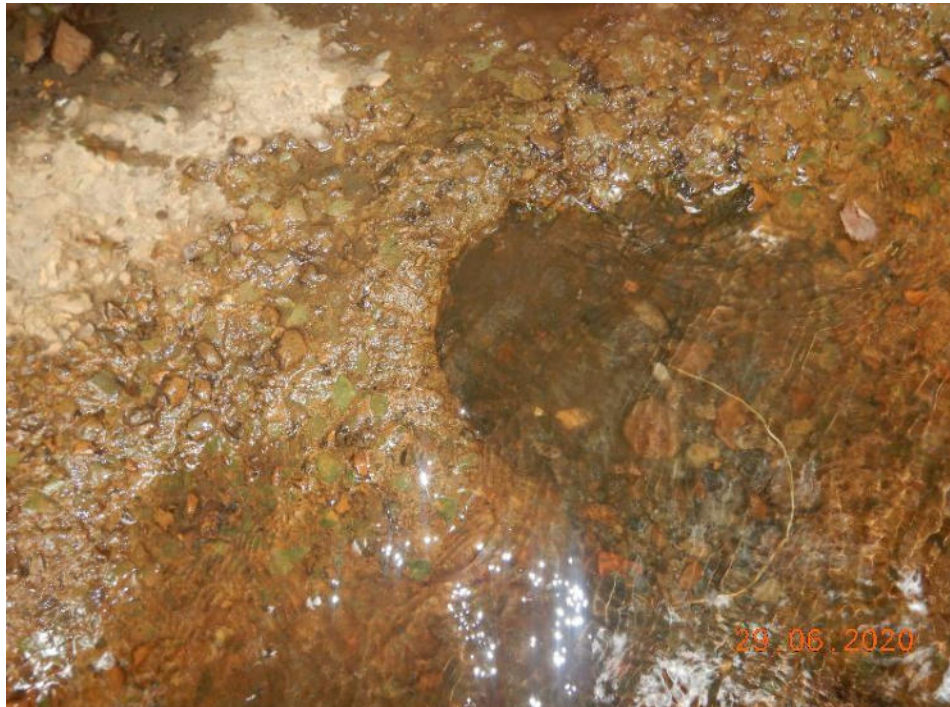
*Photo 71 – Scour hole to the right side of the invert (92.9m)*

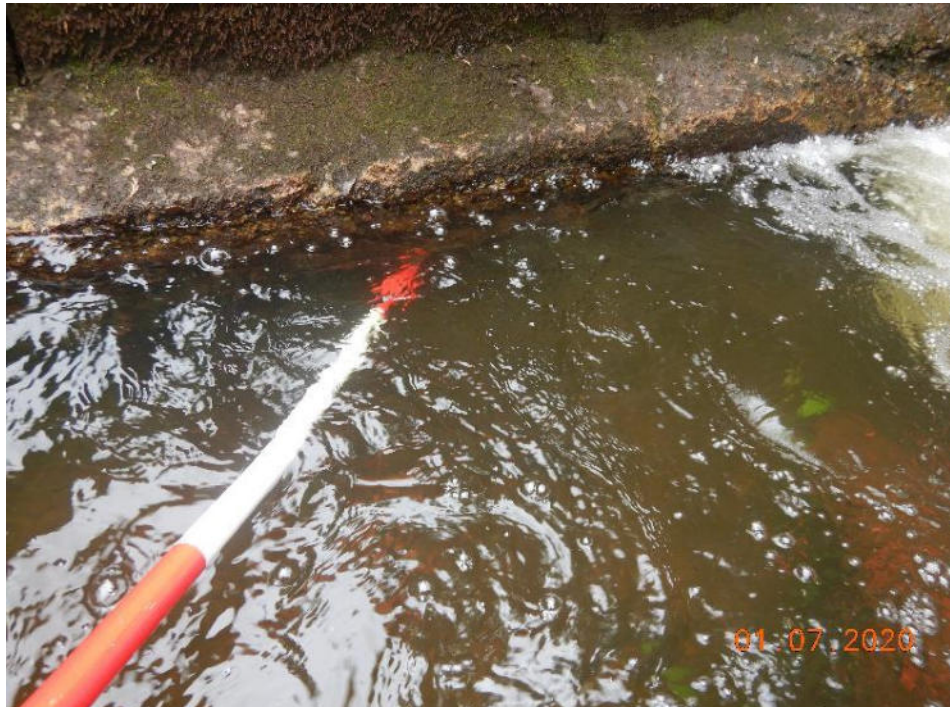
*Photo 77 – Undercut to concrete toe (139.7m – 158.8m)*
