**Rhondda Cynon Taf County Borough Council**

**A8066 Tynybryn River Channel Survey**

July 2020

Inspection team	Nicholas Tucker	Ifan Thomas
	Andrew Duncan	Mike Bond
Report by:	Nicholas Tucker	
Inspection date	29 <sup>th</sup> June 2020 & 1 <sup>st</sup> July 2020	
Report No.	A8066

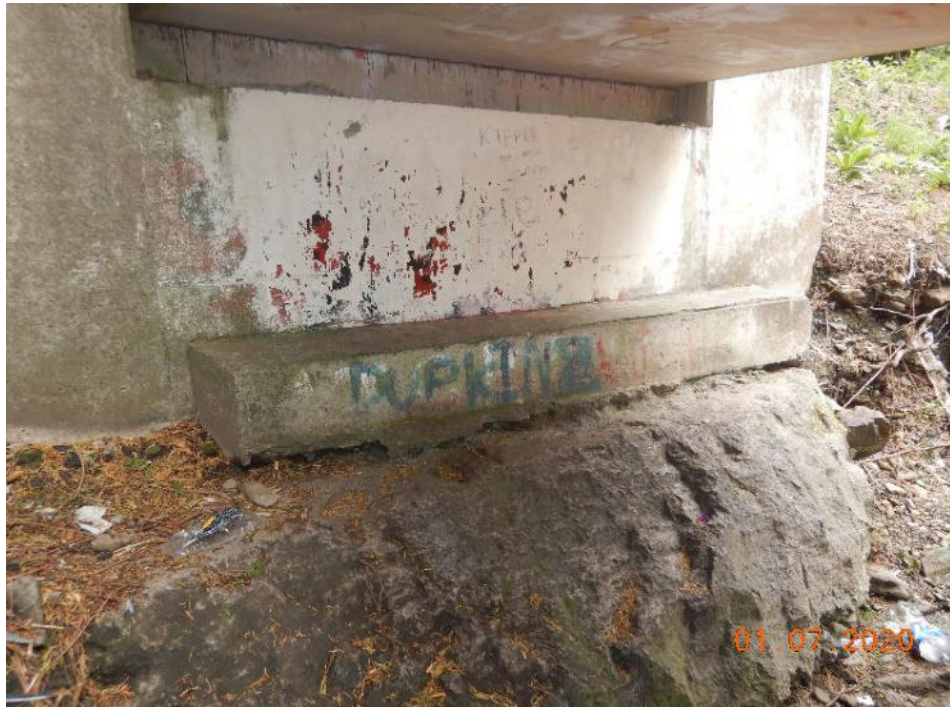
*Photo 79 – Tynybryn footbridge west abutment (156m – 158.8m)*

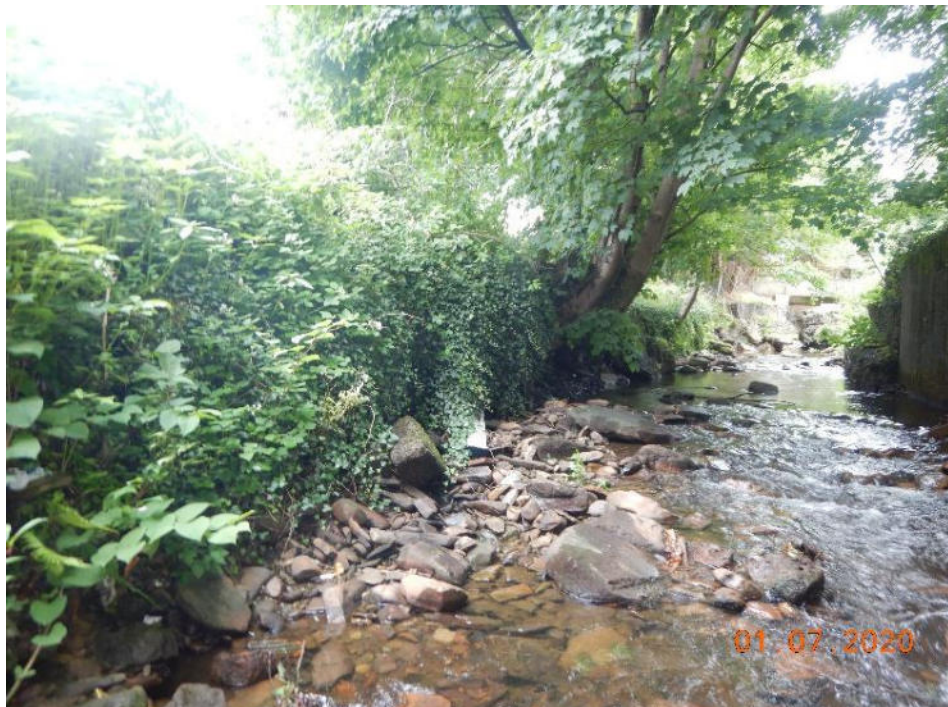
*Photo 84 – Vegetation growth to the embankment (180m – 246.6m)*

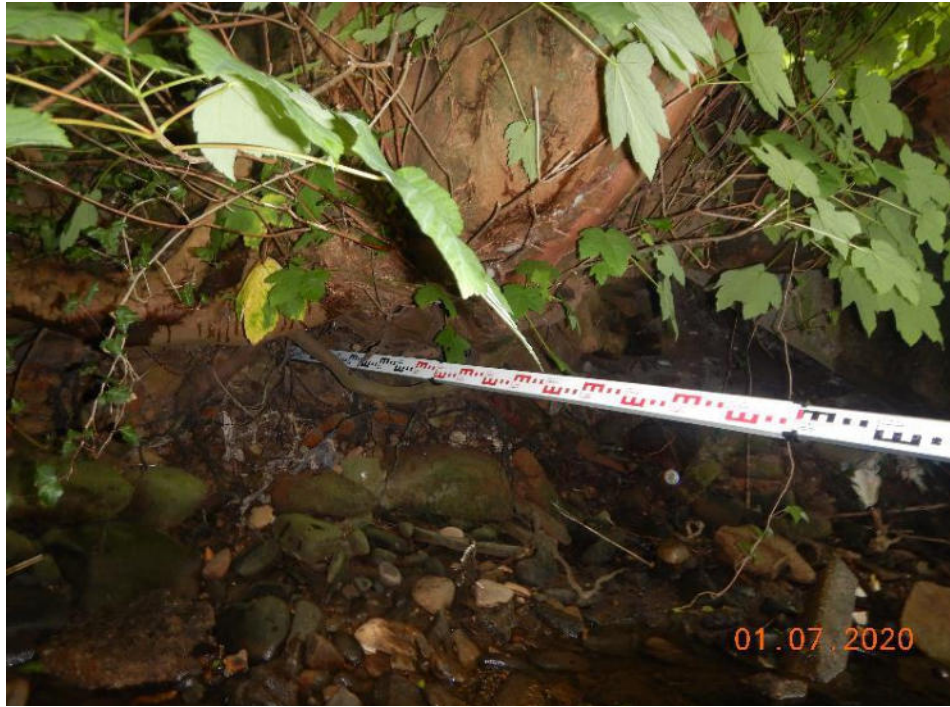
*Photo 85 – Scour undercutting a large tree (196m – 203.5m)*

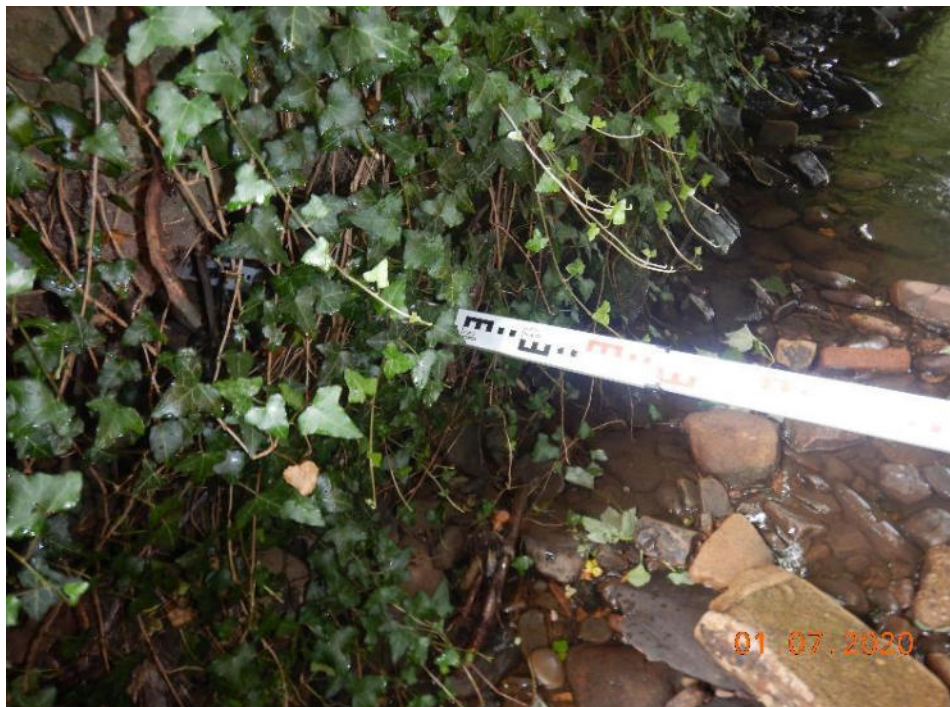
*Photo 86 – Scour to the embankment (196m – 203.5m)*

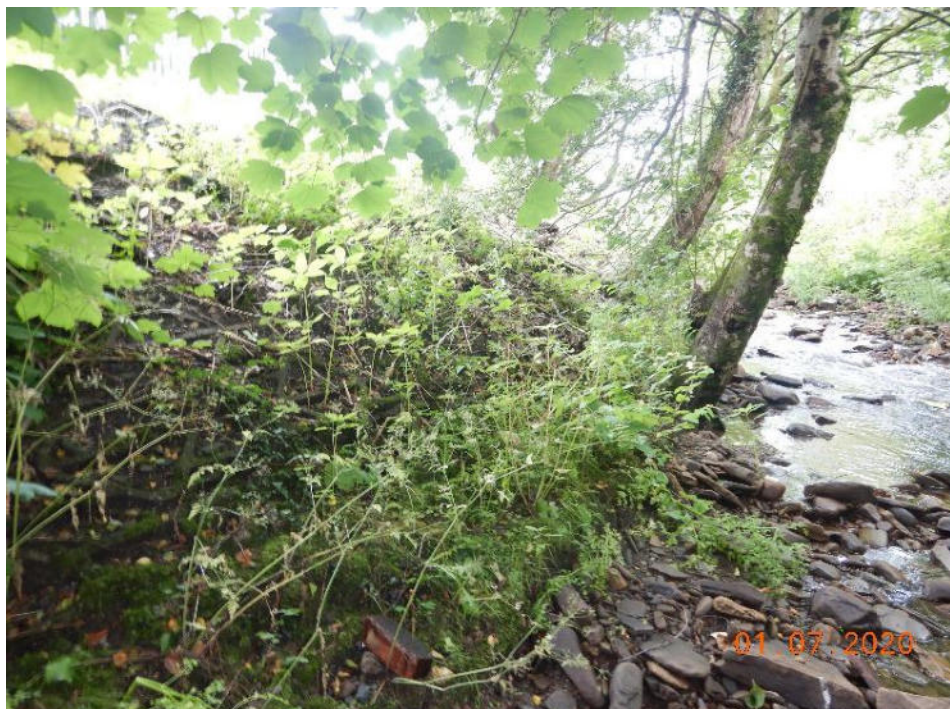
*Photo 90 – Vegetation growth to the revetment (293m – 304.5m)*

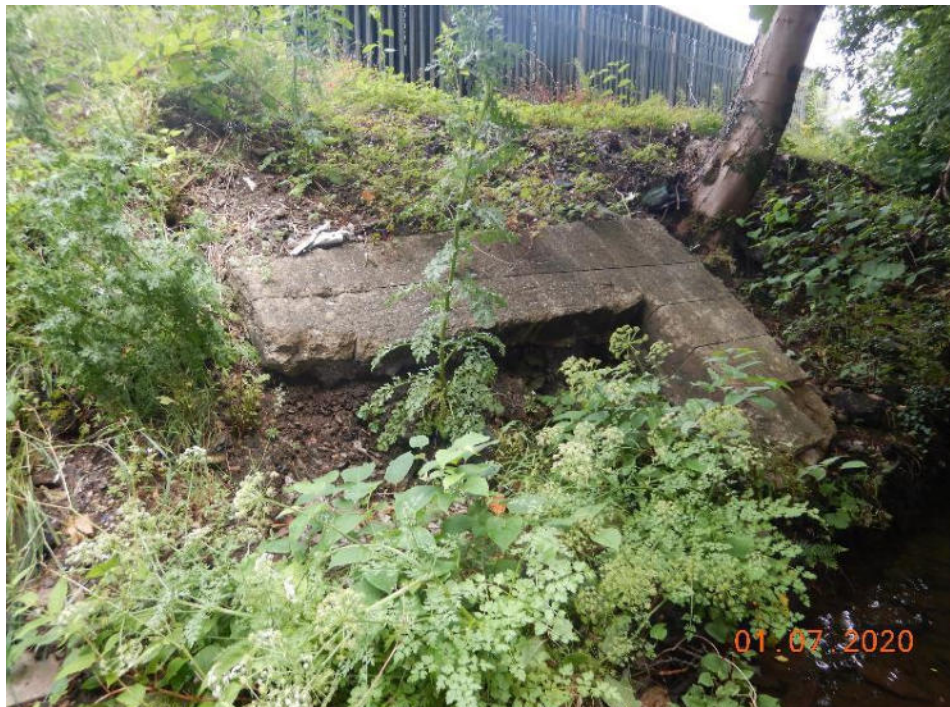
*Photo 92 – Section of concrete present to the embankment (317m)*

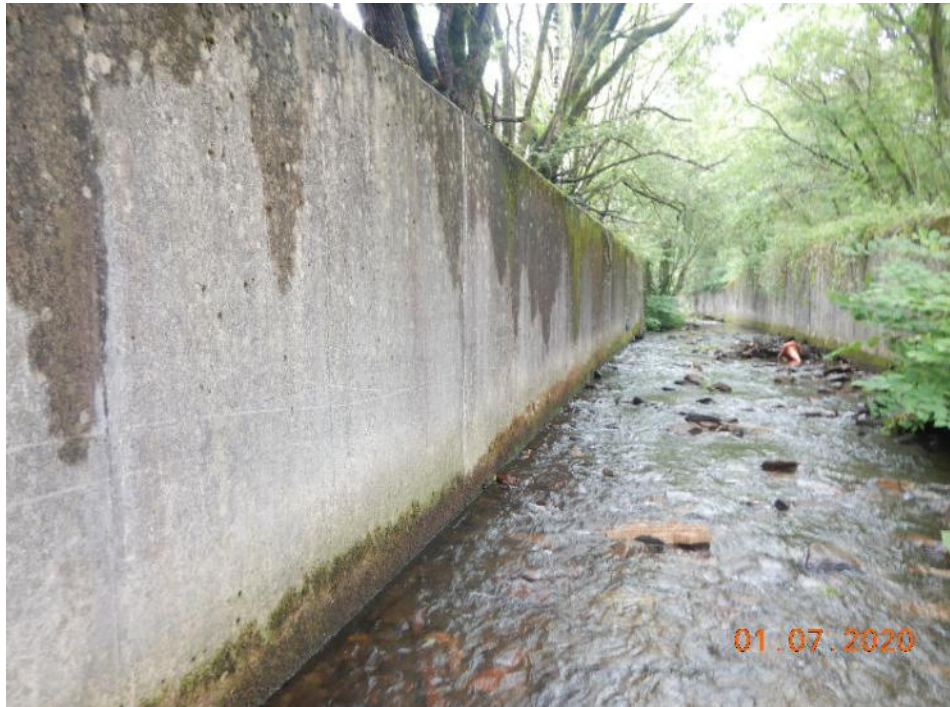
*Photo 93 – General view of the concrete retaining wall (320.5m – 413m)*

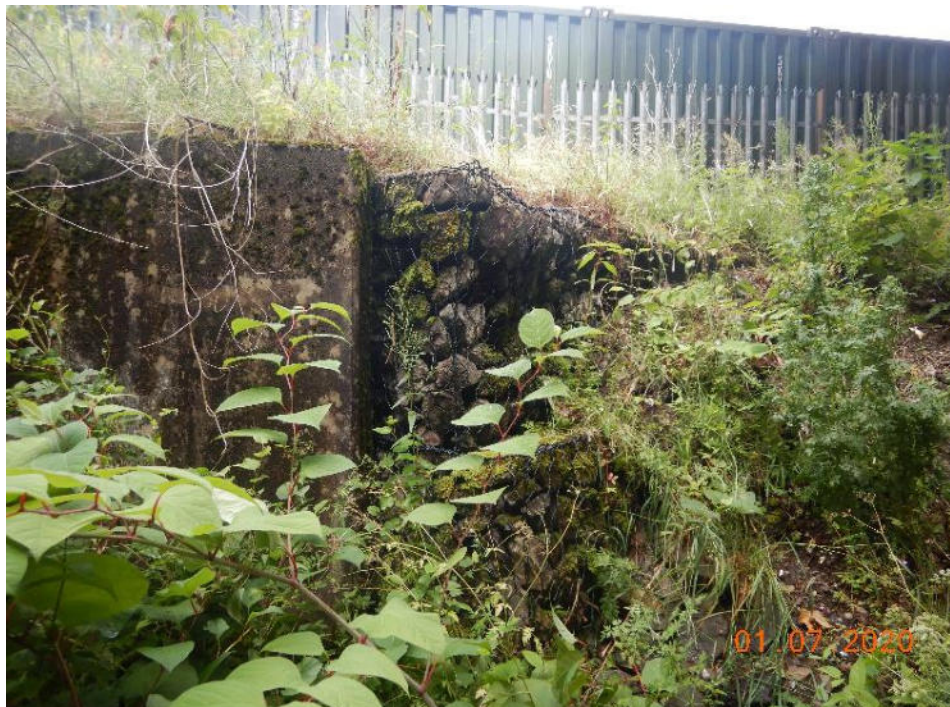
*Photo 94 – Condition of gabion baskets (320.5m)*

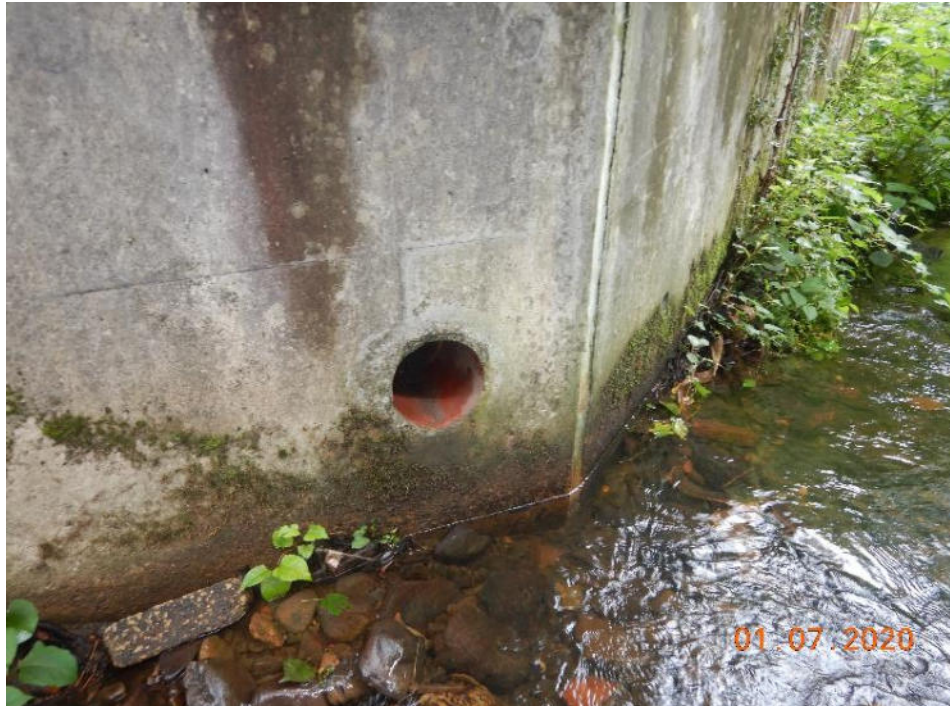
*Photo 97 – Clay drainage pipe (332.1m)*

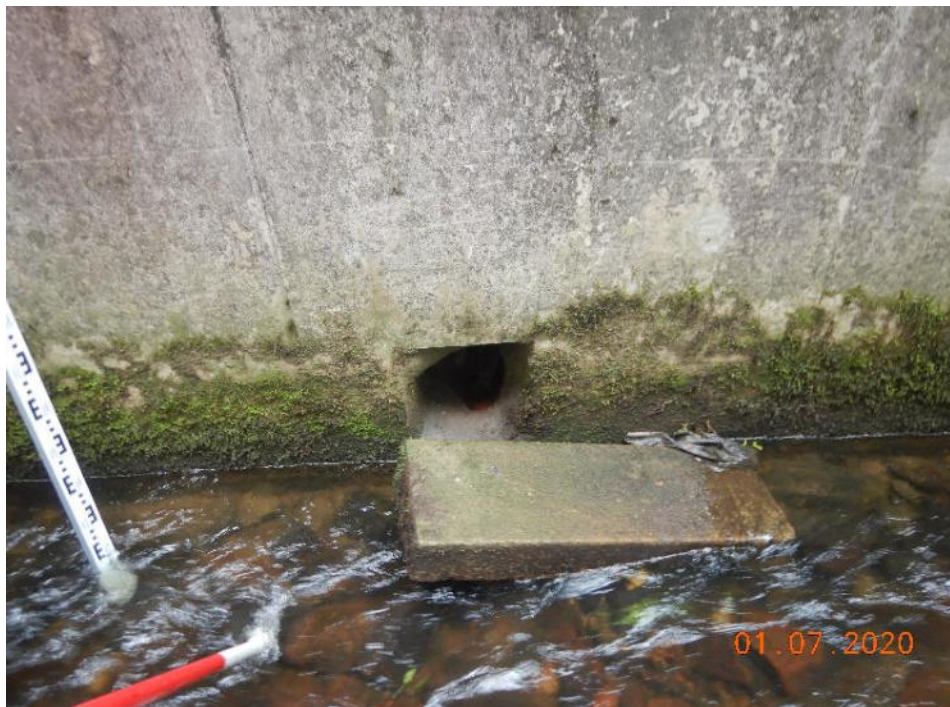
*Photo 98 – Clay drainage pipe (364.4m)*

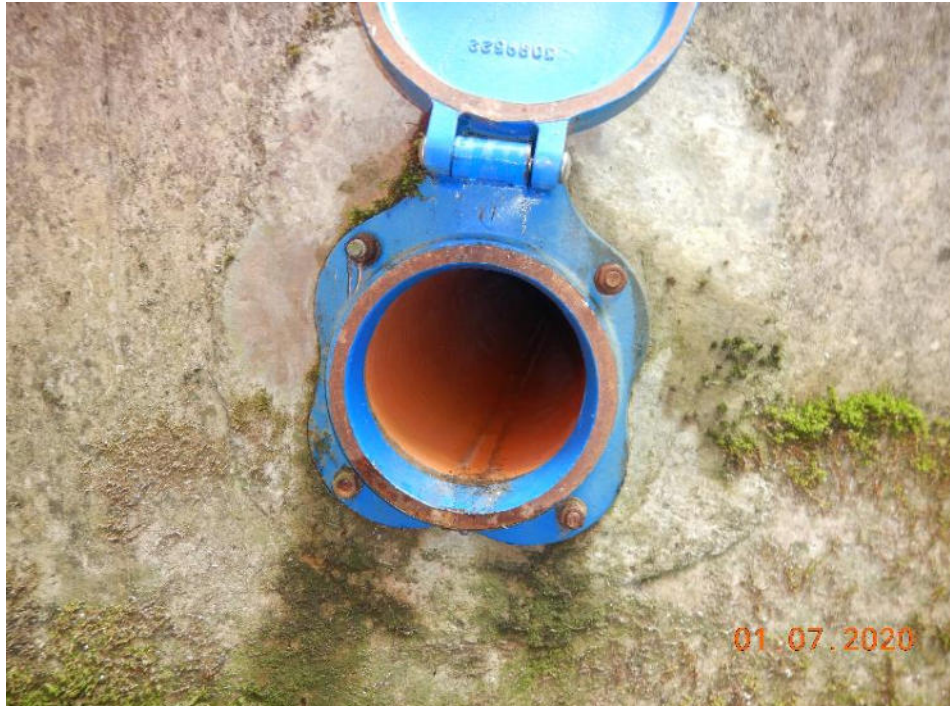
*Photo 99 – Clay drainage pipe (368.3m)*
