SAB, Flood risk and Drainage Technical Note

Cog Road, Sully

Cleaning • Surveys • Lining • Civils  
Job - 20958 - 01 - 001

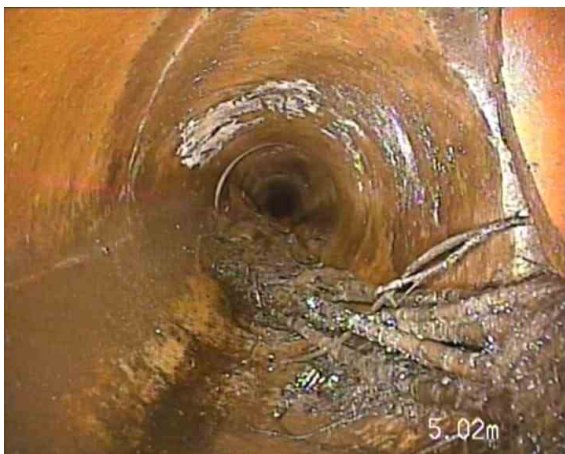
4, 00:01:18, 5.02 m  
Fracture, spiral from 8 o'clock to 1 o'clock

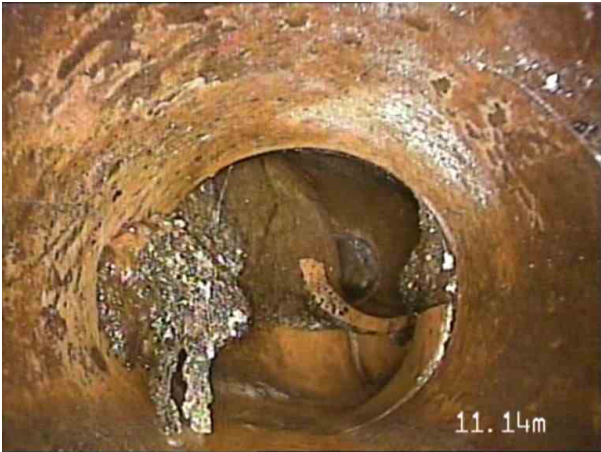
1, 00:01:41, 11.14 m  
Roots, mass, 15% cross-sectional area loss

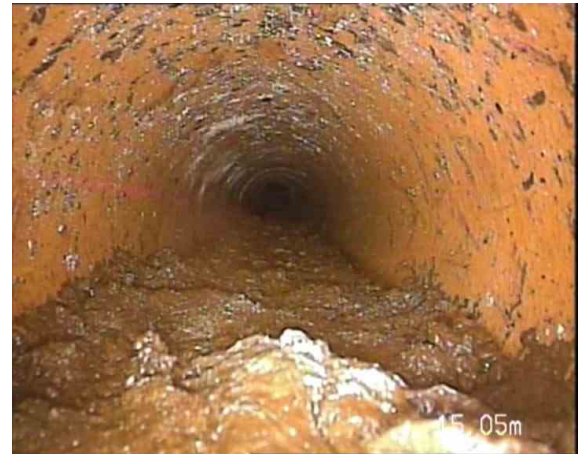
4, 00:02:34, 15.05 m  
Survey abandoned, UNABLE TO GET PAST SILT

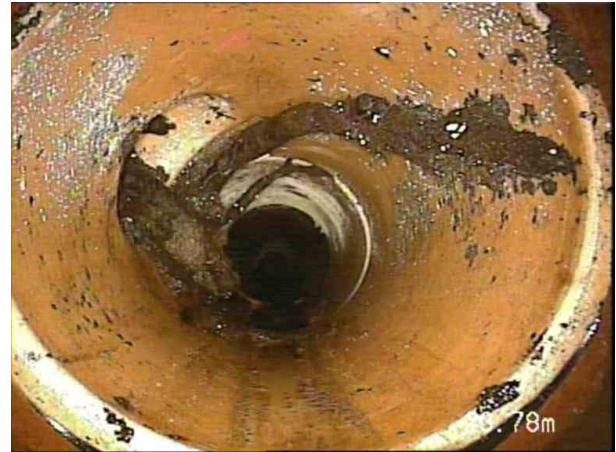
14, 00:04:26, 23.78 m  
Roots, tap, OUT OF JUNCTION

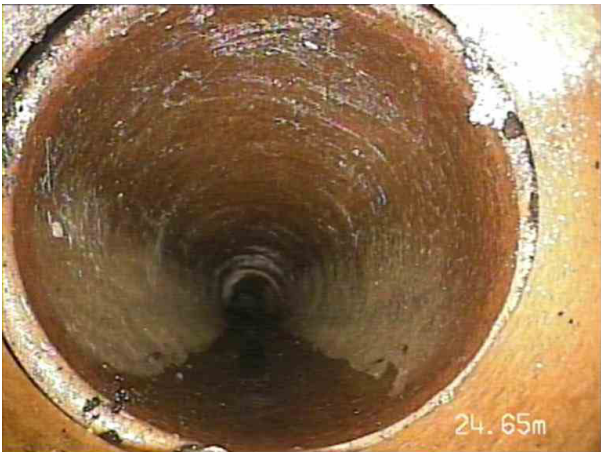
15, 00:04:40, 24.65 m  
Open joint, medium

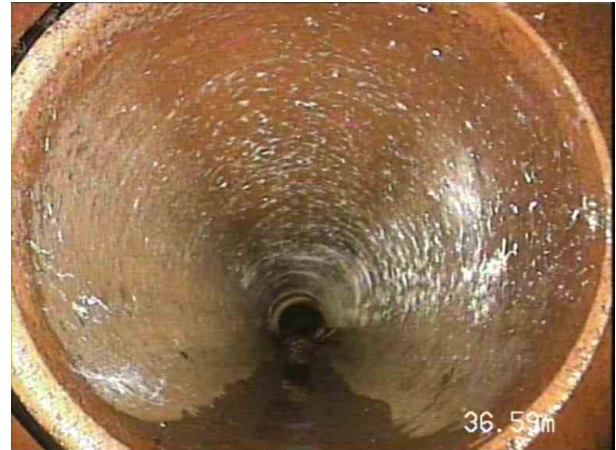
20, 00:06:12, 36.59 m  
Open joint, medium

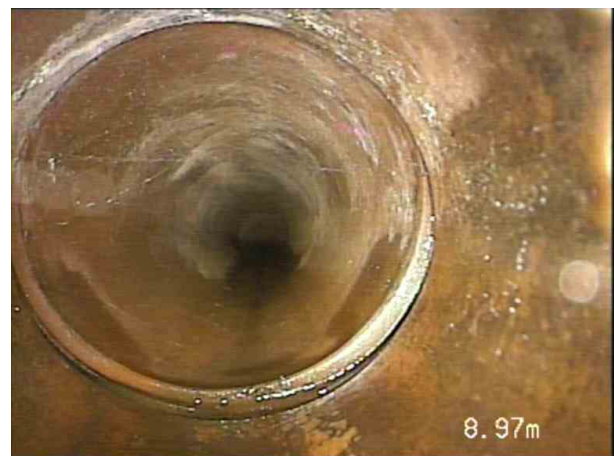
4, 00:01:34, 8.97 m  
Open joint, medium

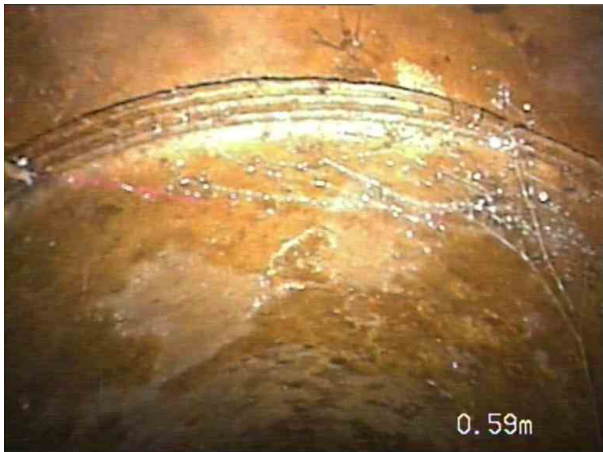
1, 00:00:23, 0.59 m  
Open joint, medium
